THE MANAGEMENT OF ORGANISATIONAL CHANGE

Trevor A. Kletz

Department of Chemical Engineering, Loughborough University

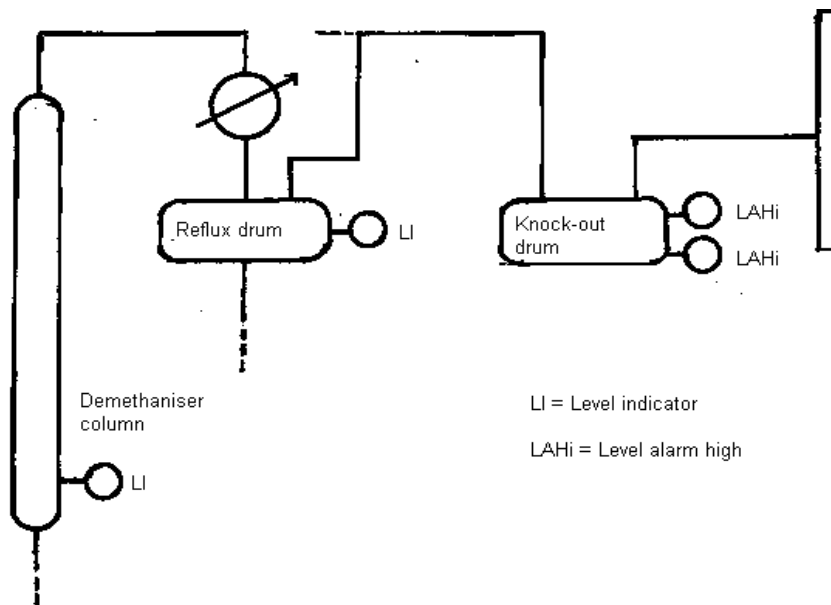
The plant was starting up after a turnaround. At 2 am on the day of the incident the shift team started the flow of cold liquid to the demethaniser column. A level should have appeared in the base of the column two hours later. It did not, but problems elsewhere distracted the shift team and they did not notice this until 7 am. By this time the temperature at the top of the column was -82°C instead of the usual -20°C and the level in the reflux drum rose from zero to full scale in 10 minutes. This should have told the shift team that the column had flooded, had overflowed into the reflux drum and would now be filling the flare knock-out drum (see Figure 1). However, neither of the two high level indicator/alarms on this drum, set at 8% and 22% of capacity, showed any response.

It was 12 noon before anyone had a thorough look at the column. They found that the wires leading from the column level indicator were disconnected and that the valves between the knock-out drum and its level indicators were closed. Both vessels were shrouded with scaffolding and the state of the wires and connections was not easily seen. Liquid was now entering the flare stack. It failed as the result of low temperature embrittlement and was followed by a fire.

The immediate causes of the incident were the failures to restore the isolations of the level instruments before start-up and the slowness of the shift teams to realise what was happening. The underlying causes were far deeper and were due to both short-term and long-term changes in organization.

Figure 1. The level indicator on the column and the level alarms on the knock-put drum were out of order. The column filled with liquid which over-flowed into the to drum and then into the stack
