A SUMMARY OF THE SIERRA CHEMICAL EXPLOSIVES MANUFACTURING INCIDENT INVESTIGATION

Kenneth H. Harrington and Susan E. Rose
Battelle Memorial Institute, Ohio, USA

On January 7, 1998, two explosions in rapid succession destroyed the Sierra Chemical Company Kean Canyon plant near Mustang, Nevada, killing four workers and injuring six others. Because of the loss of life and extensive damage, the CSB sent a team to investigate the explosion in an attempt to understand the causes of the incident. The investigation, which was the first investigation initiated by the CSB, focused on identifying the most probable initiating event and the factors that may have contributed to the incident.

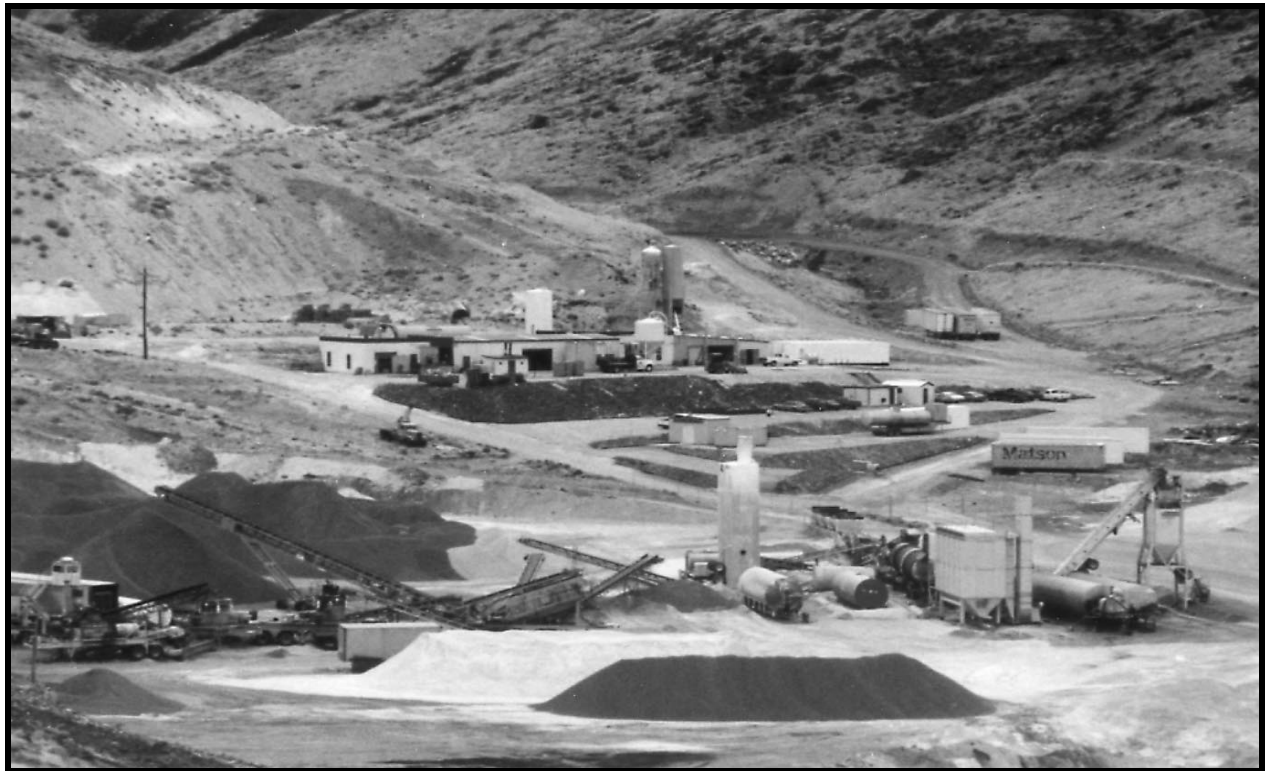
Figure 1. Kean Canyon Facility

The plant's facilities were built on a series of terraces as shown in Figure 1. The highest terrace was a storage yard for equipment and materials. The next terrace contained storage tanks for process water and soda ash. Booster production, flux mixing, and soda ash repackaging operations were located in the production building on the third terrace down, approximately ten feet below the previous terrace. A chemistry lab, an employee break room, and a parking area were located on the fourth terrace, which was 18 feet lower than the previous terrace. The PETN building and magazine were located on the fifth terrace, approximately five feet below the previous one, or about 23 feet below Booster Room 2.

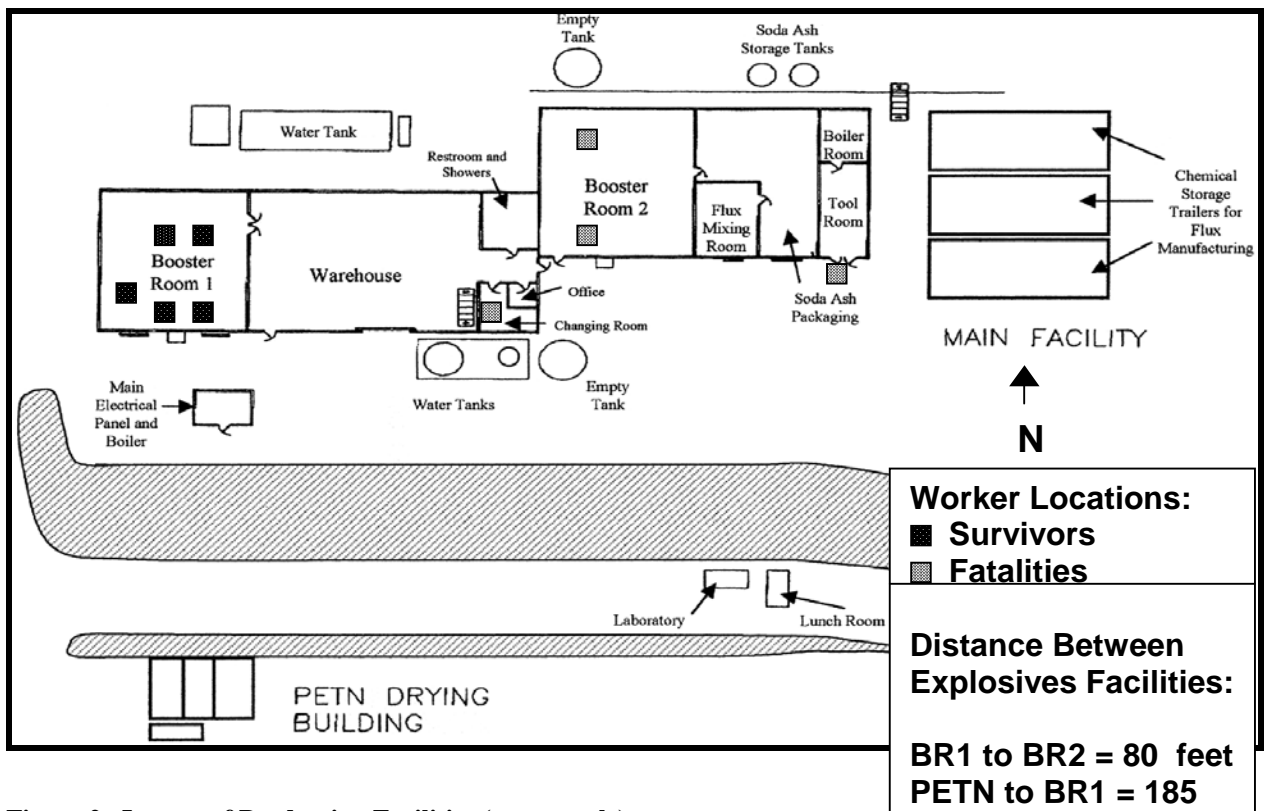
Figure 2. Layout of Production Facilities (not to scale)

Figure 2 shows the various buildings and rooms used in the melt/pour, flux, and soda ash operations. Booster Room 2 was built before 1974 and was refurbished for the melt/pour operation in 1996. For convenience, north is shown to be at the top of Figure 2, perpendicular to the back wall of the production buildings.

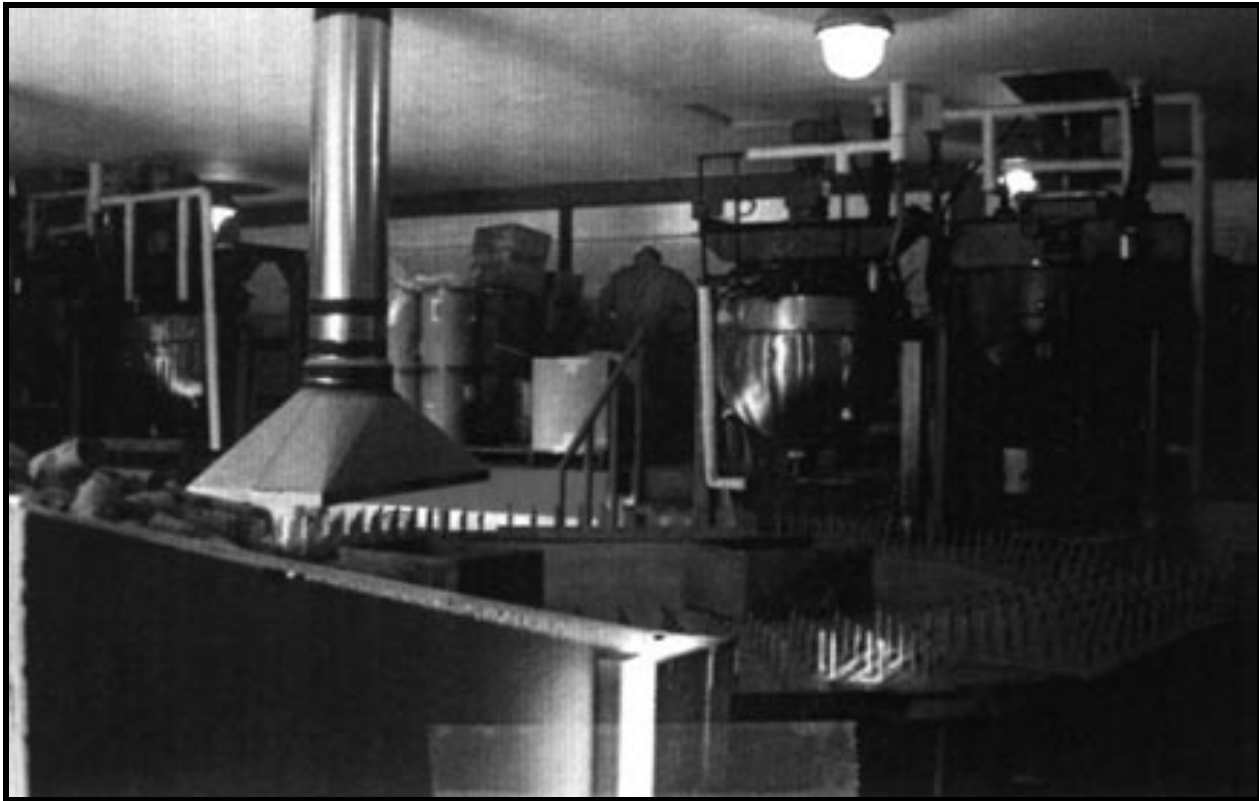
Figure 3. Booster Room 2

Booster Room 2, shown in Figure 3, was approximately 40 feet wide by 40 feet long and had been put into operation about four months prior to the explosions. A platform along the north wall of Booster Room 2 had an 8-inch, reinforced, poured-concrete floor supported by steel I-beams. Workers placed materials in the center of the platform between two independent melt/pour production lines.

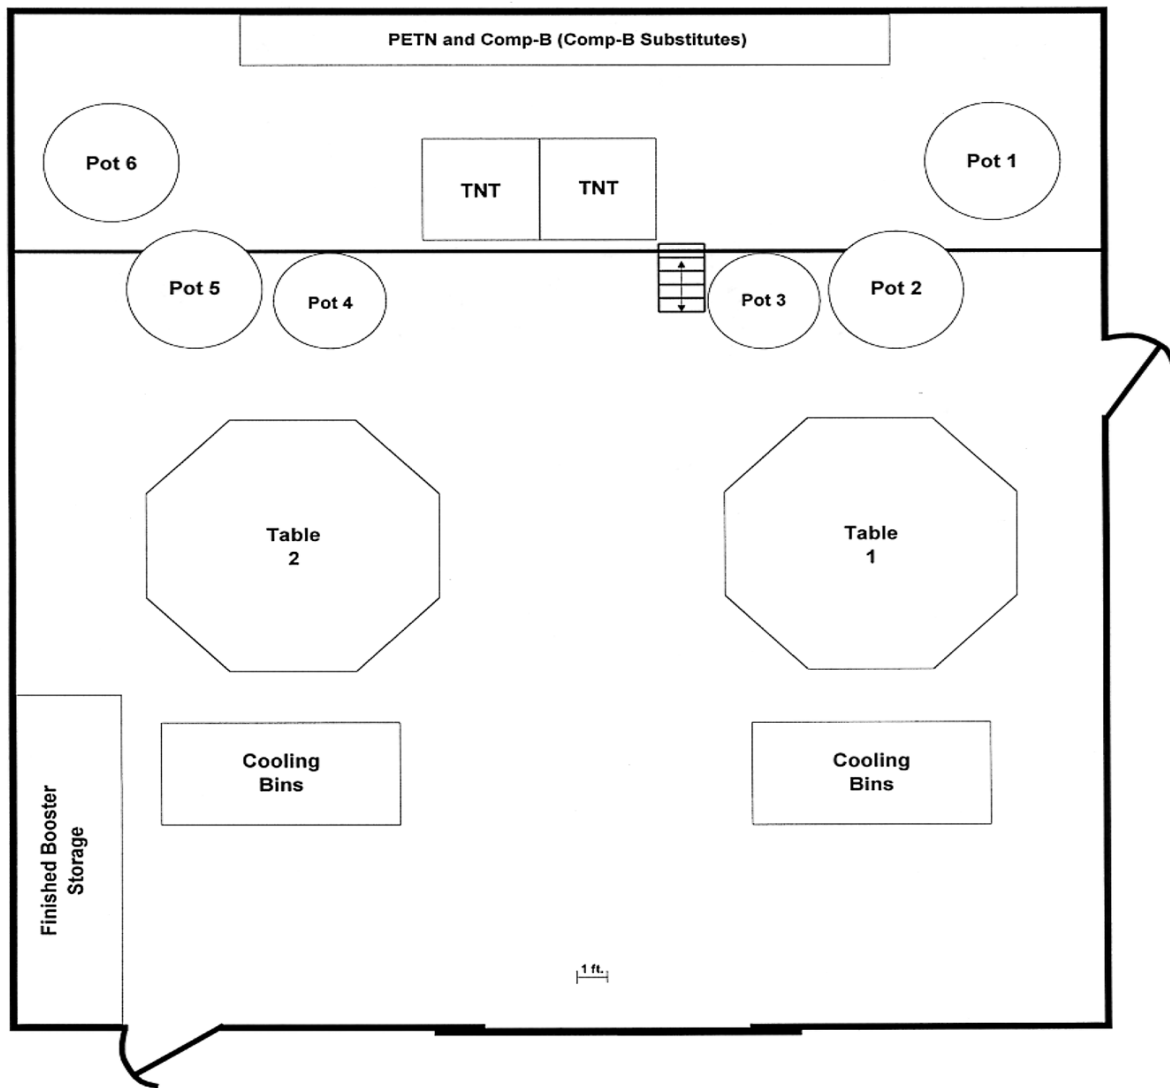
Figure 4. Booster Room 2 Layout

Booster Room 2 contained six mixing pots on or beside the four-foot high platform along the north wall. These pots were numbered 1 to 6 from east to west. Pots 1, 2, and 3 were placed in a mirror image of pots 6, 5, and 4, respectively. Pots 1 and 6 had not yet been placed in service. Pots 2 and 5 were used to make the base mix consisting of TNT, Comp-B, and PETN. Pots 3 and 4 were smaller and were used to make Pentolite from PETN and TNT. They were mounted in an I-beam support structure located directly in front of the raised platform. All mixing pots were equipped with gauges that indicated steam jacket temperatures and explosive mixture temperatures to aid operators in controlling the process. Each pot had an exhaust line to carry any dust or vapor from the pots outside through a series of particulate filters. The mixing pots in Booster Room 2 and the location of explosives between the pots is shown in Figure 4.

Operators were responsible for the preparation of explosive mixes, the operation of the mixing pots, and pouring mixes into booster cylinders. (See Figure 4 for layout of Booster Room 2.) At 3:00 p.m. on January 6, an operator for the west side of Booster Room 2 left work early, leaving 50 to 100 pounds of melted explosive base mix in pot 5. He mentioned this to the other operator in the room, who later checked and saw the explosives in pot 5.

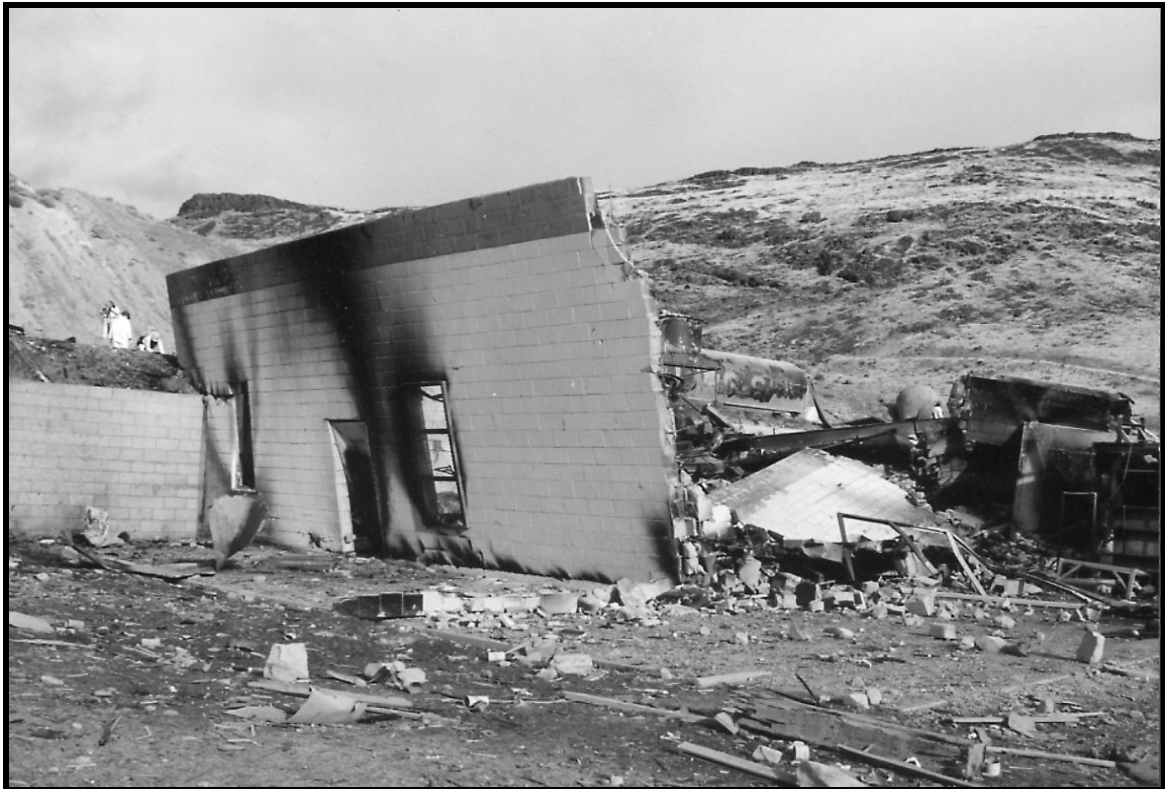
Figure 6. Booster Room 1 After Explosion

A total of 11 Sierra employees were at the site at the time of the incident. Following the explosions, five workers in Booster Room 1 were trapped temporarily under the collapsed building, but were able to crawl out within a few minutes; three were seriously injured and two received minor injuries.

The blast effects of the explosions leveled the site and threw structural materials, manufacturing equipment, raw materials from the booster and flux operations, and other fragmentation up to 1,000 yards away. Figure 6 shows Booster Room 1 and Figure 7 shows Booster Room 2 following the explosions. The legs and cross bracing from an empty tank, which previously stood at the corner of the change room, were imbedded in a motor home located 900 feet from the production building. The doors of one of the large magazines and a portable magazine located west of the production facility were sprung open by the negative pressure pulse; however, large quantities of explosive materials that were stored inside did not detonate. Many undetonated boosters had been scattered throughout the site by the explosion. Other hazards at this time included fires, toxic chemicals, and potential detonation of the explosives in Booster Room 1 as the fire progressed.

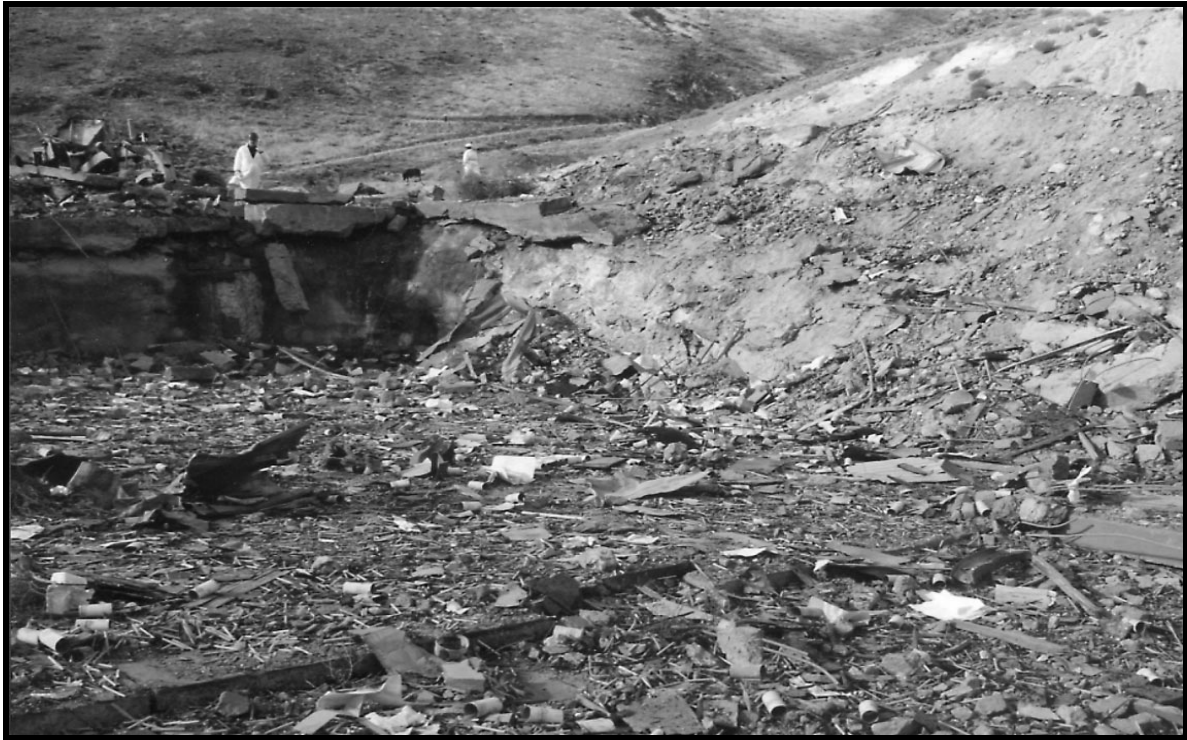
Figure 7. Booster Room 2 After Explosion

The day before the incident, one melt/pour operator working in Booster Room 2 needed to leave work early. When he left, there were between 50 and 100 pounds of base mix left in his large mixing pot. The mixing pot's blade extended about two inches into the mix. The following morning, the same operator turned on the motor to the mixing pot in which the mix had stratified and solidified overnight. The bottom of the mixer blade, which was

embedded in the solidified explosives in the pot, detonated the explosives by impact, shearing, or friction of the explosive material with the pot wall. Another possibility is that chunks of explosive material were pinched between the mixer blade and the pot wall, causing the detonation.

The explosive shock wave detonated several thousand pounds of explosives in the room that then destroyed the building. A heavy piece of equipment or burning debris from this first blast most likely fell through the reinforced-concrete roof or the skylight of the PETN building, initiating the second explosion 3.5 seconds later.
