AN OVERVIEW OF THE SHELL FLUOROAROMATICS PLANT EXPLOSION

D.G. Mooney
Shell UK Limited, Stanlow Manufacturing Complex.

The consequences and cause of a runaway reaction during the production of difluoro-nitrobenzene are described. A previously unknown reaction, resulting from contamination of recycled solvent by an unforeseen route, heated the reactor contents to a temperature at which they decomposed in a violent second reaction. Lessons for safety assessment during batch reaction development and design are highlighted.

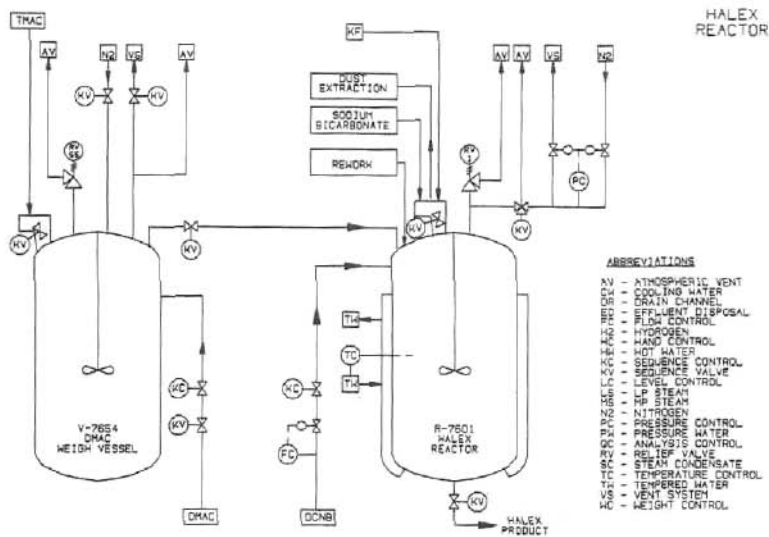
Figure 3 Halex reactor flowscheme

The pressure in the reactor was controlled throughout the reaction at about 0.2 barg by a split range controller which either admitted nitrogen or vented to the plant vent header. Build-up of pressure had never been observed during any CFA or DFA halex reaction during the 14 years the plant had been in operation. A remotely-operated vent valve also discharged into the same vent line, which contained a restriction orifice to prevent possible high venting rates (eg after nitrogen-pressured transfers) from overloading the vent header. The reactor was fitted with a relief valve set to relieve to atmosphere at 5 barg and sized for what had been calculated to be the worst case - a utility failure during the production of another fluoroaromatic.

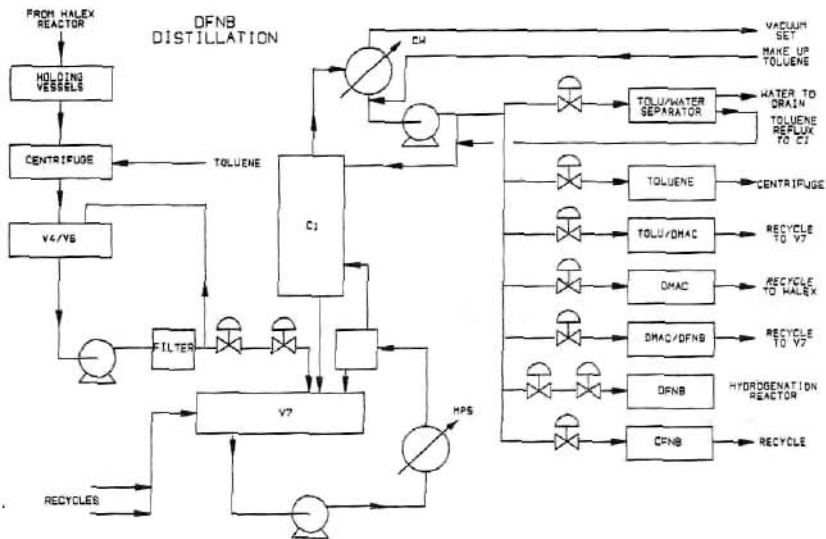
Figure 4 DFNB distillation

On the 2nd March, a very large quantity of water entered V7 via two passing valves from the centrifuge system, which was being routinely washed to remove accumulated salts. The contents of V7 were moved to holding vessels and returned batchwise for water removal by repeated azeotroping. This appeared to be successful but, when the distillation sequence was continued on the 10th March, 1% water was found in the DMAC/DFNB intercut and the nominally DFNB product stream obviously contained another compound, later shown to be dimethylamino fluoronitrobenzene. The distillation column contents were therefore drummed off for disposal. Various samples were taken for later examination and proved invaluable for the explosion investigation. Between the 10th and the 19th of March similar attempts to recover product from the remaining contents of the various holding vessels were unsuccessful but apparently on-specification DMAC was recovered to storage for use in the next hallex batches.

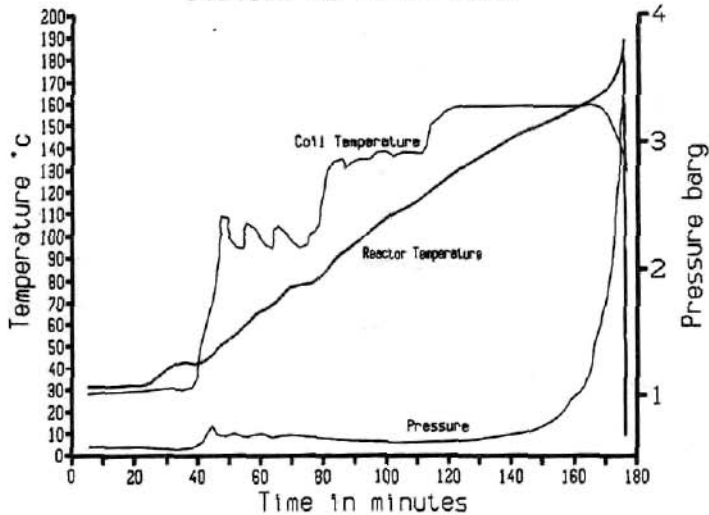
Figure 6 Process conditions - DFNB runaway batch

The reactor process conditions were recorded as one minute averages by the plant computer but only transferred to "hard" disc storage at 5 minute intervals. After the explosion the disc was recovered but it only showed the one minute interval spot readings upto the end of the last complete 5 minute interval before the explosion. The reactor pressure and temperature and the jacket temperature are shown pictorially in Figure 6. This indicates a typical runaway reaction, but other possibilities were systematically investigated and have been eliminated.

2,4 - DFNB Batch 44
Stanlow 20 March 1990

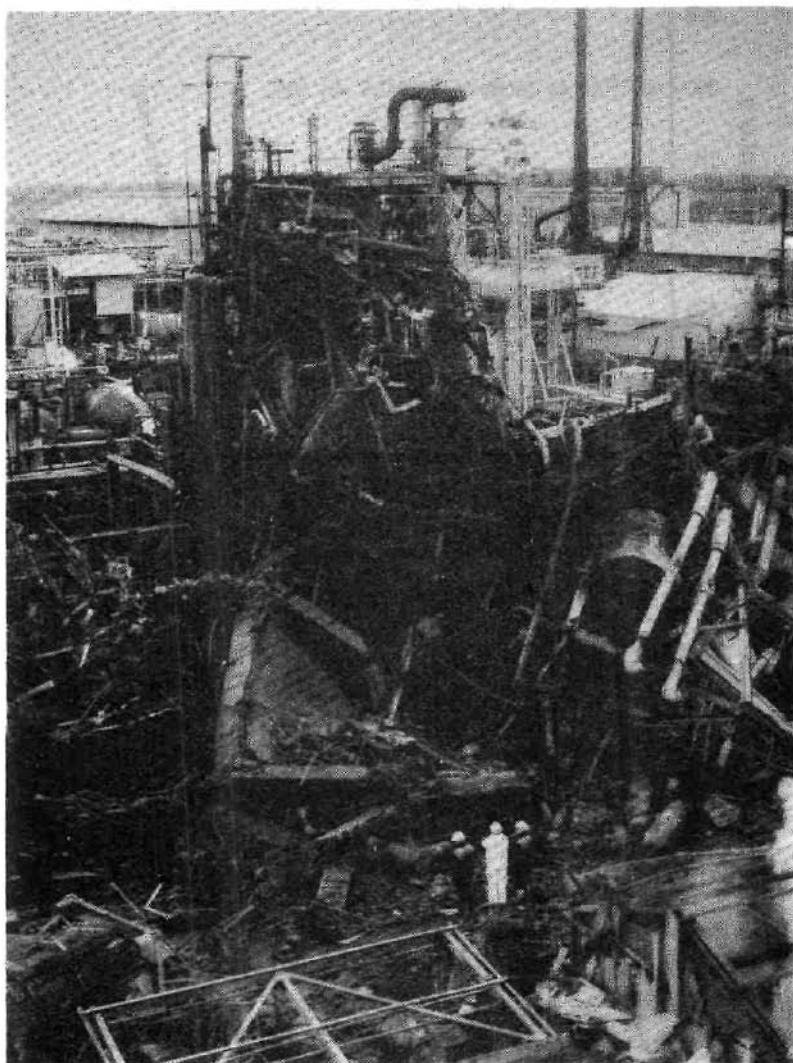
Figure 5 Fluoroaromatics plant after explosion

The reactor was torn into three large pieces one of which was thrown 200 metres. Almost all the other missiles which fell outside the immediate area landed between NNW and NW of the reactor. The reactor itself became virtually a straight piece of metal, the plant structure within about 5 metres was either turned into missiles or buckled beyond recognition and the surrounding structure collapsed. (See Figure 5). Off-plot blast damage was erratic, suggesting shielding or an asymmetric event. In Thornton Research Centre, 300 - 500 metres to the east, there was random damage, mainly windows cracked and broken, and doors and panels displaced.

Witnesses report that the reactor contents formed a fire ball. This started local fires and initiated what became a major conflagration in an adjacent unit where vessels containing xylene were damaged by the blast and/or missiles. The various fires took about four hours to extinguish but the County and Shell fire fighters were able to prevent further spread.

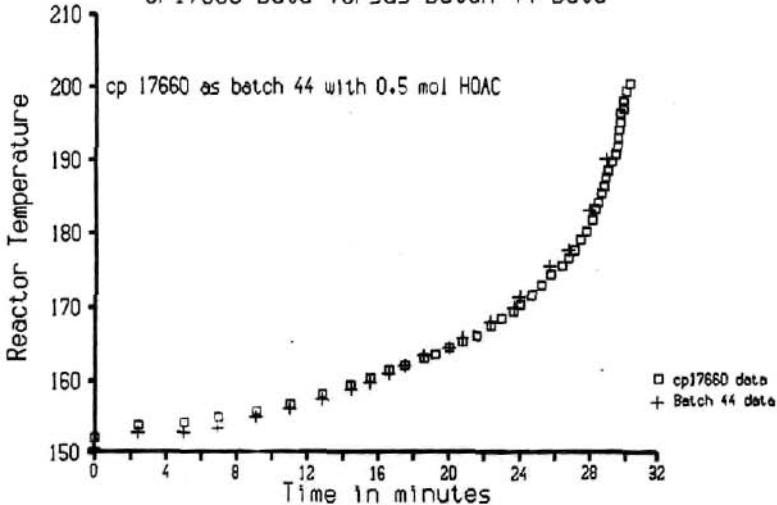
Figure 7 Laboratory simulation of runaway batch conditions

Analysis of the samples of DMAC taken from the plant after the explosion indicates that enough acetic acid had entered to cause the incident as observed.

THERMAL STABILITY INVESTIGATION
CP17660 Data Versus Batch 44 Data

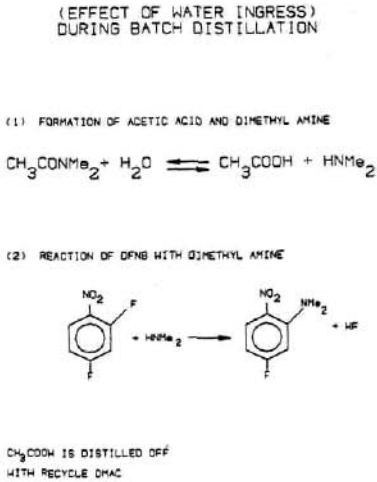
Figure 8 Water in DFNB distillation

However, it was also shown that a massive water incursion would have led to the formation of two phases in the unmixed distillation still vessel V7. Initially some of the aqueous upper layer would probably not have been circulated from V7 to the column and so water would have remained in the system to react with DMAC during the higher temperature stages of the distillation.

Further work confirmed the existence of a DMAC-acetic acid azeotrope with a similar boiling point to DMAC, which would have been recycled with the DMAC to the storage tanks under the distillation conditions. Finally, it was shown that all the fractions distilled from this DMAC-acetic acid mixture contained between 0.5 and 4.5% water, suggesting a possible ternary azeotrope and indicating that water would not be fully separated by simple distillation once acetic acid had been formed.

From the plant records and the various analyses it has been shown that all the water was not removed with the toluene. Both acetic acid and water remained in the intercut vessels and were found in the recycle DMAC samples. The operators were unaware of their inability to remove all the water once acetic acid had been formed.

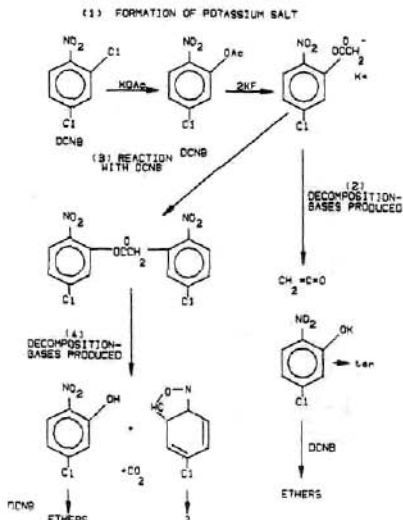
Figure 9 Acetic acid in "halex"

The reaction of acetic acid with the halox reaction components was investigated. Initially acetic acid and KF react to form potassium acetate, which in turn reacts with DCNB to form an acetoxy-chloronitrobenzene. This is not stable under the reaction conditions and reacts further to give decomposition products among which are ketene, carbon dioxide, polyaryl ethers and tars. (See Figure 9). This reaction was not previously known but was successfully simulated in a laboratory experiment. There is no literature precedent. The quantity of gas generated during the actual runaway reaction has been estimated from the reactor pressure record to match the gas generated experimentally with 0.5 mole acetic acid per mole of DFNB. This is of the same order of magnitude as the ratio of acetic acid to DMAC found in the fire-water contaminated DMAC charge vessel under the debris after the explosion.

EFFECT OF ACETIC ACID IN HALEX:
POSSIBLE MECHANISMS
