INVESTIGATION INTO THE CAUSE OF AN EXPLOSION DURING THE DRYING OF POROUS NITROCELLULOSE POWDER

J.W.Hartgerink^{*}

The investigation into the cause of an explosion in a propellant factory in the Netherlands is described. A combination of an analysis of the hazards involved in the particular process and a thorough study of the properties of the relevant porous nitrocellulose propellant led to the hypothesis that incorrect operation of the equipment caused the formation of electrostatic charges followed by spark ignition of the propellant. This hypothesis was substantiated by the results of model studies and it was possible to discard other theories.

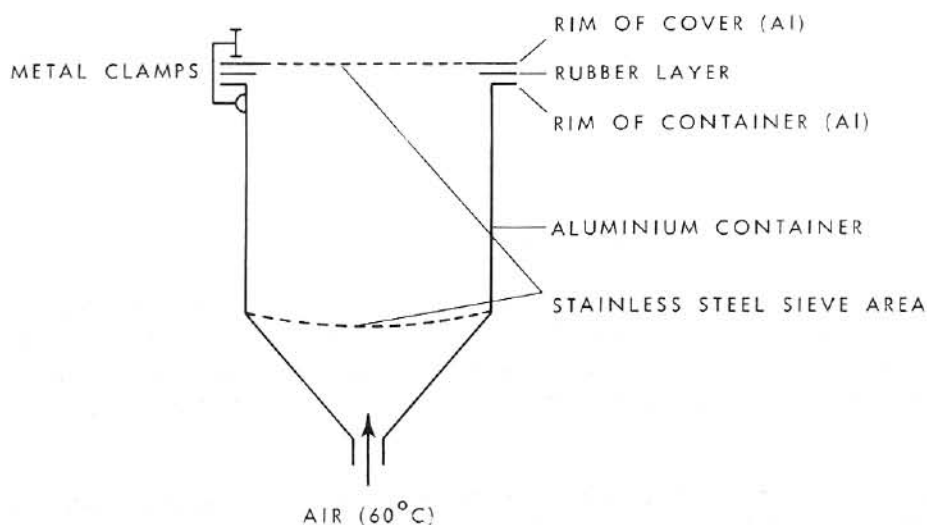
Fig.1 Setup of the drying process

The container with the propellant is connected to a source of hot air thermostatted at 60°C. The air leaves the container through its cover which basically consists of a flat aluminium ring with a large stainless steel sieve area in the middle. The cover is attached to the container by means of clamps; leaking is prevented by a thin rubber layer between cover and container. When the contents of a certain container are dry, the air flow is disconnected and the cover is lifted about ten centimeters by means of a hoisting device. The cover being fixed in this position the container can now be removed by means of a manually operated hydraulic lift car which carries the containers just a few centimeters above the floor.

A simple analysis of the actual disconnecting procedure shows that two actions have to be performed in the correct order. First the closing of the hot-air valve (and disconnecting the flexible air inlet from the container) and secondly the removal of the clamps, which keep the cover attached to the container, followed by hoisting the cover ten centimeters to be fixed in that position.

Another - less obvious - point is the fact that the cover is no longer grounded when the metal clamps are removed, since only the container itself is grounded and an insulating rubber layer is present between cover and container. Under normal conditions this does not matter too much, but with the air-flow still on it may result in a dangerous situation as the electrostatically charged propellant particles will be blown against the insulated cover, that might obtain a charge as well. This had to be verified by model studies and the amount of charge on an insulated cover of an authentic container had to be estimated in order to establish whether a spark discharge from the cover to the vessel would have sufficient energy to ignite the propellant.

When processing electrostatically charged materials one should always ground the several parts of the equipment when there is even the remotest chance that they might become disconnected due to incorrect handling.

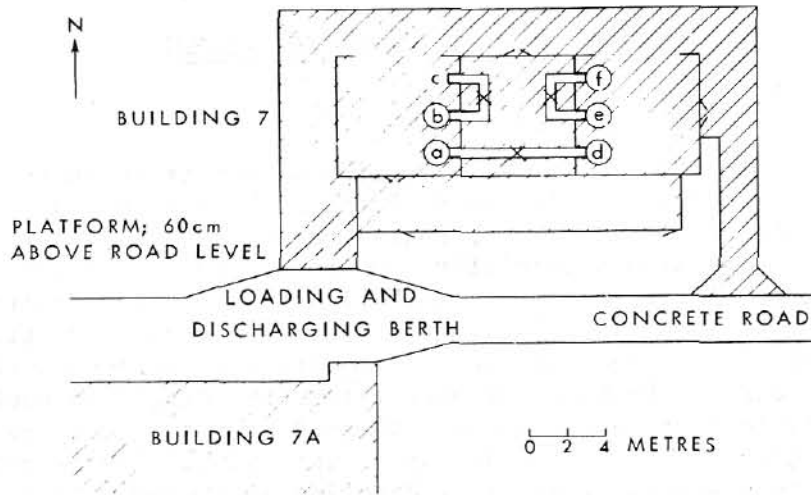
Fig.2 Situation in the drying building before the explosion

Fig.2. The two drying rooms - each with three units' capacity - were open on the northern side and had a light roof construction. The thickness of the walls does not show in the Figure; for instance, the southern side of the building consisted of a 1 metre brick wall.

Only three hot air generators were present in the central part of the building, each being connected with two containers by means of \varnothing 33 cm tubes. The two drying rooms were therefore connected by means of such a tube.

When a building consists of several compartments in which explosive materials are processed one should never make a connection between these rooms (for instance by means of a tube), since a sympathetic detonation should be prevented in the case of an accident in one room.

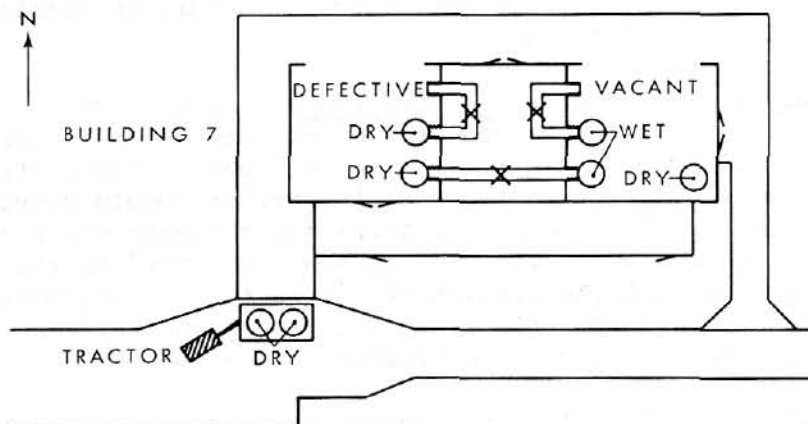
Fig.3 Situation in the drying building at the moment of the explosion

A wet container is fetched and connected to the now vacant drying unit and a second dry container (for instance e) is carried to the vacant position on the transport cart outside; the second wet vessel is taken inside, etcetera. This procedure will result in the situation shown in some detail in Fig.3. The exact time of the explosion in relation to the usual work schedule suggests that this situation was actually reached at the moment of the explosion.

The dry propellant in one of the two containers in the western drying room (Fig.3) was almost certainly ignited by a spark on the top rim of the container. The propellant mass in the container itself resembled a fluid bed due to the drying air; presumably this will have facilitated a deflagration - detonation transition. The second vessel will come to a detonation as well and the presence of the $\emptyset 33$ cm tube between the two drying rooms enables a sympatic detonation of the containers in the eastern drying room. The two containers with the dried product standing outside on the flat transport cart were probably hit by high velocity fragments and detonated as well. The damage observed on the surface of the concrete road suggests that one container exploded in upright position and the other one while falling after being blown away by the blast of the explosion inside the building. All seven containers were completely fragmented and the building was destroyed including the southern 1 metre brick wall. An account of the damage on the factory grounds and in the nearby village
