**MAJOR INCIDENT
INVESTIGATION
REPORT**

**BP GRANGEMOUTH
SCOTLAND**

**29th MAY – 10th JUNE
2000**

**A PUBLIC REPORT
PREPARED BY THE HSE
ON BEHALF OF THE
COMPETENT AUTHORITY**

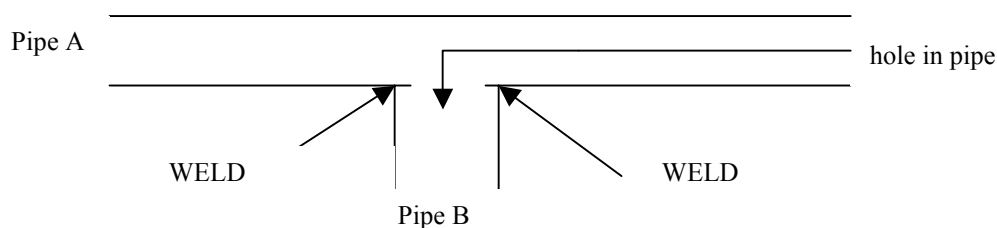
A tee-piece which is formed by welding one pipe over a hole made in another. In this case the tee-piece is formed by the pipes themselves with the joining weld being at the junction of the tee-piece. This is distinct from a forged weld-reducing tee-piece where

the junction is in the forged fitting and is at a distance from the welds between the fitting and the adjoining pipes.

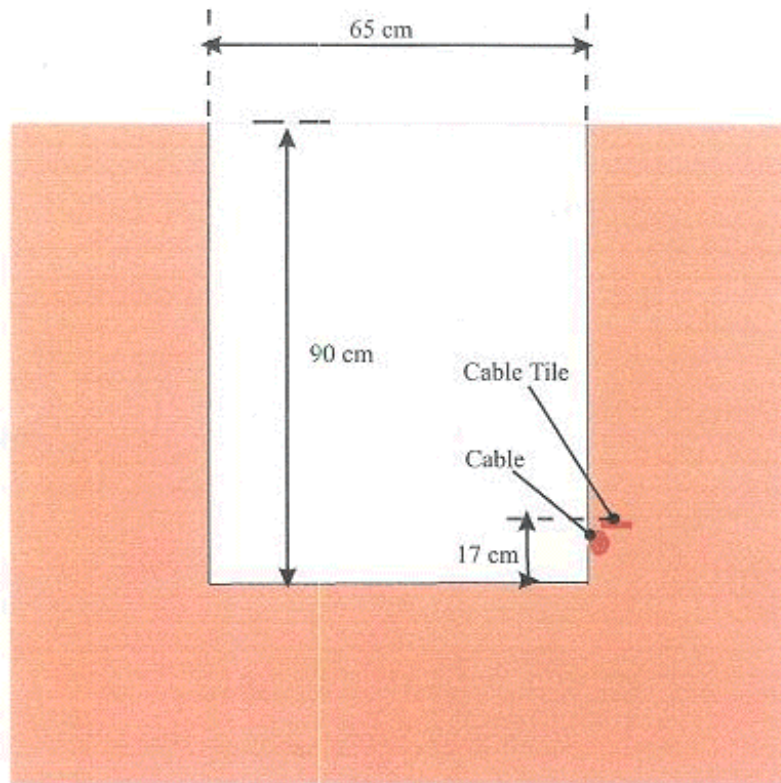
Figure 2 – Trench Diagram

Elevation of Trench Showing Cable Just Inside Side Wall

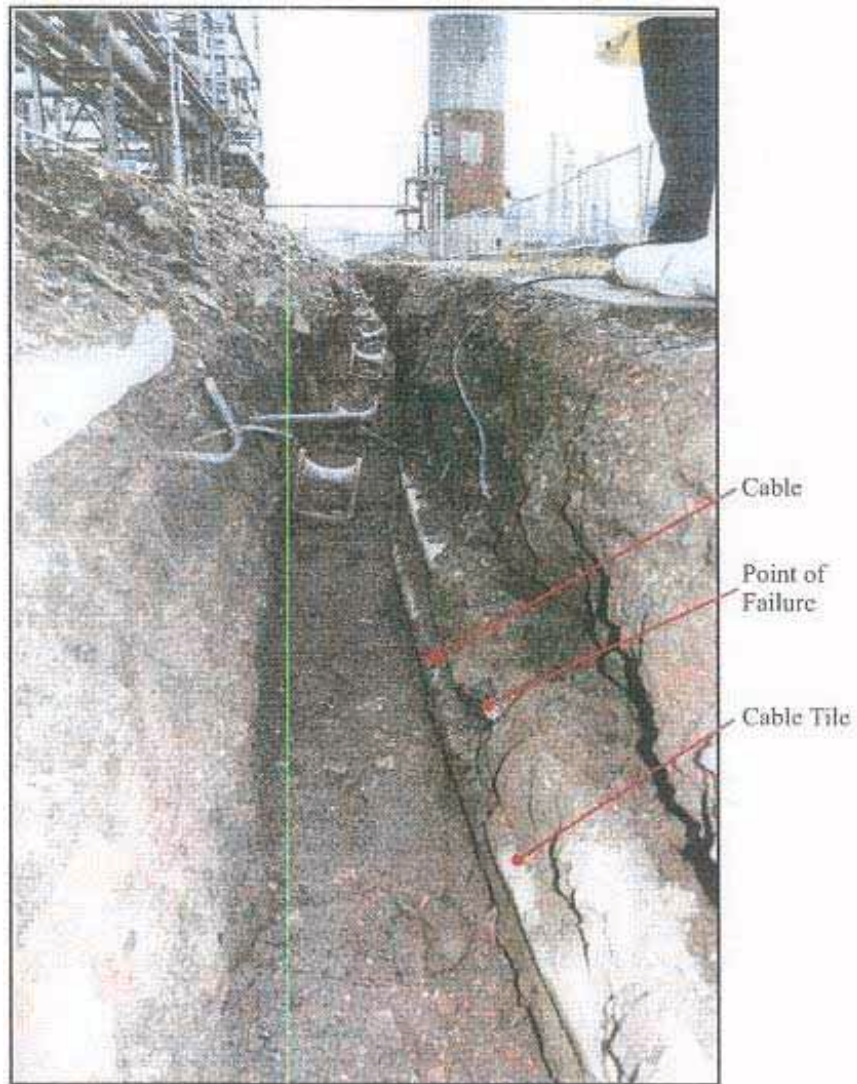
Figure 3 – Trench Photo

Cable Trench Showing Damaged Cable and Offset Cable Tiles

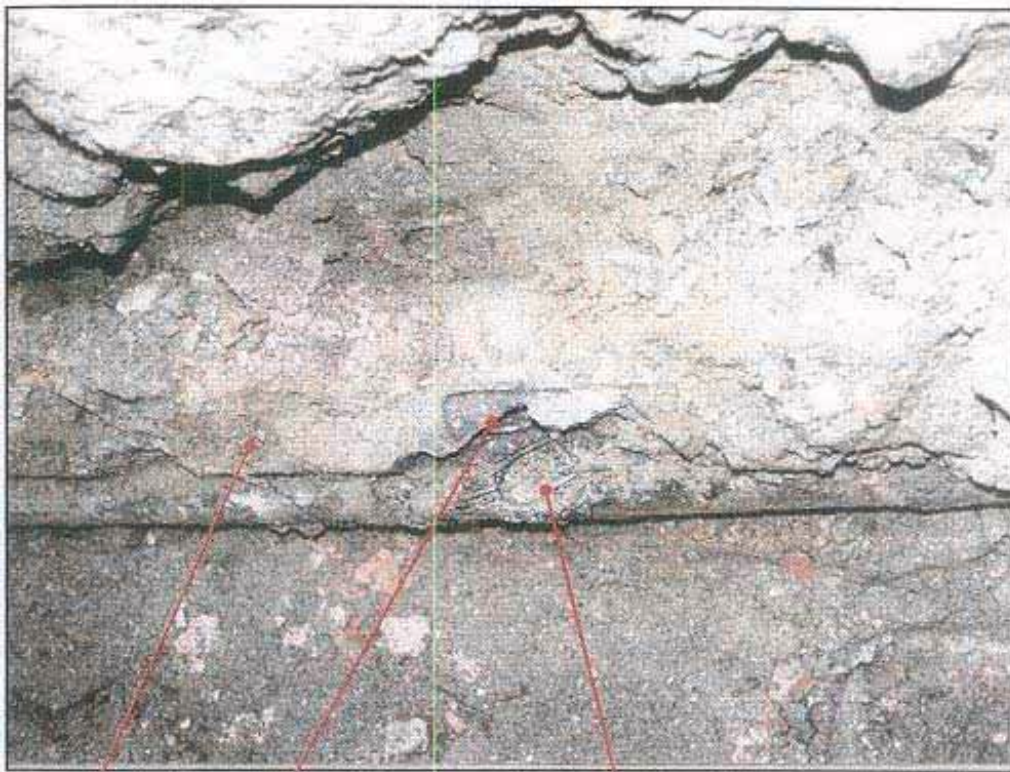
Figure 4 – Trench Photo

Cable Tile

Damaged Cable Tile

The Damaged Section of Cable and Cable Tile

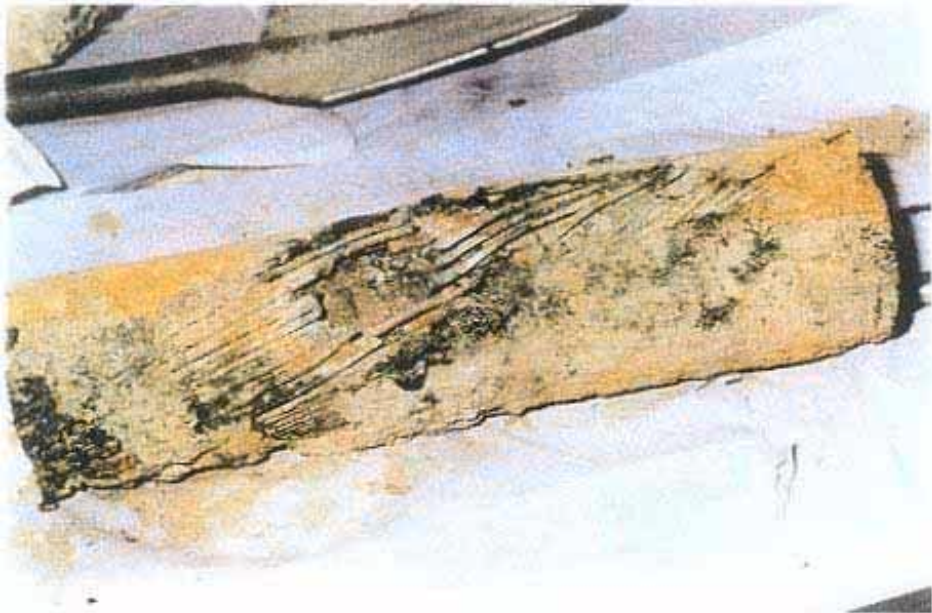
Figure 6 – Cable Photo

- Section of damaged cable prior to examination

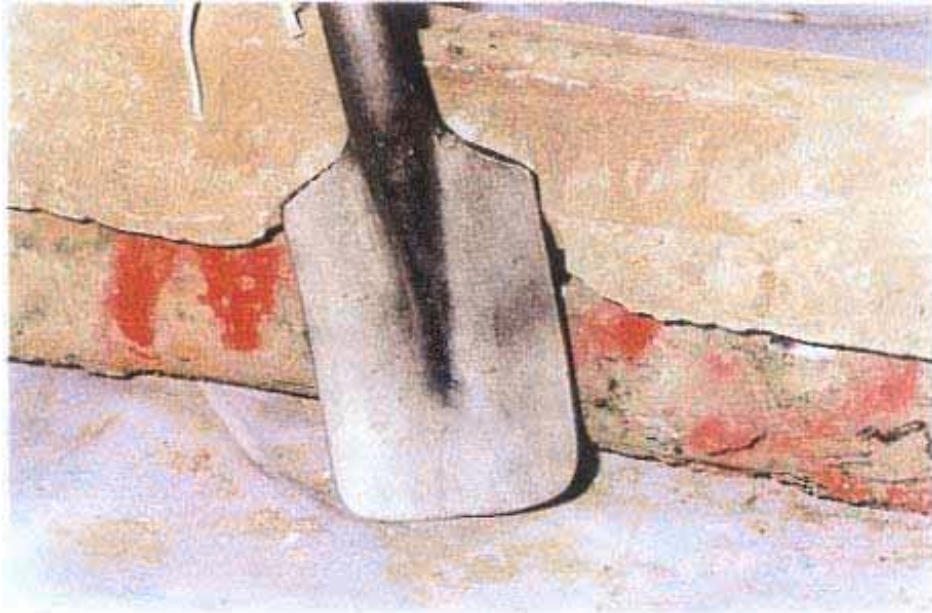
Figure 7 – Clayspade Photo

- Small pneumatic clay spade fitted to the damage site of Photograph

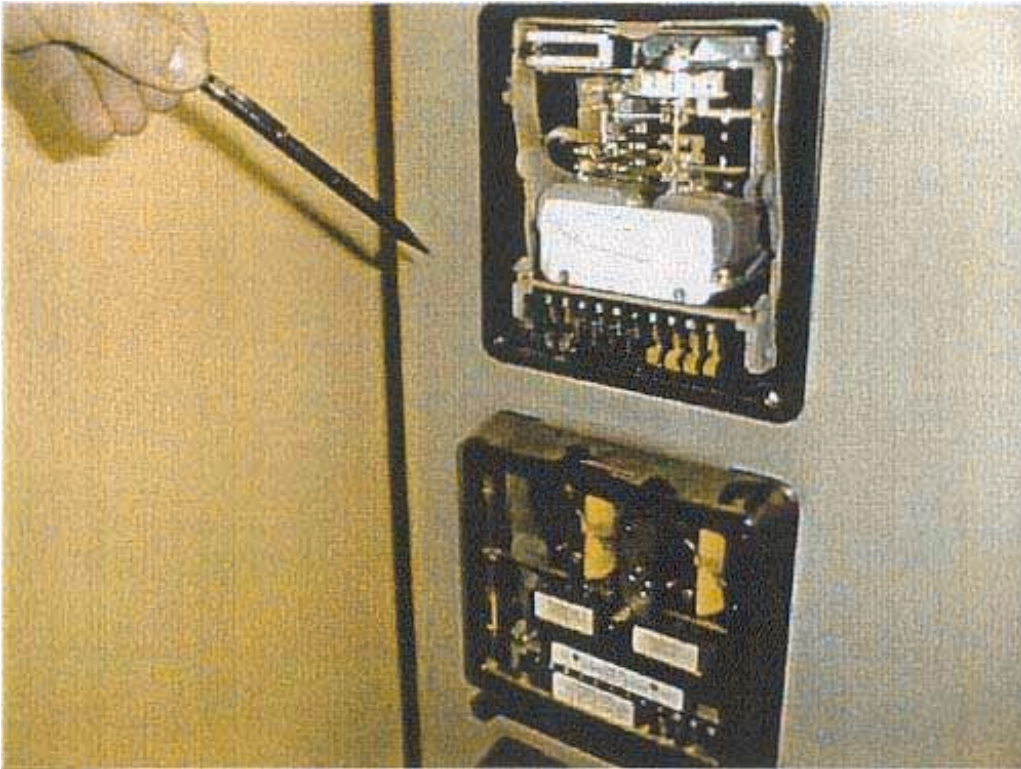
Figure 9 – Plastic panel Inserts

The local circuit breaker on the distribution system failed to operate due to the insertion of small plastic connectors which isolated the relay. Two circuit breakers located elsewhere in the distribution system subsequently tripped to clear the fault resulting in the loss of power supply to significant parts of the Complex.

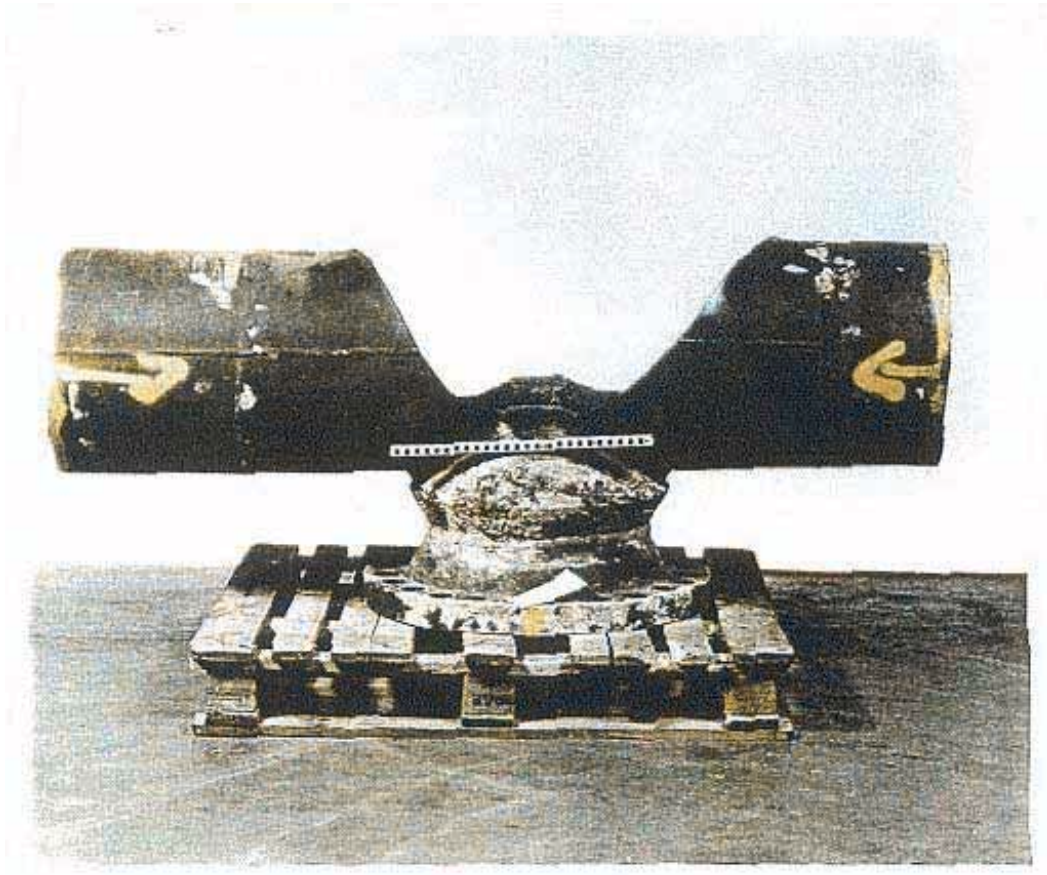
Figure 11 – Rupture Photo

An 18” medium pressure (MP) steam main located near to the A904 Bo’ness road ruptured at 23:18 p.m. on 7th June 2000 resulting in a significant loss of MP steam directly into the atmosphere. The steam leak damaged fencing immediately adjacent to the ruptured pipework. Debris and steam was blown across the road until the leak was isolated. The leak also caused significant noise (similar to a jet engine) being heard in the Grangemouth area. A member of the public walking the dog 300 metres away sustained rib injuries from tripping over the dog.

The site wide power distribution failure on 29th May 2000 resulted in excess amounts of water (associated with the shutdown of utility supplies) being sent to drain, as well as the unavailability of electrical power to drainage pumps. This led to the flooding of culverts (service tunnels) beneath the A904 Bo'ness road through the site which contained medium pressure (MP) steam distribution lines. During the following investigations to determine whether the flooding had caused any damage to the pipework a steam trap located in a low point in the section of pipework beneath the road in the West Gemec culvert was closed to allow safe access for inspection. The steam trap was subsequently not re-opened and this prevented the removal of condensate (hot water produced by the condensation of steam) from this section of the system. As the liquid condensate level built up in the pipework a quantity of steam (or “steam bubble”) was trapped between the hot condensate and closed isolation valves on the southern side of the culvert beneath the road. Eventually collapse of the steam bubble resulted in a phenomenon called “condensation induced water hammer” which led to a gross overpressure and the subsequent catastrophic failure of the pipeline.
