BUNCEFIELD MAJOR INCIDENT INVESTIGATION BOARD

EXPLOSION MECHANISM ADVISORY GROUP REPORT

The Mechanism of the Buncefield Explosion

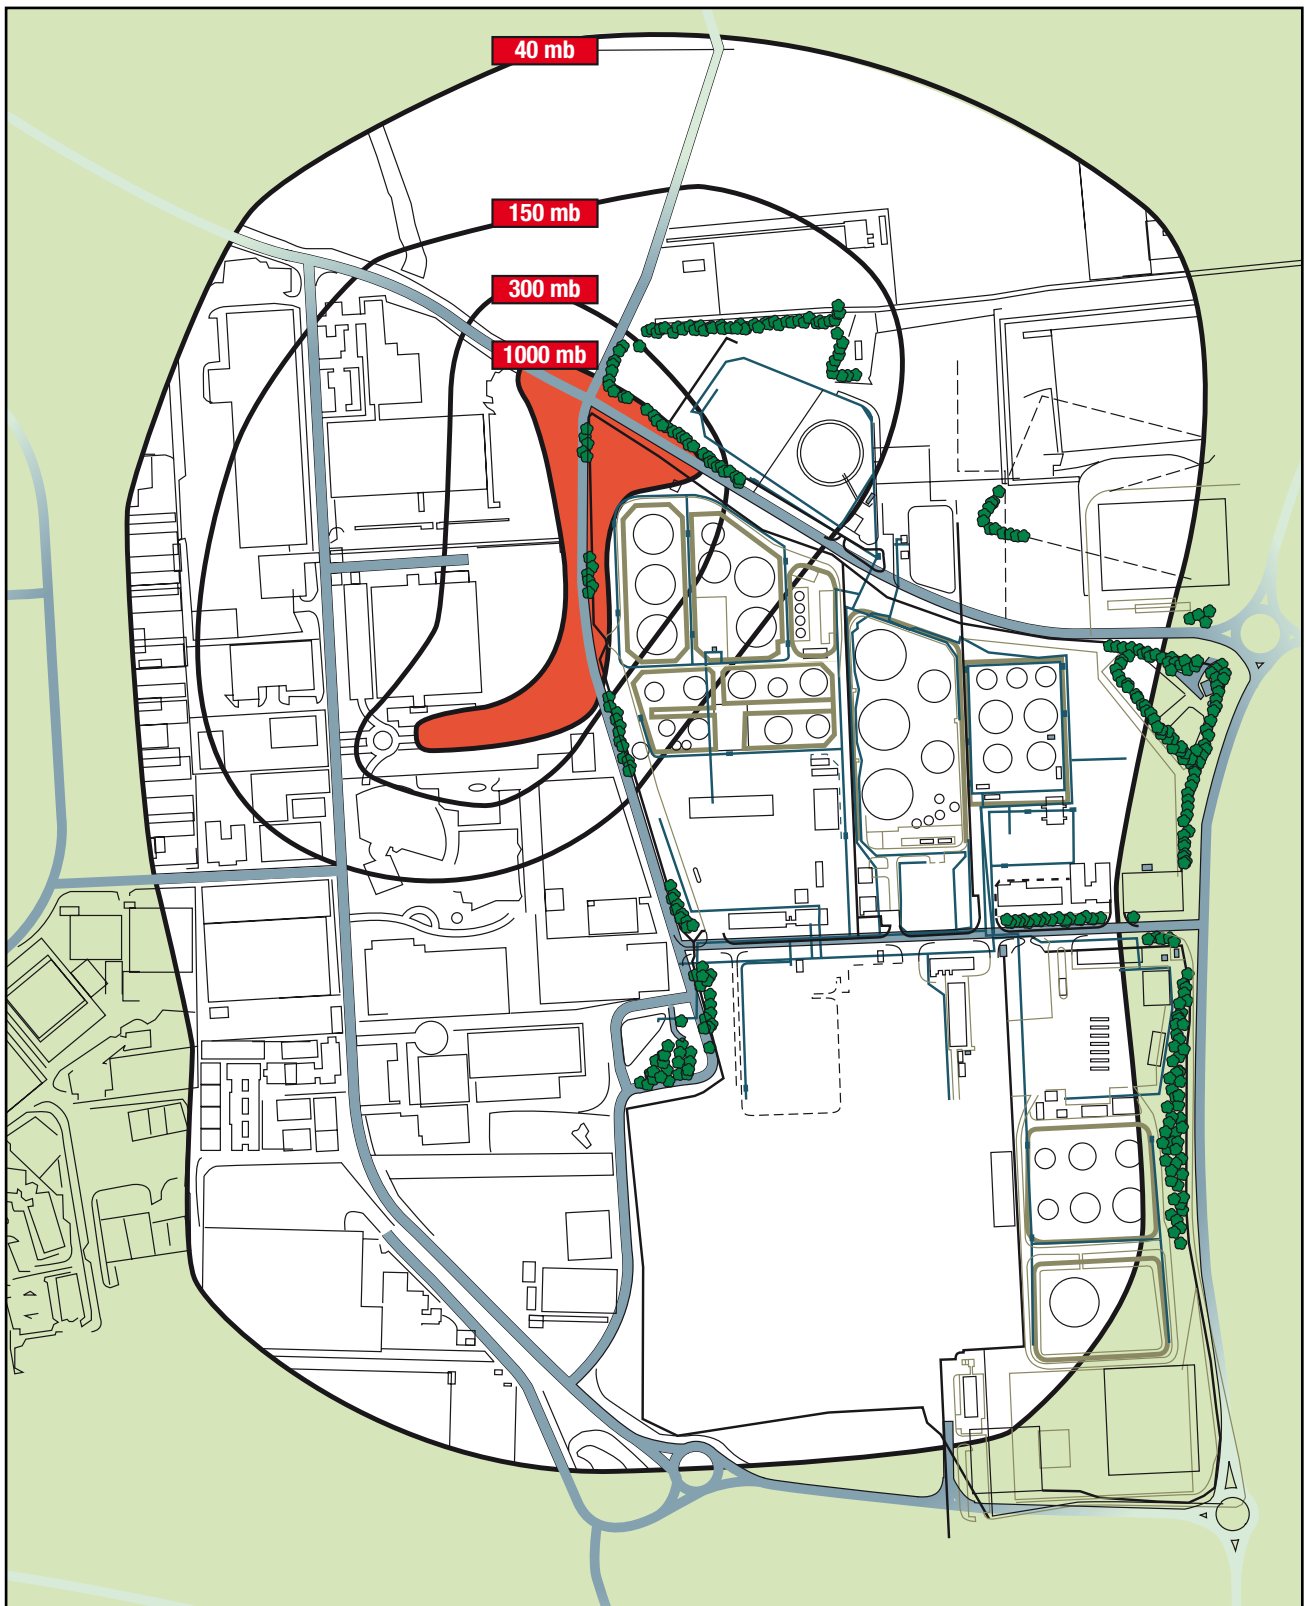
- An attempt has been made to summarise over-pressures on the map in Figure 1, with overlaid isobars of 1000, 300, 150 and 40 mbar. Regions with pressures above 1000 mbar are shown shaded.

Figure 1 Map of the area around the Buncefield site showing approximate over-pressure isobars. These are based on the distribution of damage caused to buildings (including the pump house and the emergency generator cabin), tanks and vehicles as recorded by the primary investigation team. Inevitably, there are large error bars, particularly associated with the 1000 mb contour. It was noted that the damage to vehicles across the car park was remarkably uniform, but there is no information available on over-pressures that are required to cause such damage. The red shading corresponds to an area in which there were convenient markers that provided strong forensic evidence that the over-pressure was greater than 1000 mb. This does not preclude the possibility that such over-pressures were achieved beyond this area.

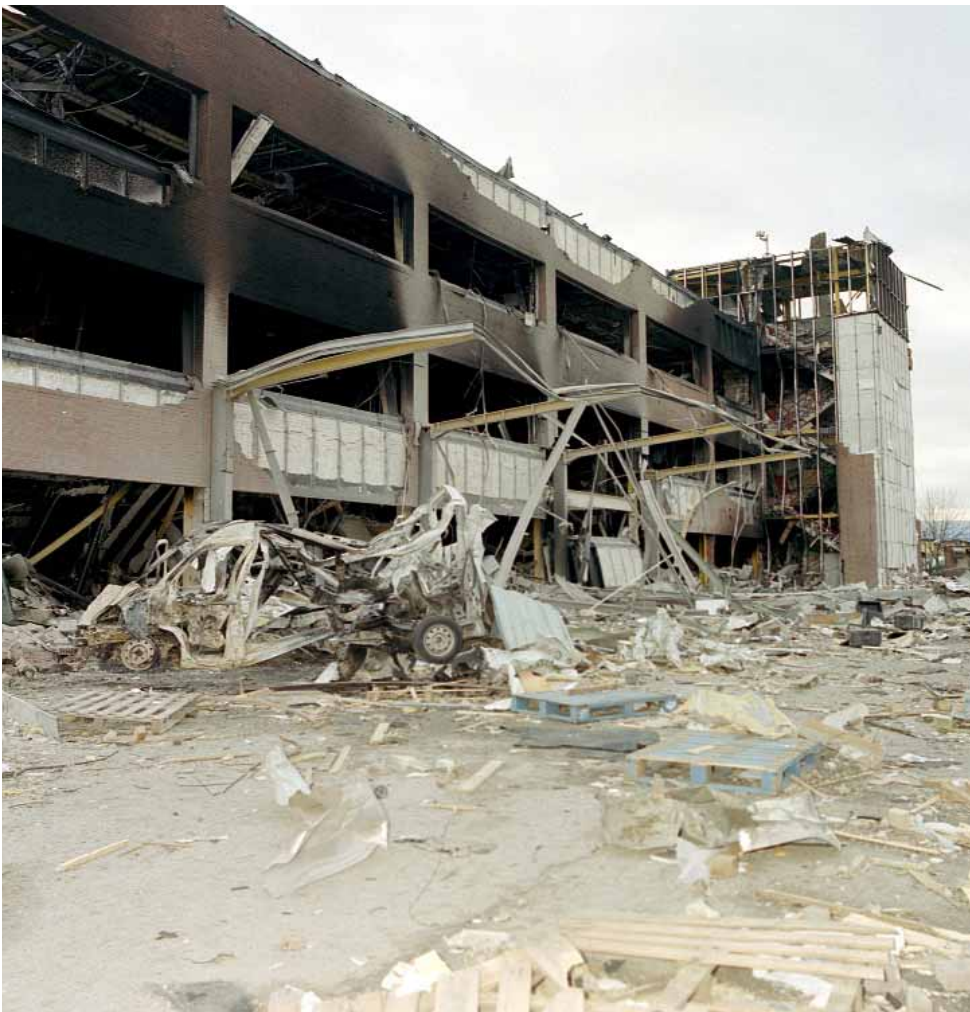
Figure 5 North side of the Northgate building

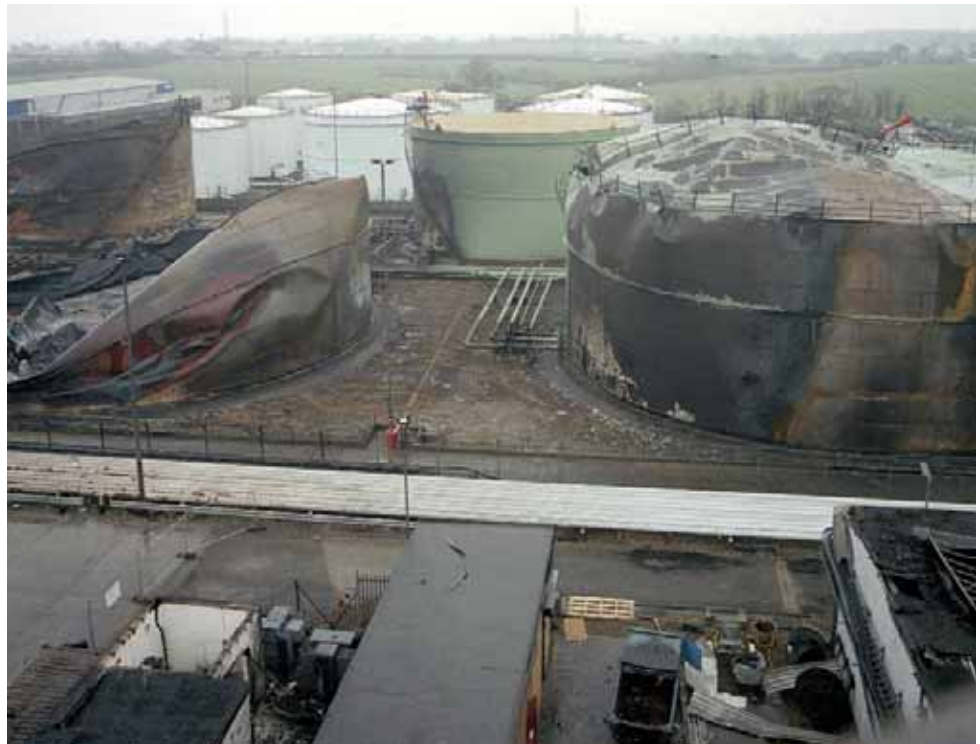
Figure 6 Looking east from the edge of the HOSL West site into the British Pipeline Agency Ltd site (Tank 4 on the left of the picture). The white tanks in the background are on the HOSL East site

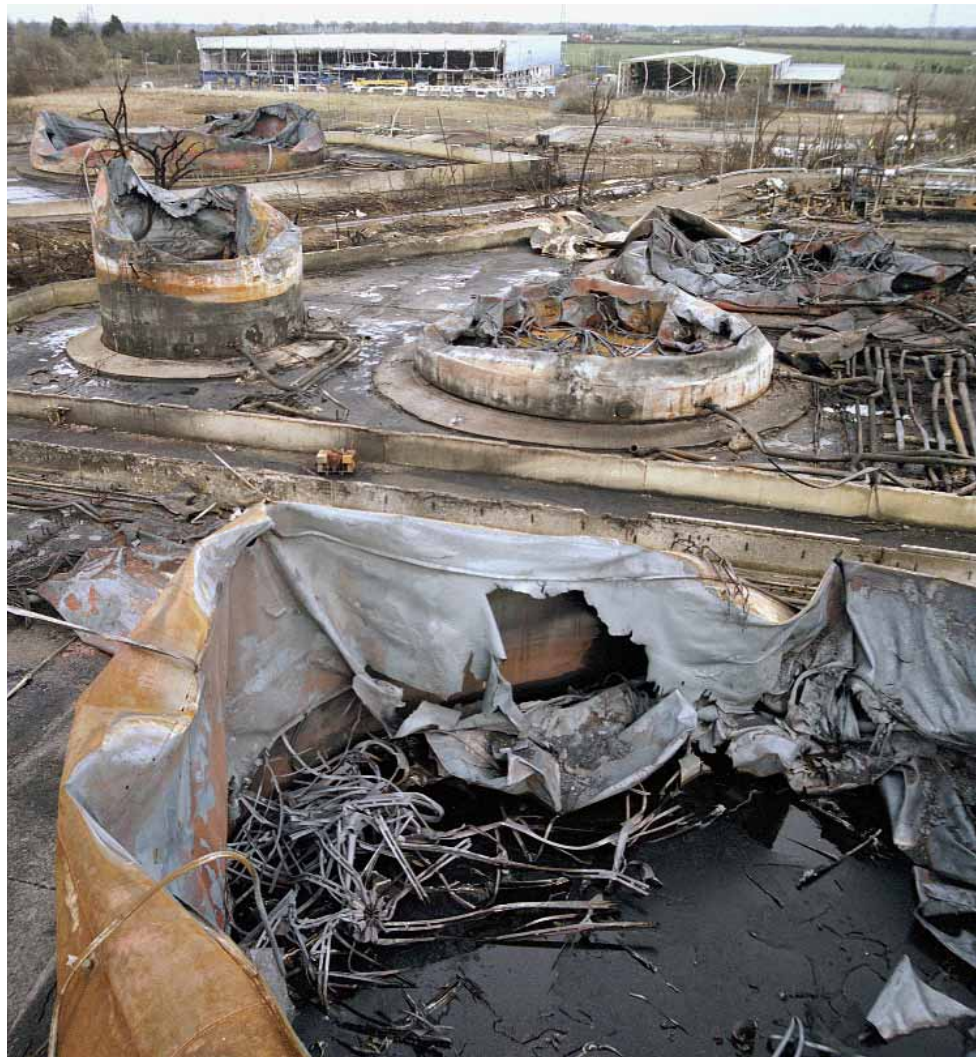
Figure 7 Looking east across the top of Tank 912. Tank 12 is in the background, across Cherry Tree Lane

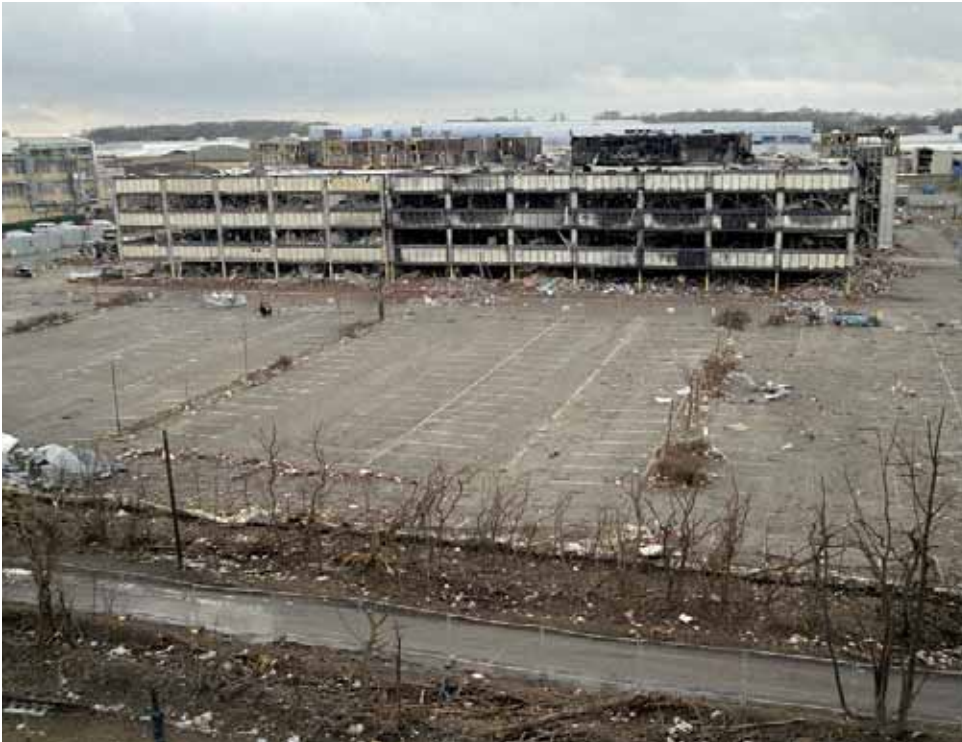
Figure 8 Looking west into Northgate building car park, from the position of Tank 912 (HOSL West)

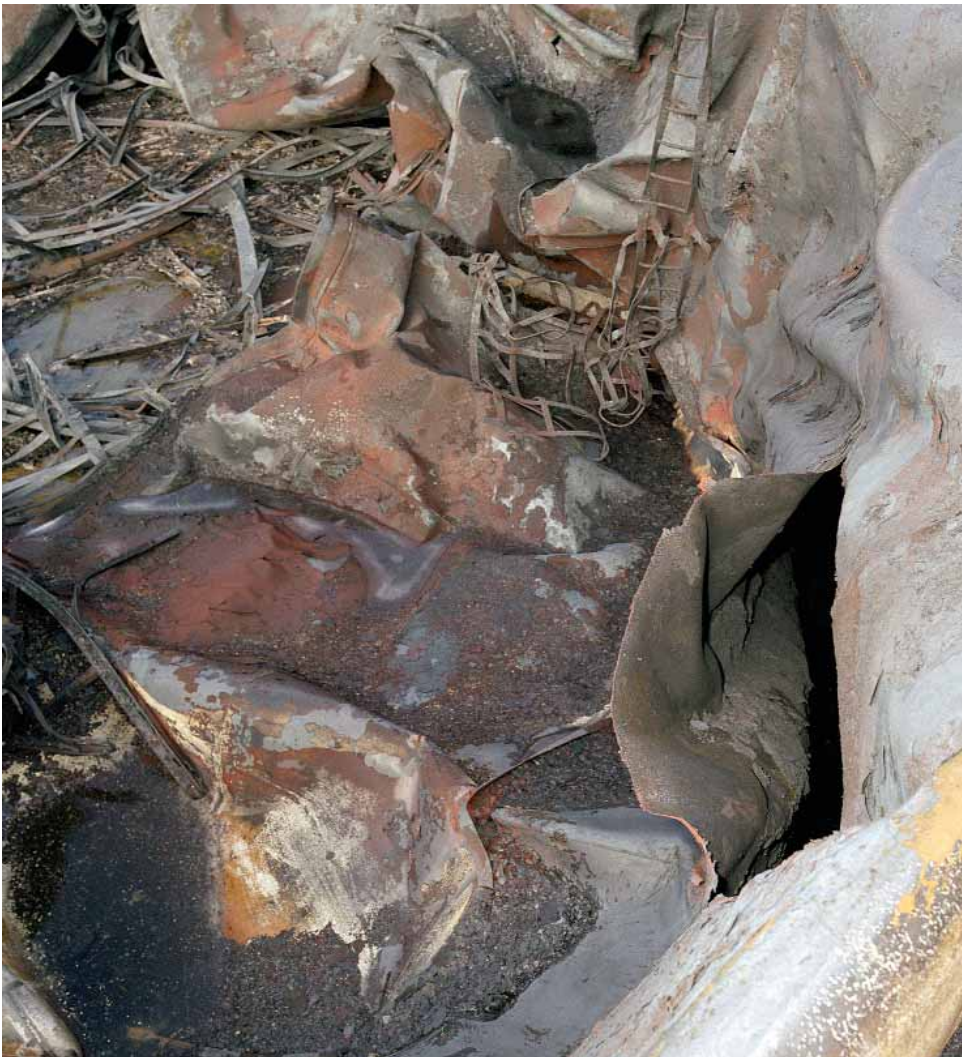
Figure 9 View into Tank 912

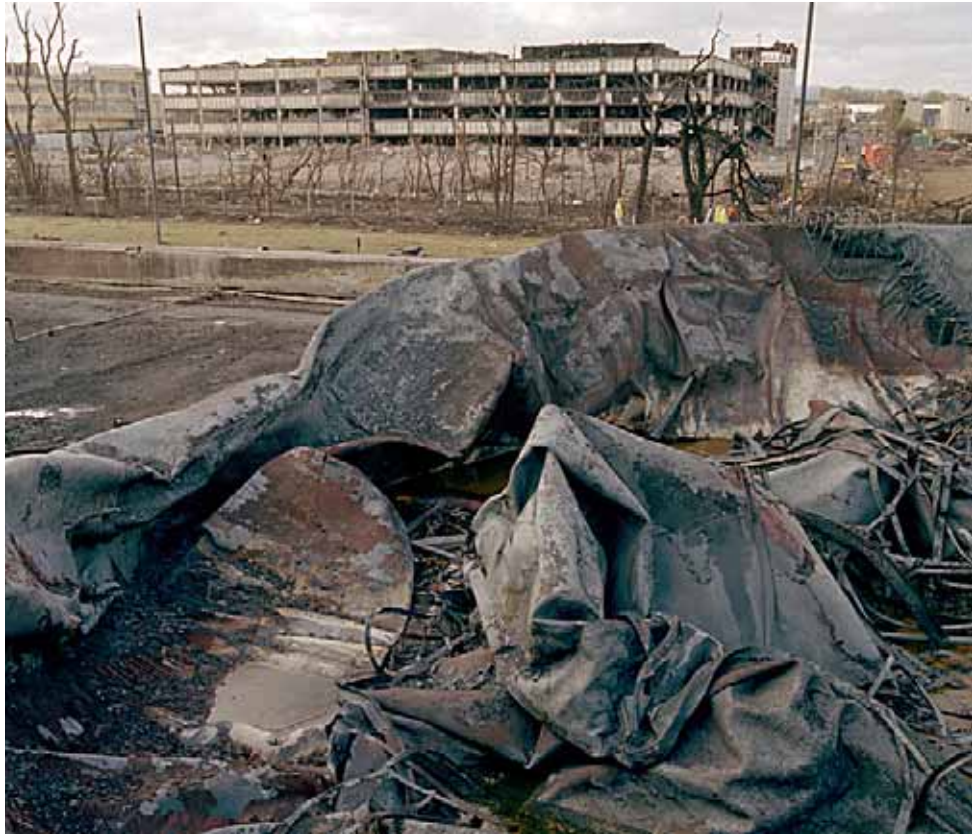
Figure 10 Looking south-west towards the Northgate building from Tank 915 (HOSL West)

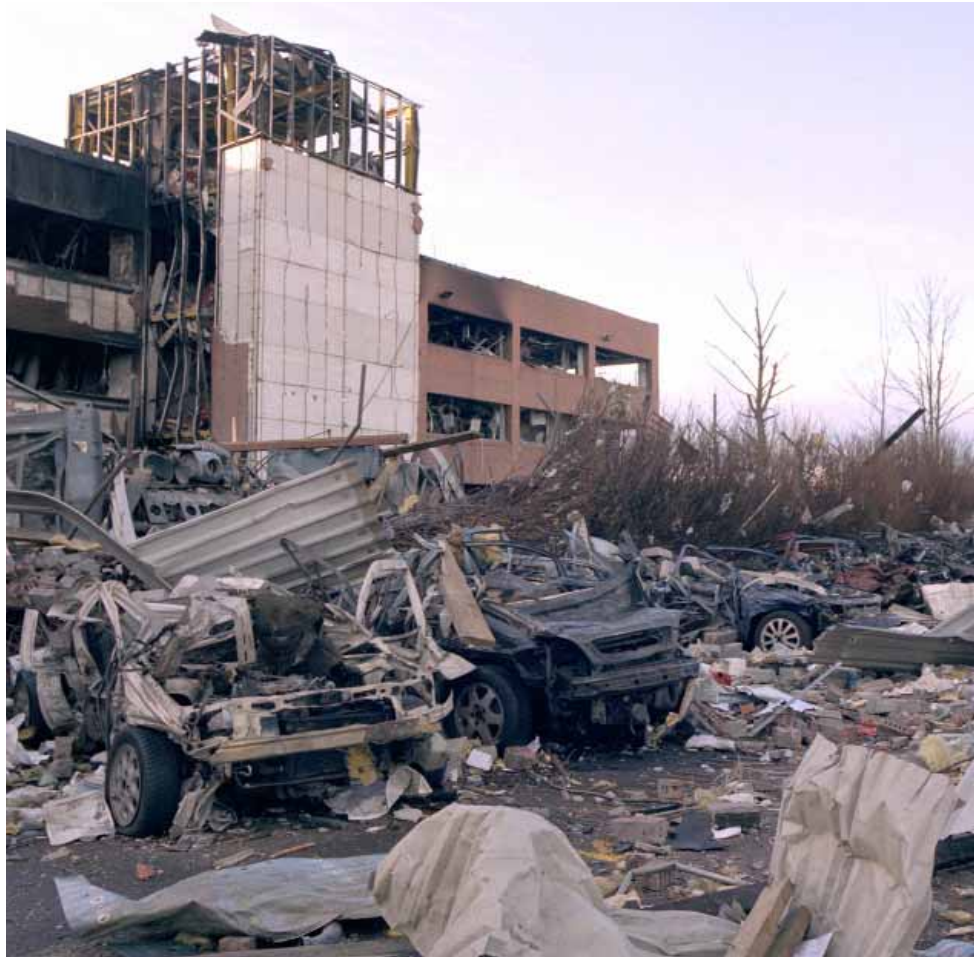
Figure 11 View of the north side of the Northgate building, between the Northgate and Fuji buildings

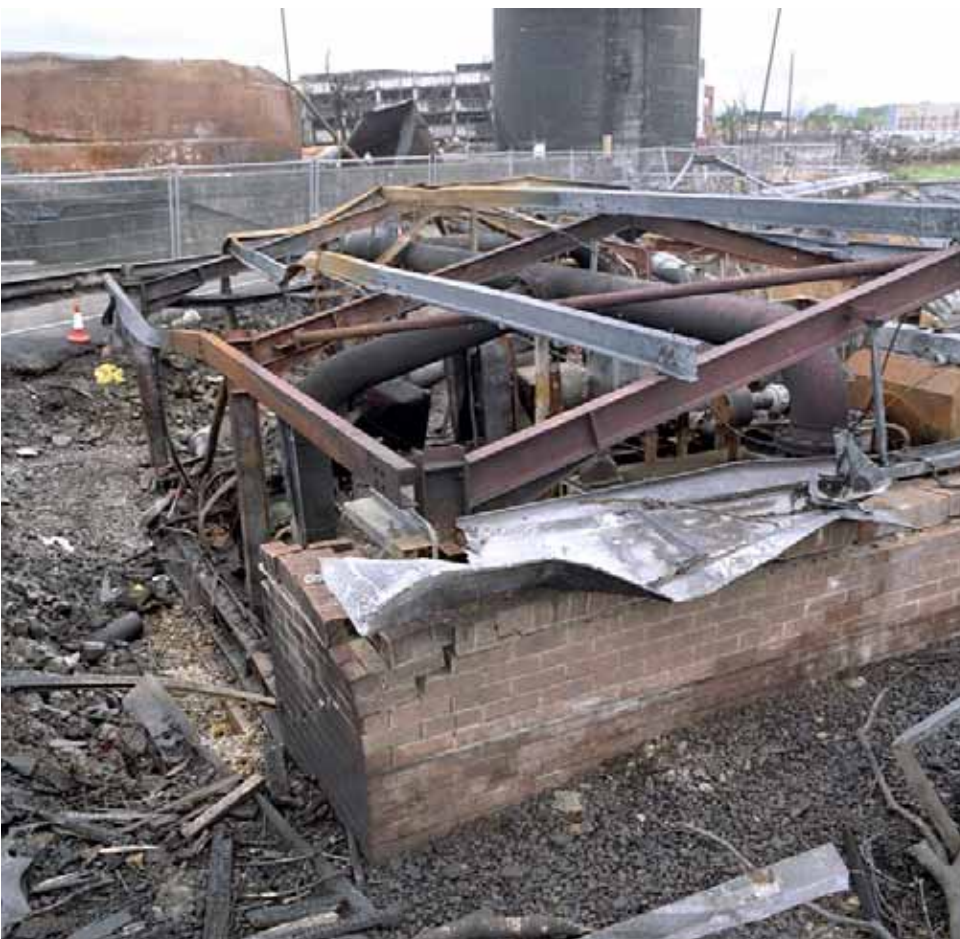
Figure 13 Emergency pump house on the HOSL West site, from its north-east corner

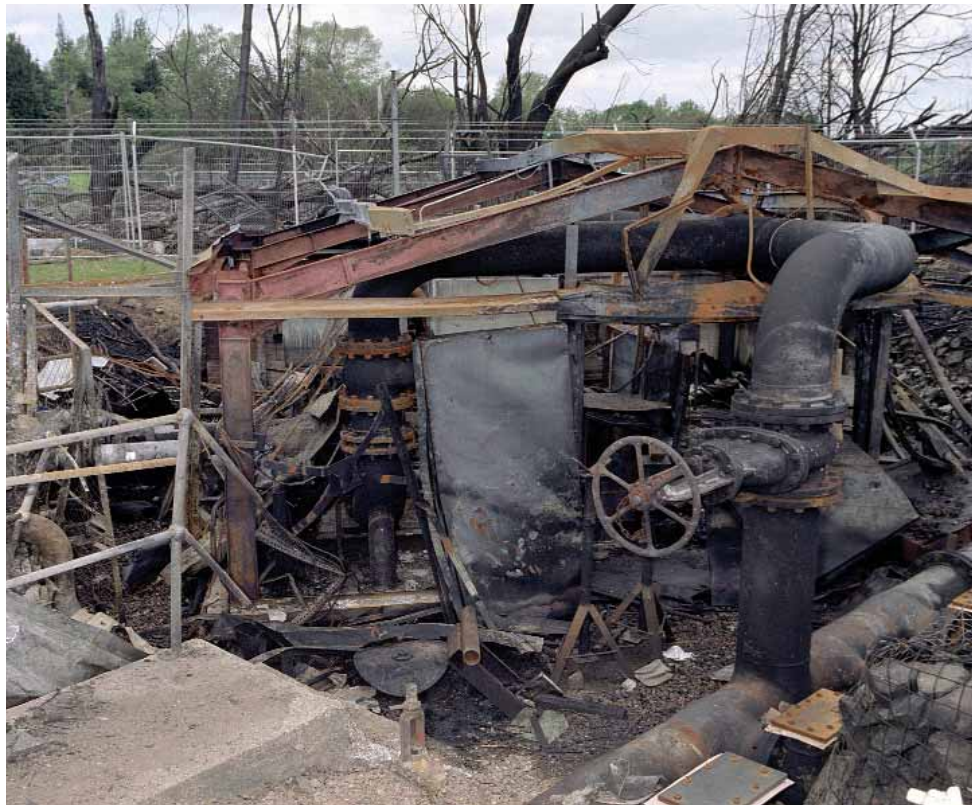
Figure 14 HOSL West emergency pump house from the south-west side. The line of trees behind marks Cherry Tree Lane

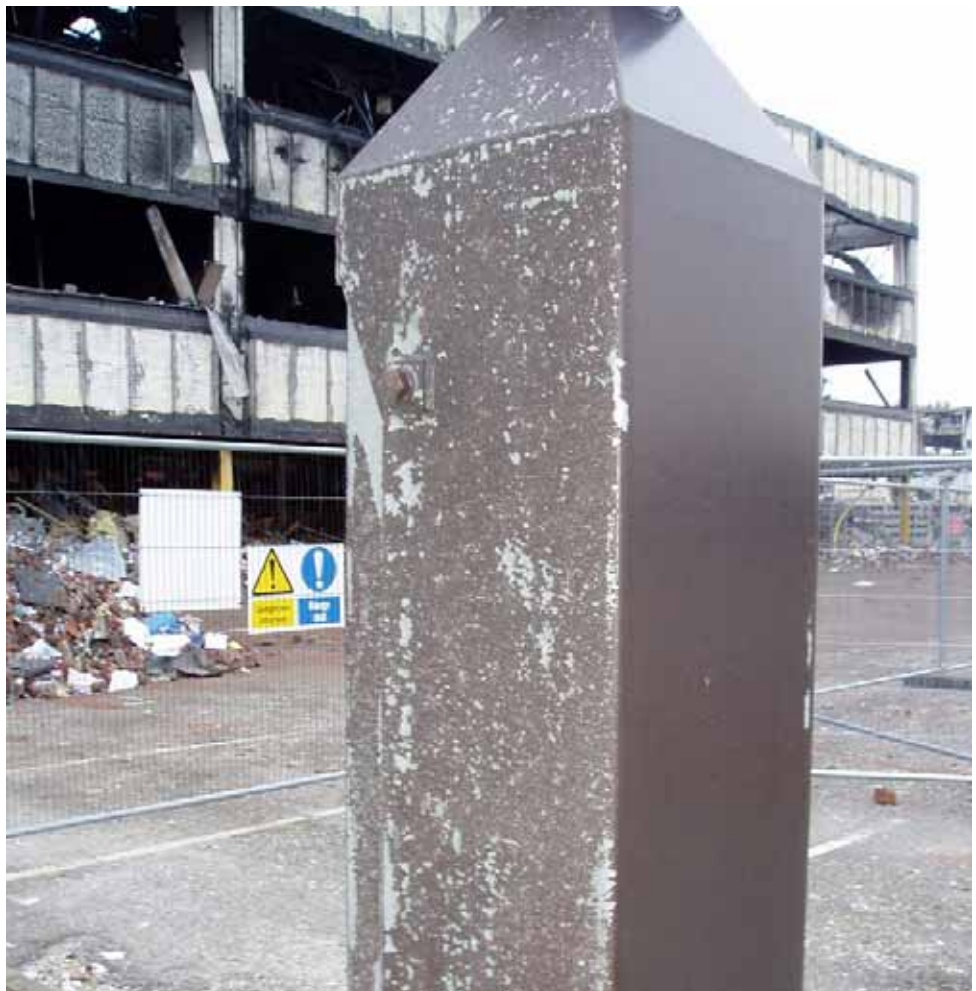
30 It is worth noting that in the third progress report³ on the incident, abrasion on the south side of posts and trees was taken to indicate a flame propagating north from the south end of the car park. The abrasions were taken to be as a result of a fast flame propagating towards the posts and trees. It was recognised by the Group that these abrasions could also have been caused by solid particles entrained by the high velocity of the burned gas, moving in the opposite direction to the propagating flame. The burned gas would tend to have significantly higher velocities than the unburned gas which would both enhance entrainment and intensify abrasion damage. Therefore the abrasions could also be indicative of a flame moving south from the north end of the car park/tree line. A difficulty with the scenario of a southerly spread of flame along the Buncefield Lane line of trees is the contrary evidence in paragraphs 16–21.

Figure 15 Steel post in the west car park of the Northgate building. The post shows abrasion marks on its south face

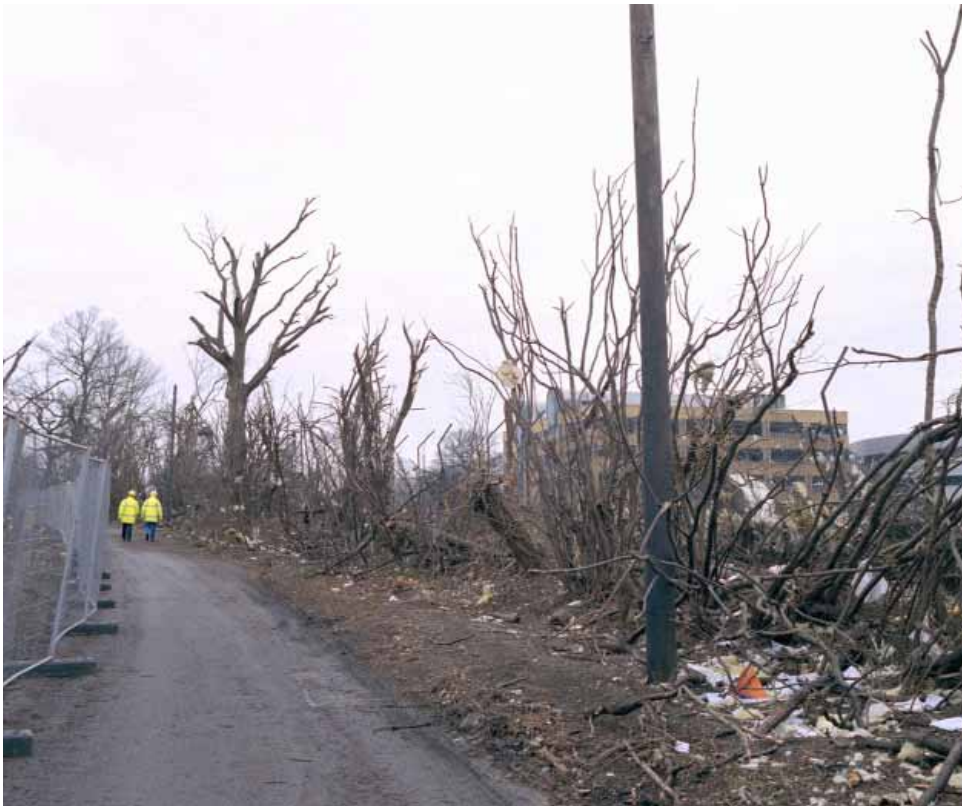
Figure 16 View south along Buncefield Lane, showing sooting of lower parts of telegraph poles and trees

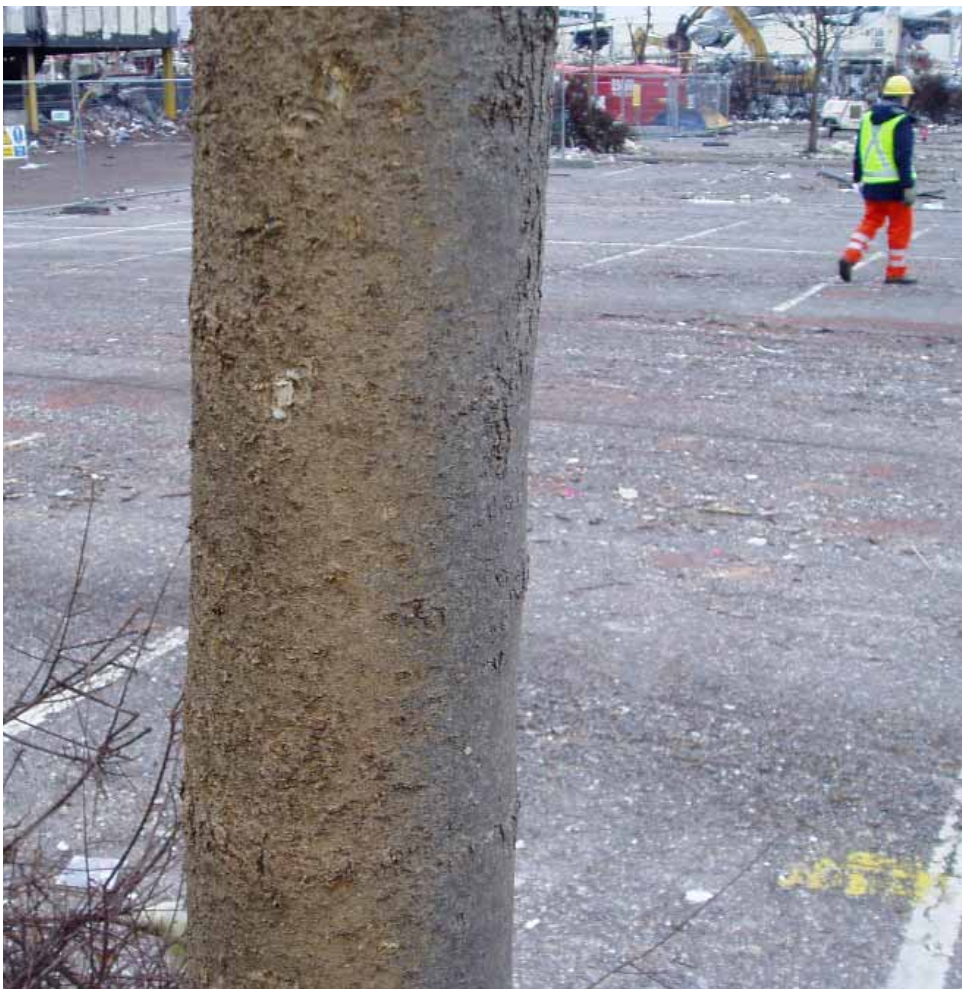
33 In this case, the tree trunk damage in the Northgate car park might be indicative of a strongly induced flow into the base of a rising fireball. In this regard, the absence of soot on the tree trunk is noteworthy.

Figure 17 Abrasions to the base of a tree in the Northgate building west car park, viewed from the south

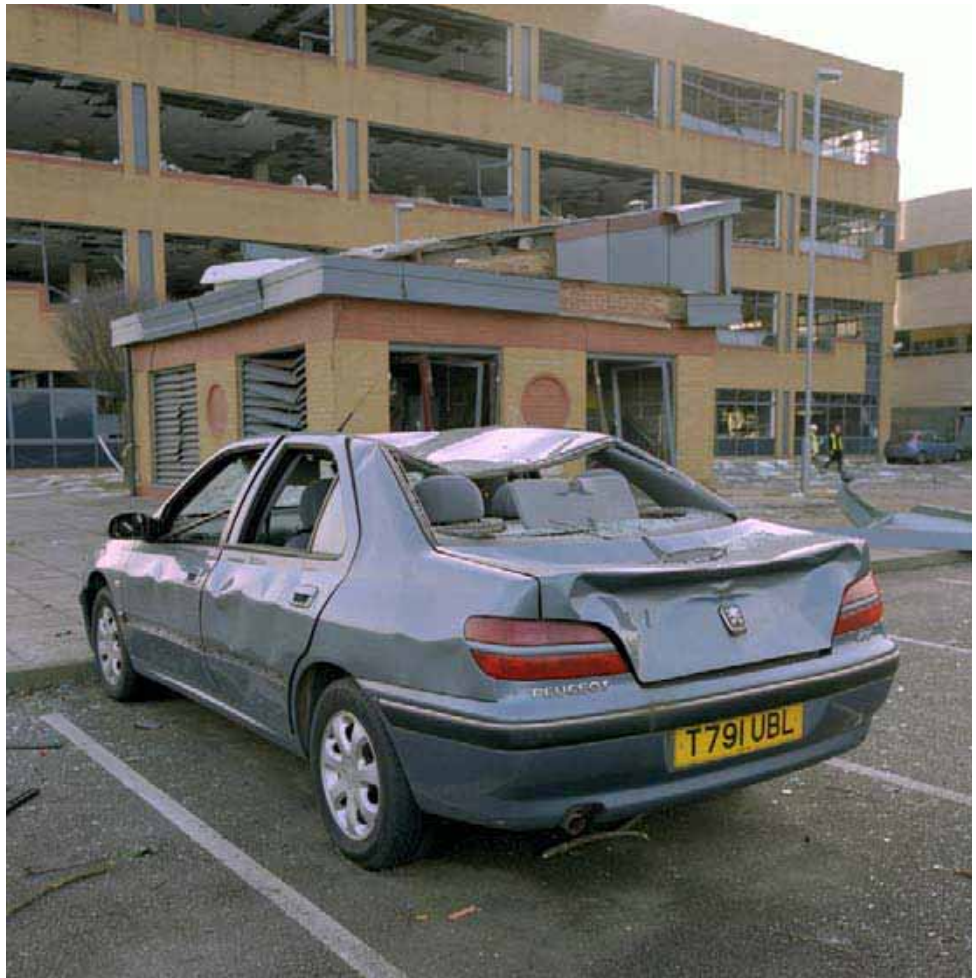
Figure 18 Damaged car in RO building car park (car facing south)

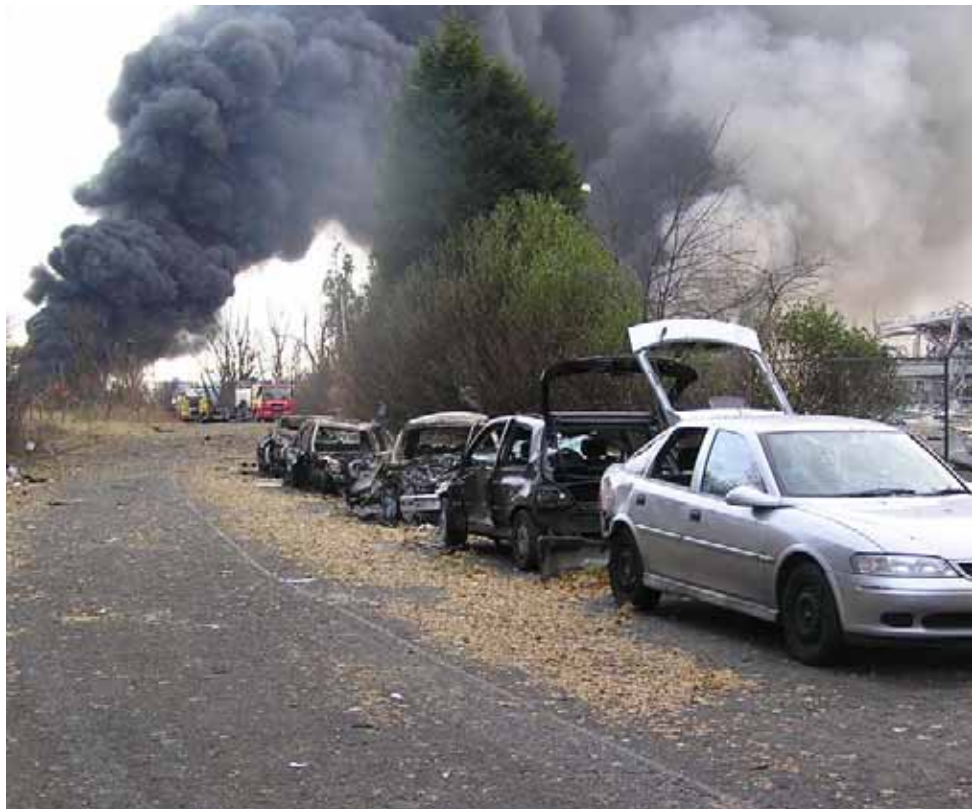
Figure 19 Cars on Three Cherry Trees Lane (near Catherine House)

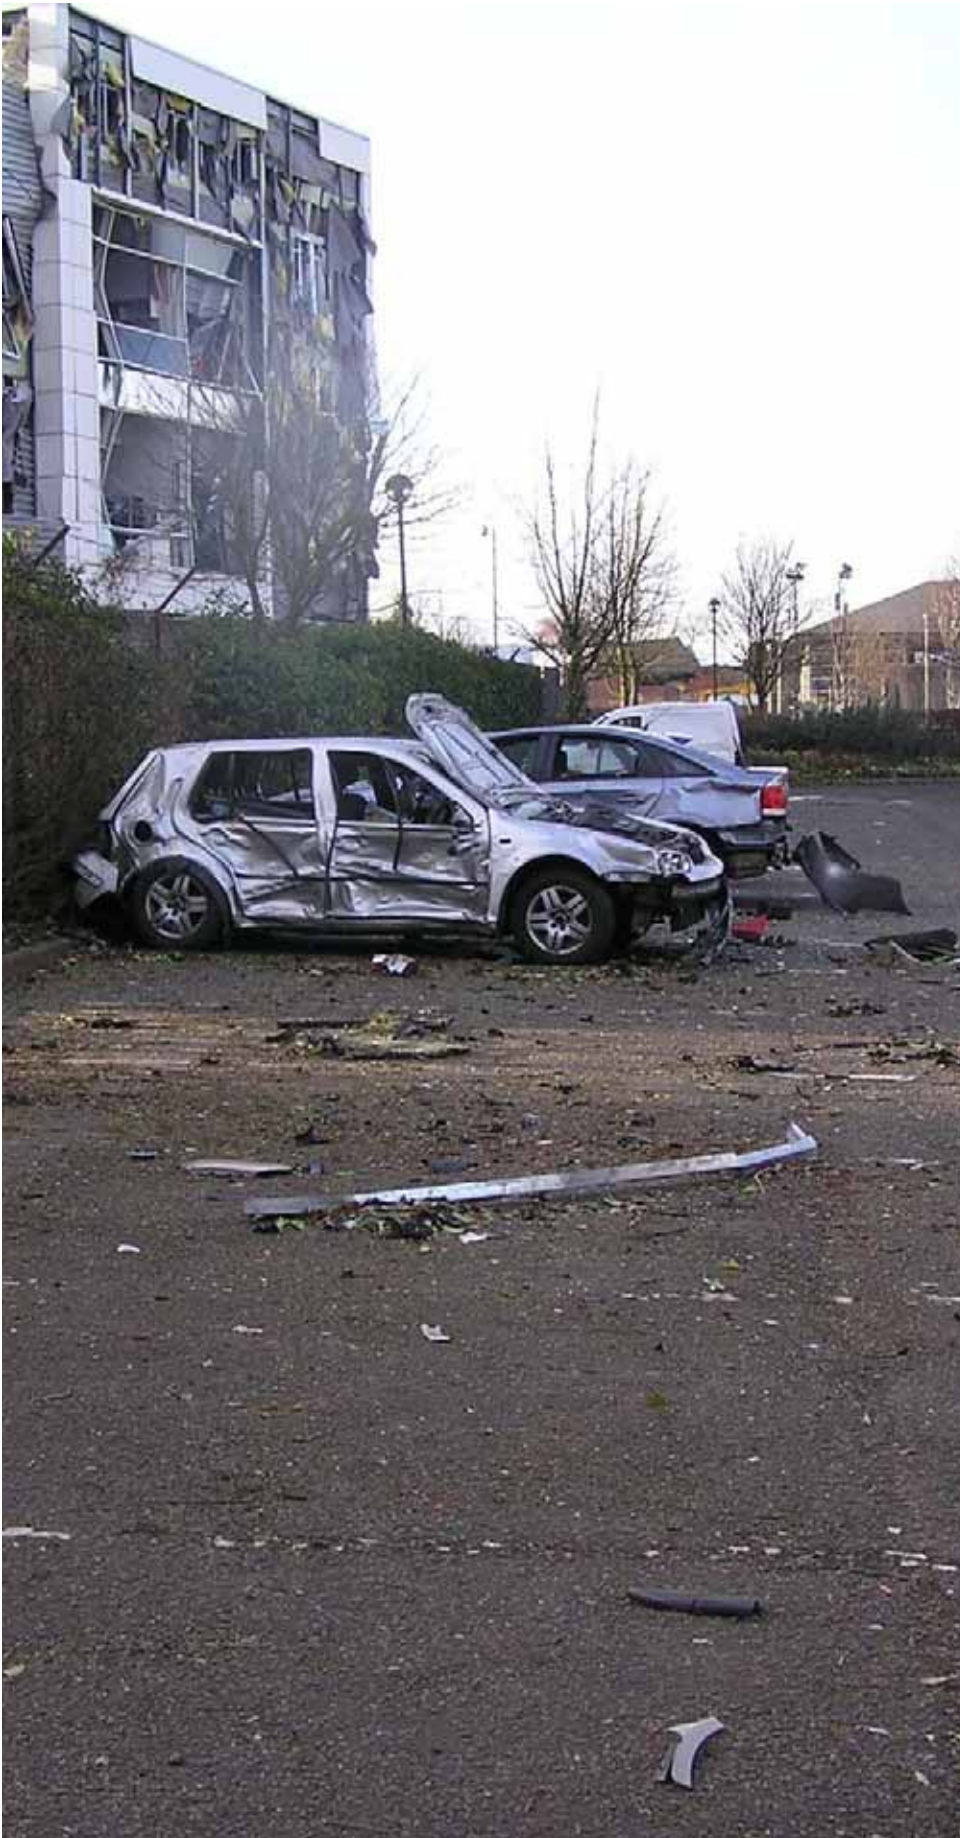
Figure 20 Damaged cars at the south-west of the Northgate building car park; Boundary Way is in the background. The picture also shows blast damage to the north-west corner of the 3-Com building

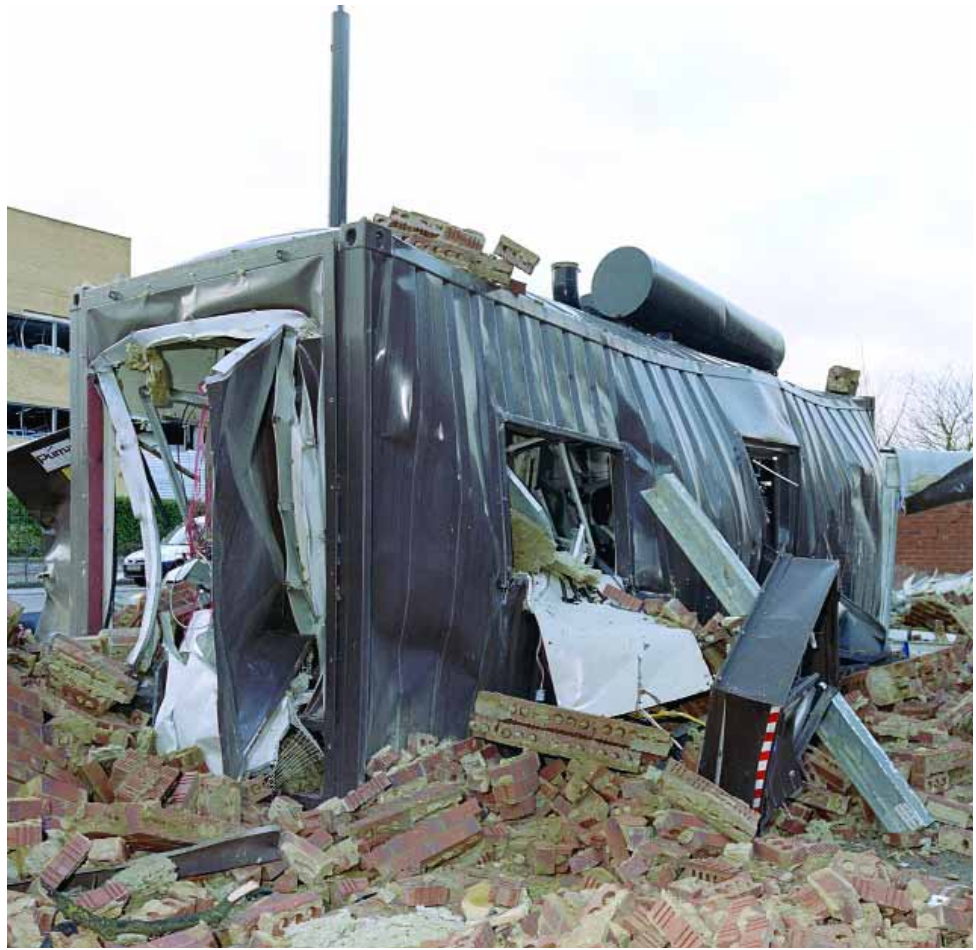
Figure 21 Emergency generator cabin, close to the south-east corner of the Northgate building, viewed from the north east. The north-east segment of the damaged 3-Com building is shown to the left of the picture
