# The Buncefield Investigation

Third progress report

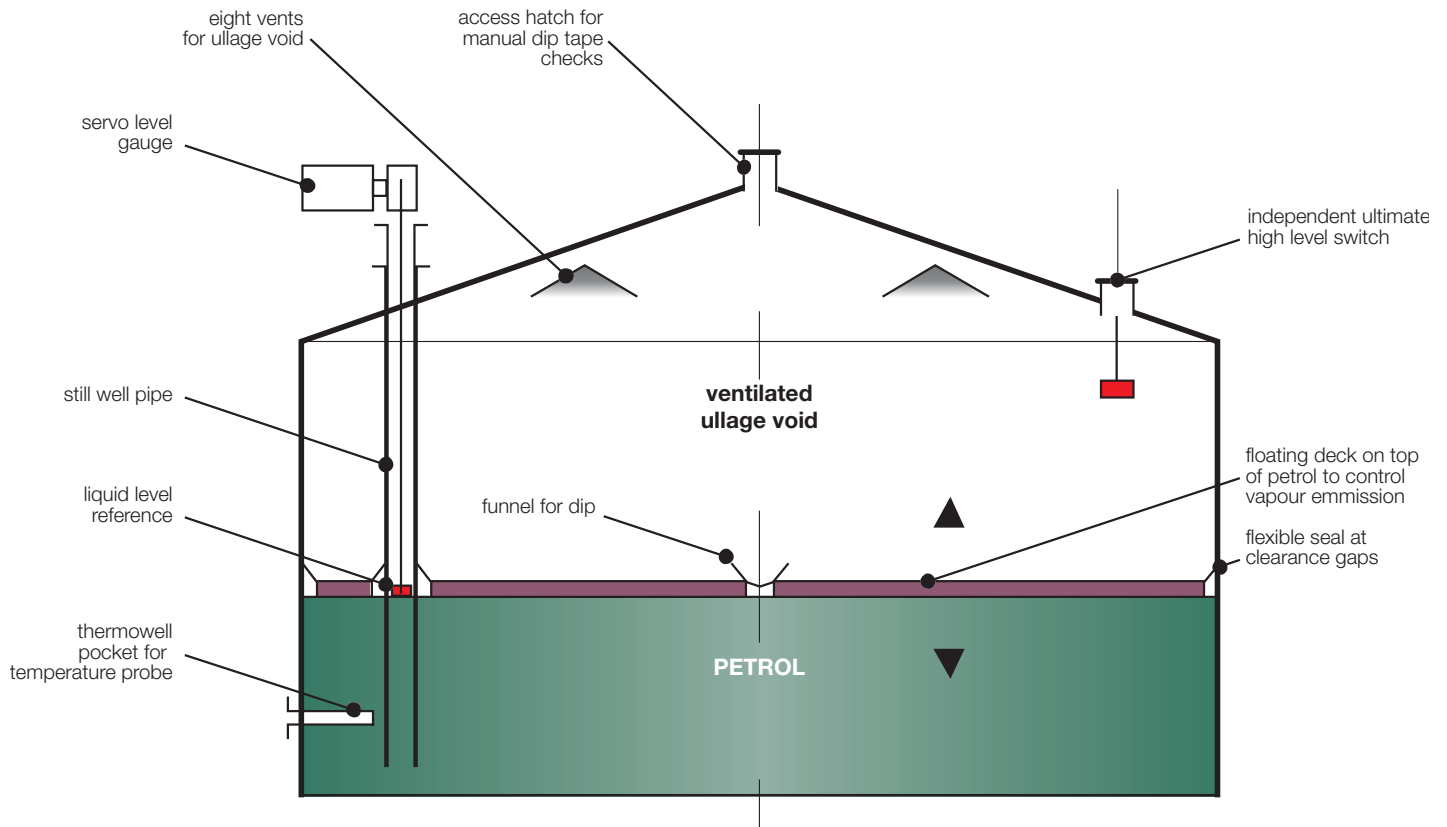
**Figure 2** Basic layout of Tank 912

12 Figure 2 depicts the basic layout of Tank 912. This was a floating deck tank whereby in addition to the fixed roof, there is a deck inside the tank which floats on the fuel, thus minimising the emission of vapour from the fuel surface.

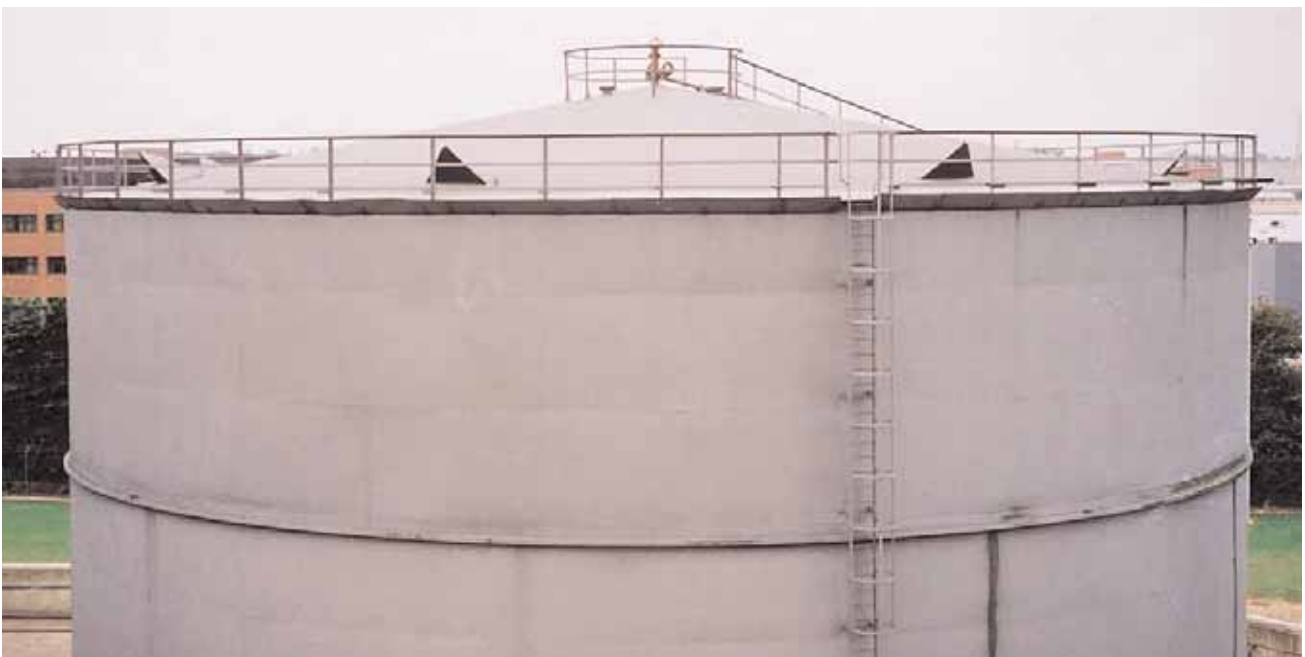
**Figure 3** Tank top details before the incident

28 Therefore overflowing of Tank 912 would have resulted in flow from the breather holes at the top of the tank. There were eight of these, each triangular in section with an area of  $0.07 \text{ m}^2$ , as can be seen in Figure 3 which is a photograph of one of the tanks in bund A taken shortly after construction.

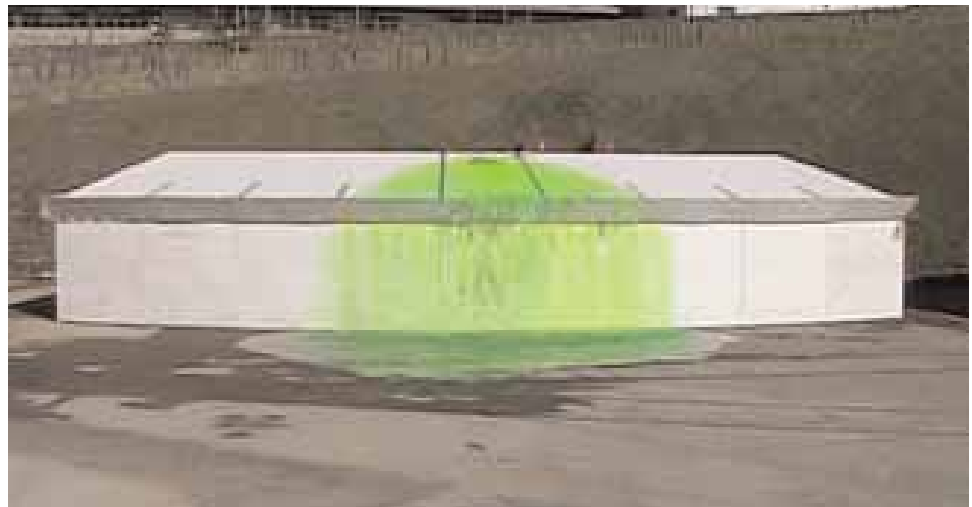
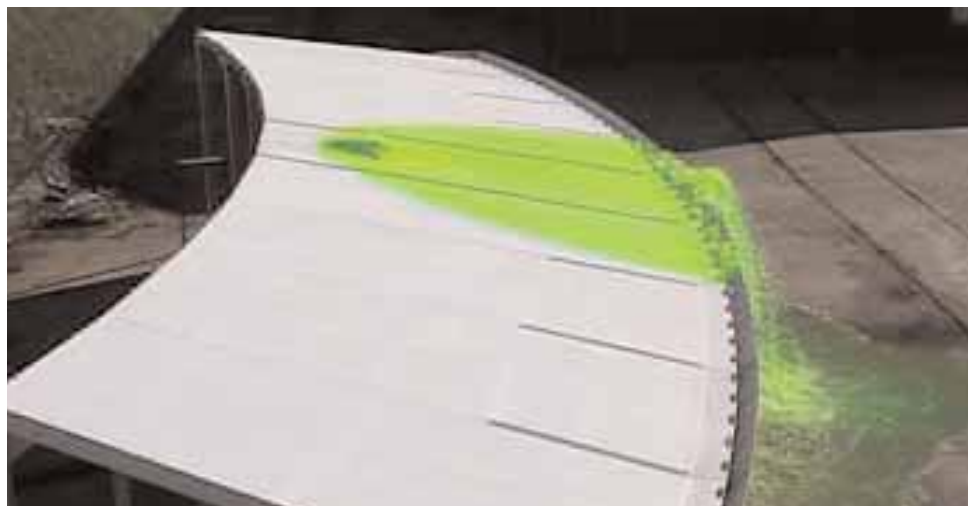
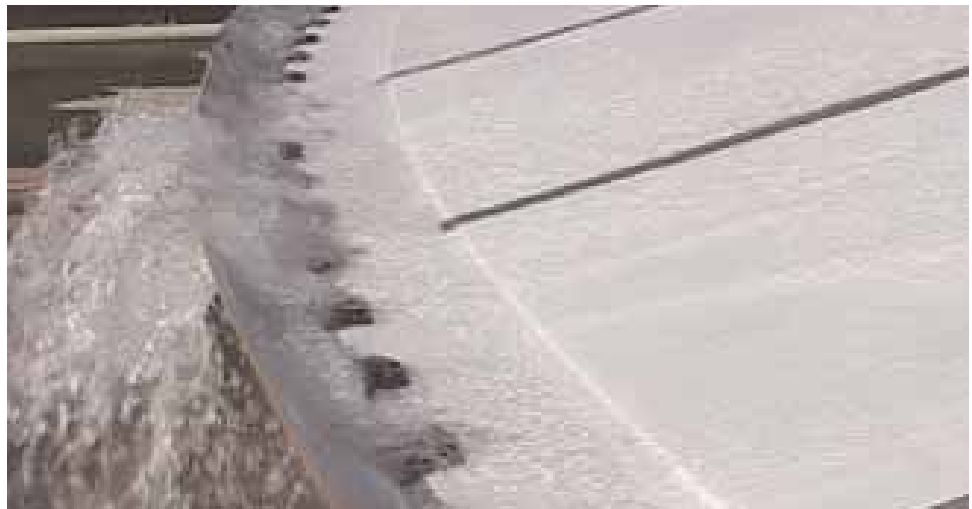
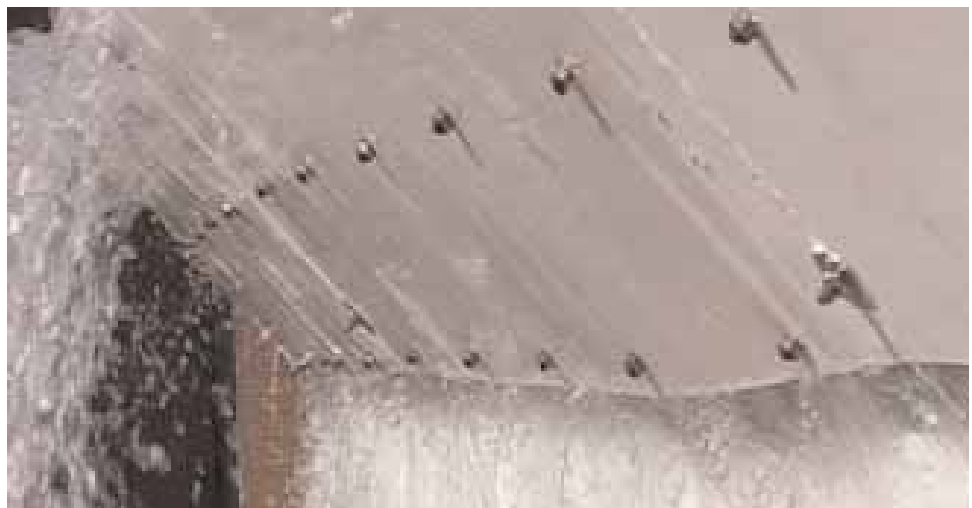
**Figure 4a-d** Liquid flow from the breather holes on the tank top

32 These tests demonstrate that the deflector plate was effective in channelling the majority but not all of the liquid onto the tank wall, but only spread it laterally over approximately one third of the wall. Images captured from video records are shown in Figure 4.

34 Much of the liquid directed back to the wall by the deflector plate will hit the wind girder which can be seen running round the tank about a third of the way down in Figure 3. It is likely that this liquid flow will be further fragmented on impact with this girder to form a second free cascade.

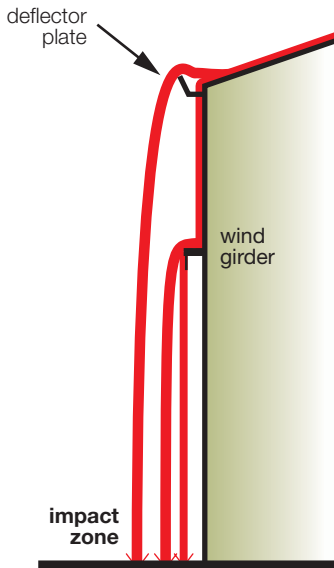
36 The general features of these processes during an overflow are illustrated schematically in Figure 5.

37 The conclusion of this work is that the flow is likely to be very efficiently fragmented, and would create relatively small droplets falling freely through air around the tank. These conditions would promote the evaporation of the lighter chemical components of petrol, eg butanes, pentanes and hexanes.

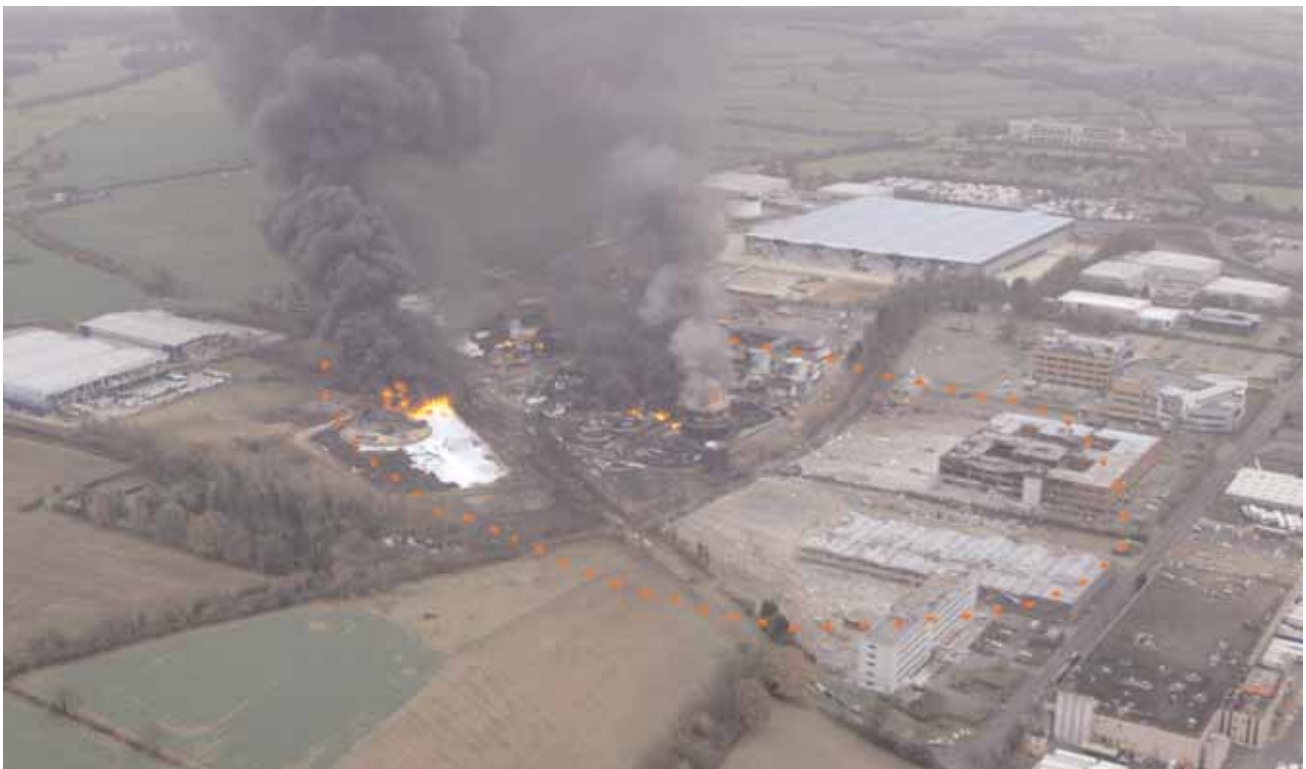
**Figure 6** Extent of burn damage (indicated by dotted line)

39 Aerial pictures of the site have confirmed preliminary conclusions about the extent of the burn damage shown in Figure 5 of the first progress report. This is also shown by the dotted line in Figure 6. This is indicative of the extent of the flammable vapour cloud.

HOSL East site. This is a little way beyond the extent of the burn damage shown in Figure 6. According to witnesses, the depth of the visible mist varied from about 1 m in the area between bund A and the loading gantry to between 5 and 7 m in Three Cherry Trees Lane.

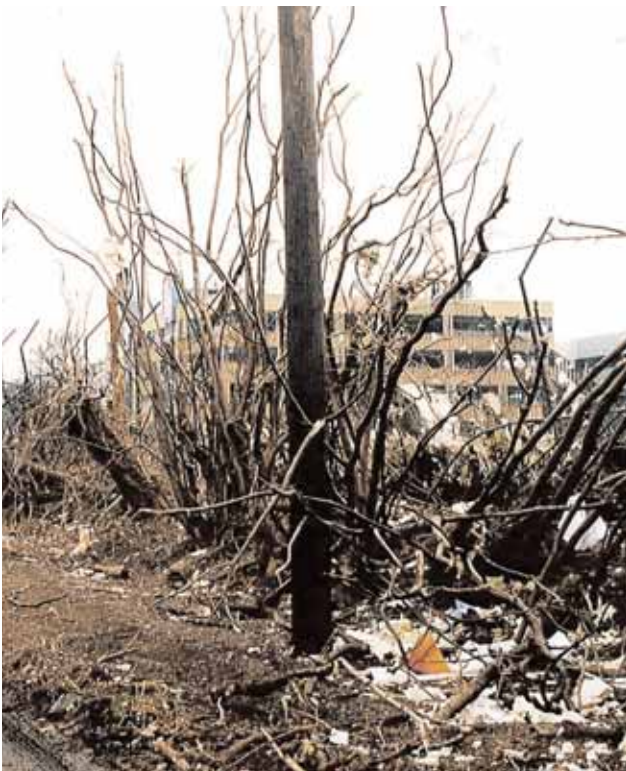
42 The telegraph pole shown in Figure 7 is in Buncefield Lane relatively close to the wall of bund A containing Tank 912. The bottom part of the pole shows soot blackening, characteristic of objects exposed to burning of a very rich vapour mixture. Video records of the fire confirm that this area was not affected by the smoke plume during the fire.

**Figure 7** A telegraph pole in Buncefield Lane, showing sooting on lower half

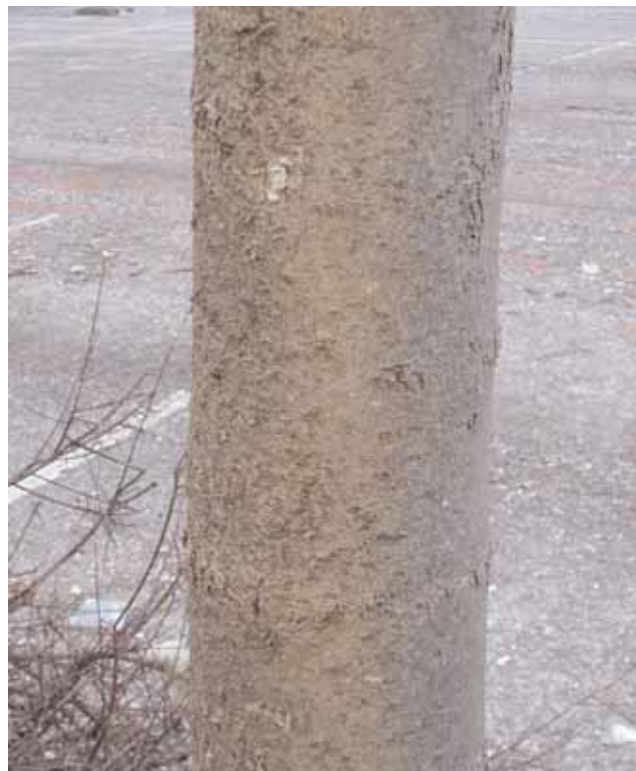
43 The tree trunk in the Northgate car park shown in Figure 8 is much further from the site and has been exposed to an explosion propagating in a more dilute vapour mixture with a composition close to the optimum for complete combustion. There is no soot on exposed surfaces but the left-hand side facing the camera has been deeply abraded by grit driven into it at high speed by the explosion. Examples of this kind of damage were found across most of the area covered by the Northgate and Fuji car parks.

44 Such observations of burn damage support the conclusion that additional air mixed with the rich vapour as it flowed out across the Northgate and Fuji car parks. This reduced the vapour concentration to the point where it could support an explosion.

**Figure 8** Part of a tree trunk in the Northgate car park showing abrasion

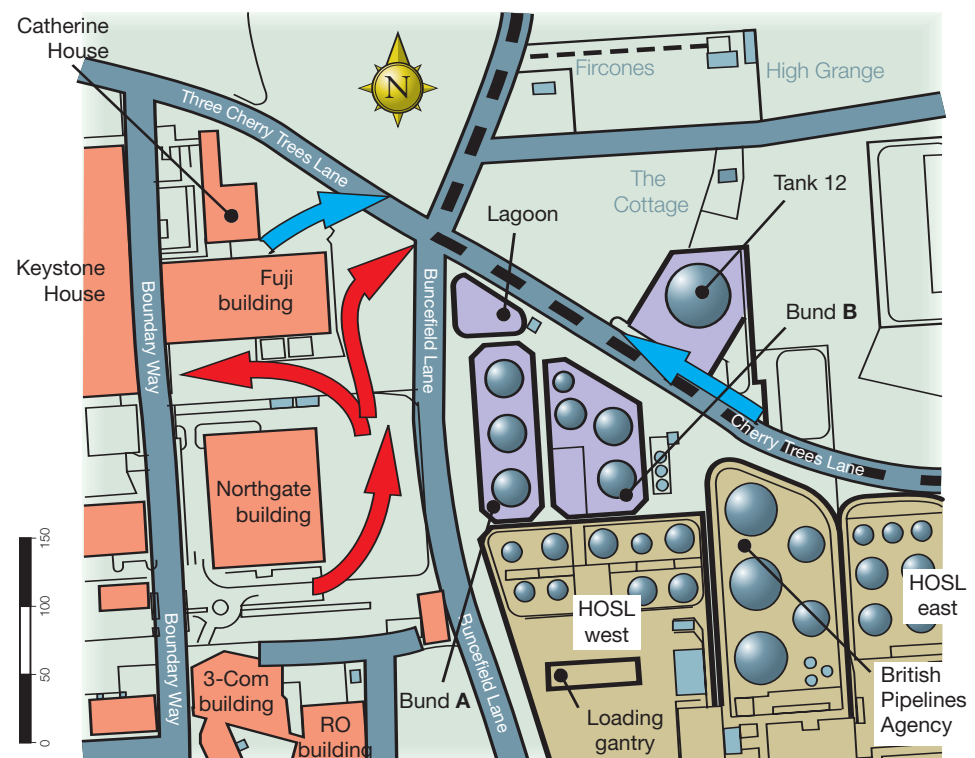
**Figure 9** Showing main and secondary explosion propagation

55 The magnitude of the overpressures generated in the open areas of the Northgate and Fuji car parks is not consistent with current understanding of vapour cloud explosions. For example, a method in current usage would predict overpressures in this sort of environment of 20–50 mbar. The investigation has, so far, been unable to establish why the ignition of the vapour cloud and the explosion propagation in the relatively uncongested environment of the adjacent car parks caused significant overpressures that produced the severe damage to property.

56 Furthermore there is evidence, from erosion/abrading on just one side of posts and tree trunks, of a powerful explosion having propagated northwards across the Northgate and Fuji car parks, as shown in Figure 8. The movement of objects like fence posts, tree branches etc indicate explosions of lesser magnitude having propagated through other areas bordering on the Buncefield site. The directions of explosion propagation are shown on Figure 9. The main explosion propagation is shown in red with secondary effects in blue.
