The Buncefield Investigation

Second progress report

Part 1 Progress with the primary investigation

1.1 Loss of containment of fuel and contaminants

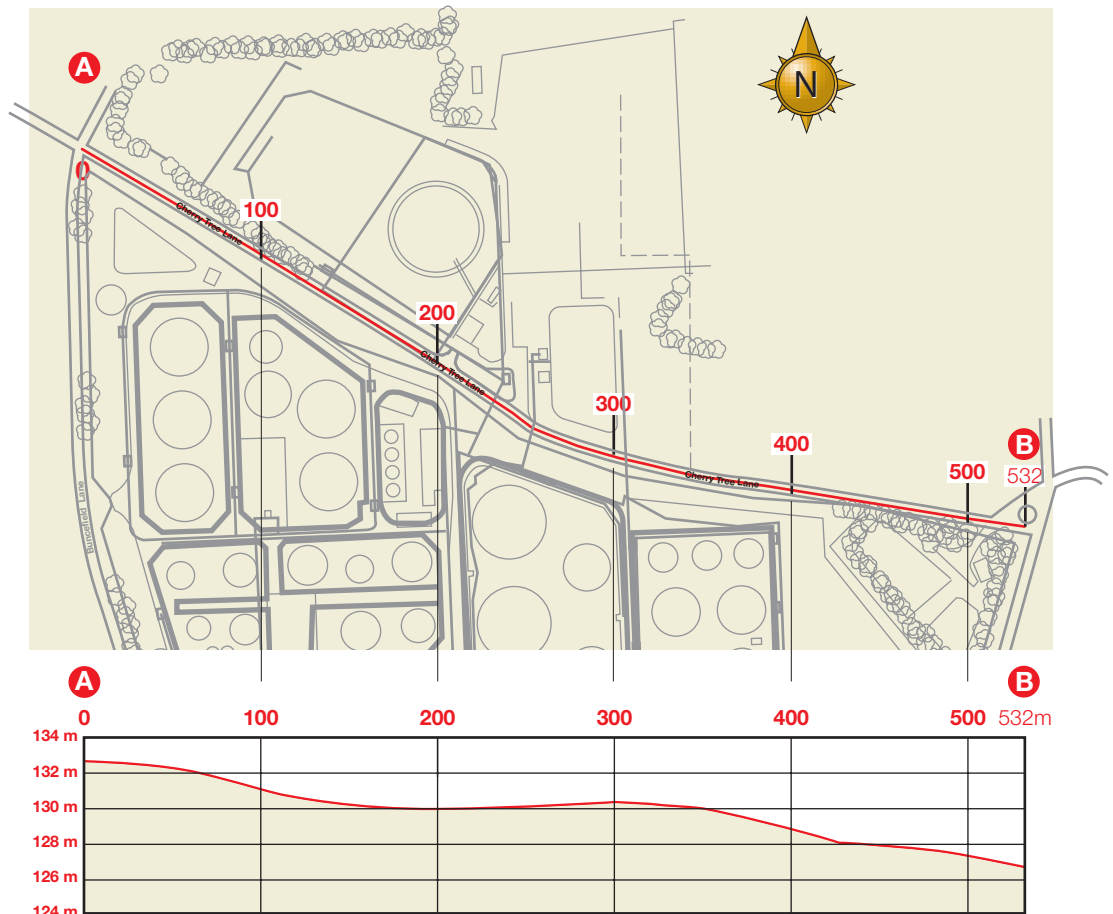
Figure 2 Schematic of topography at Cherry Tree Lane

26 During the incident, the internal roadways were submerged by fire water and fuel flowing to the lowest point. Fire water and fuels flowed through the site drainage and along the roads within the site perimeter. At the low point on the site perimeter the flows overtopped the road edge, which was not kerbed, and flowed into Cherry Tree Lane.

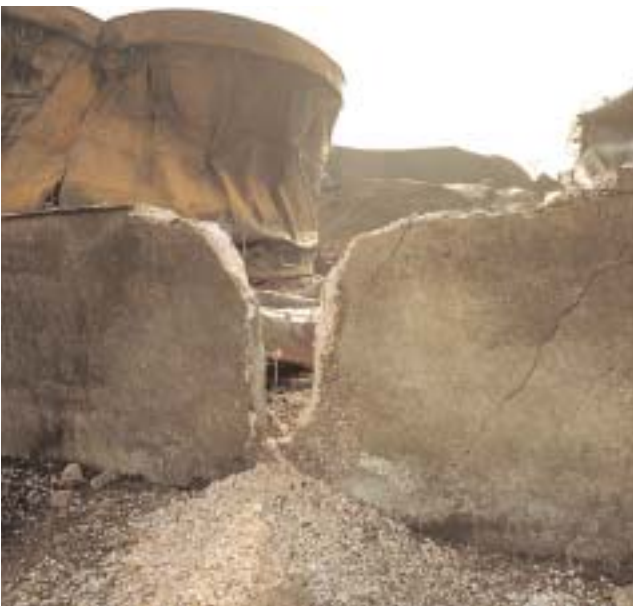
16 While the bunds substantially remained standing throughout the incident, their ability to fully contain the fuel and fire waters was lost as a result of the explosion and subsequent fires. Figure 3 shows the damage caused to bund walls as a consequence of the incident. Pools of fuel were burning in the bunds as a result of loss of fuel from the tanks, along with fires from the tanks themselves. Figures 4 and 5 show a bund, where the concrete panels had been infilled with a joint sealant. This sealant has been lost as a result of the fire and/or hydraulic pressure within the bund.

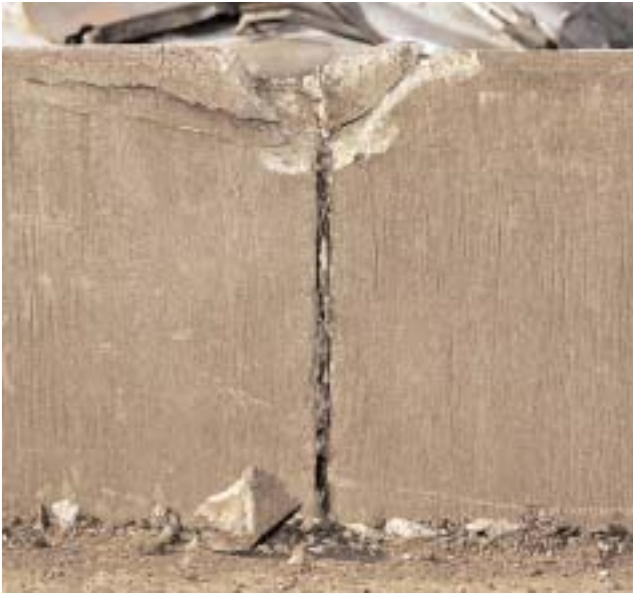
17 Many of the bunds around the site have suffered varying degrees of sealant damage. Figure 6 shows fire water and product leaking from such a joint in the later stages of the incident.

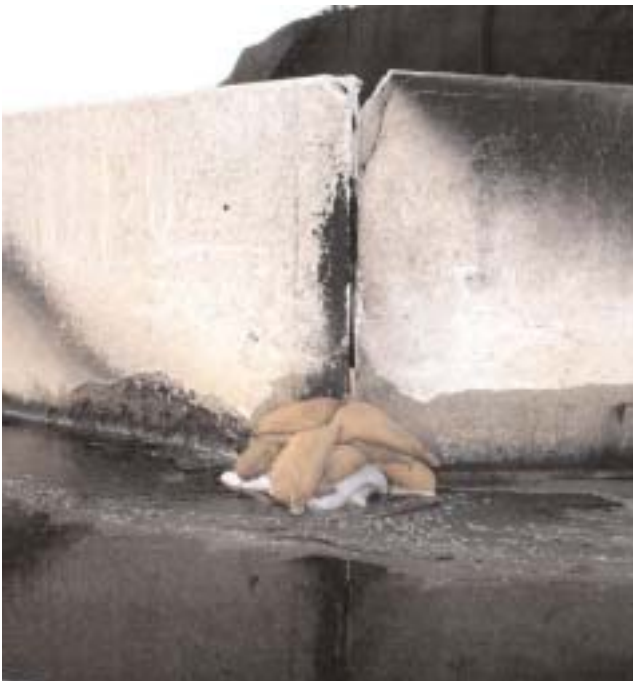
Figure 7

18 Another two leakage mechanisms can be seen in Figure 7. Here a corner joint has opened up, releasing fire water and product. Visible along the lower edge of the bund wall, a 'tide mark' shows where liquids were seen to seep through the concrete itself.

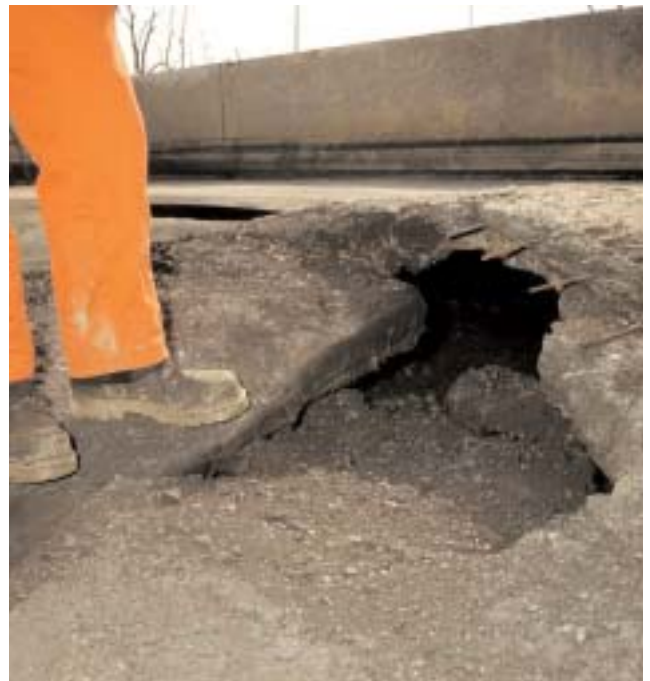
19 Figure 8 shows the base of a bund where the concrete panels have undergone significant 'heave' which has resulted in the escape of product and fire water.

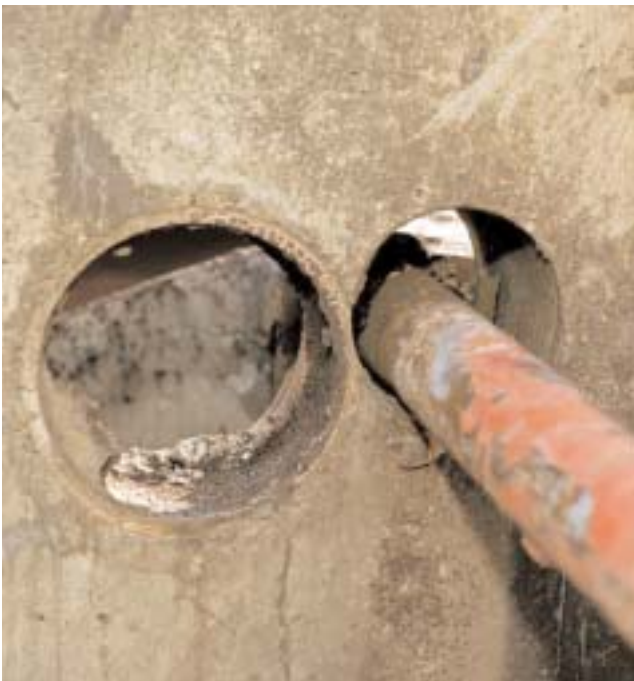
20 Figure 9 shows the inclusion of penetrating pipework in the construction. Here the sealing material surrounding the pipes has been lost.

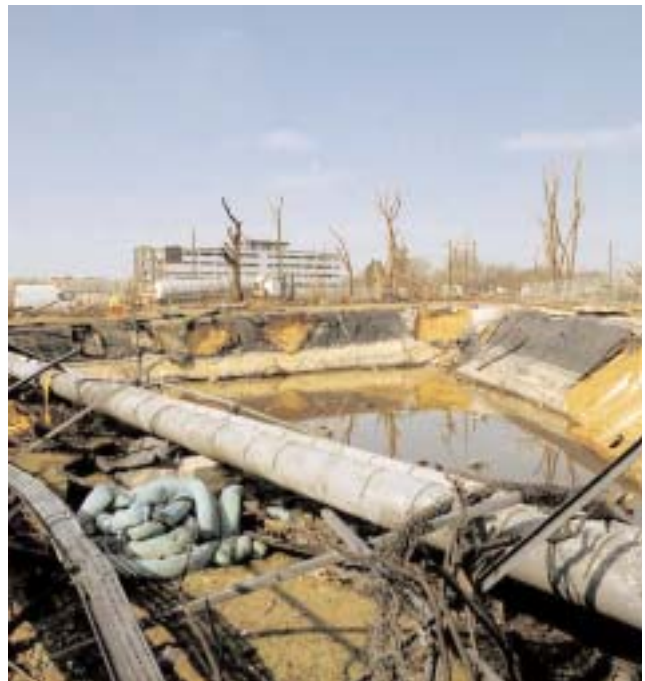
Figure 10

23 There are lagoons on the site which provide a reserve of fire water for use in emergencies. One of the lagoons (to the north of bund A) shows evidence of significant damage to the lining that may have resulted from the explosion or the fire.

24 As a result of the breach to the lining, some of the liquids in the lagoon, which included contaminated run-off liquids from the bunds and fire fighting, may have escaped into the ground. The natural clay layer beneath the site would have helped to minimise the extent of any contamination of the ground from this source.

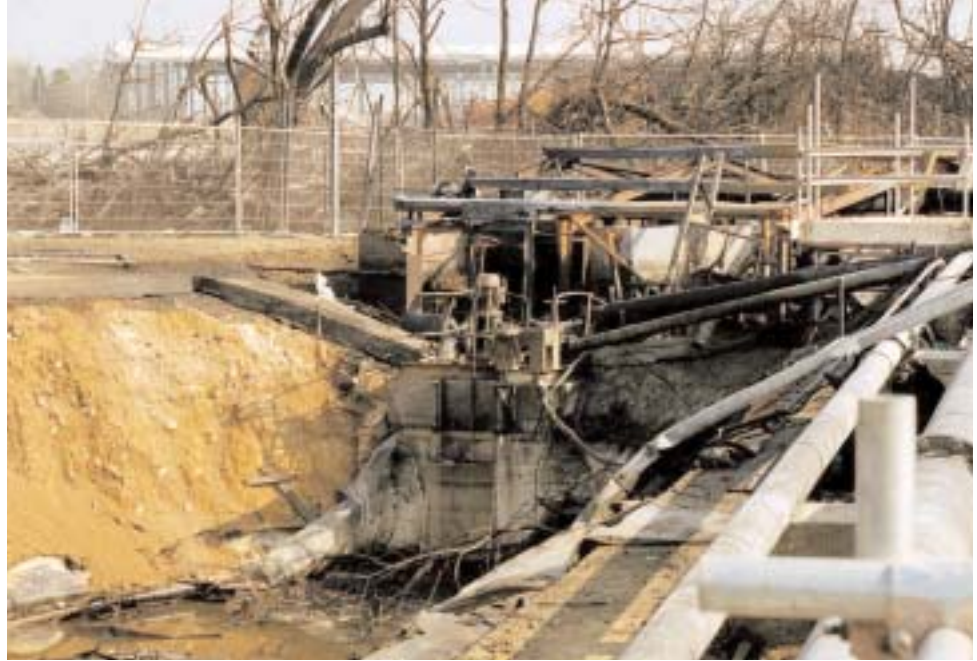
25 The pumphouse to the north of bund A, adjacent to the lagoon, was destroyed by the explosions. The control of water on the site was dependent on the use of the pumps located within the pump house. Because the initial explosions destroyed all of the fire-fighting equipment in the affected area, the lagoons were never brought into use and the fire services had to establish alternative arrangements.

Figure 11 The three parallel bars show where the pumphouse stood before the incident

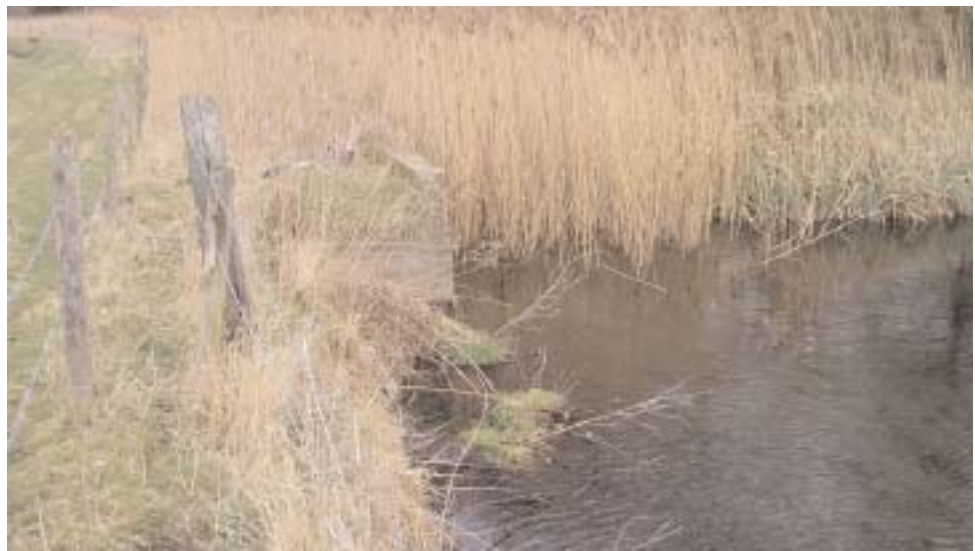
35 Surface water monitoring has concentrated on the River Ver, as it receives surface water from the Buncefield site. Two balancing tanks (which provide buffers to prevent uncontrolled surges of water), the Maylands and Redbourn lagoons, receive surface water from the site and the surrounding area, and subsequently discharge into the River Ver.

Figure 15 Picture of Maylands Tank outfall into River Ver

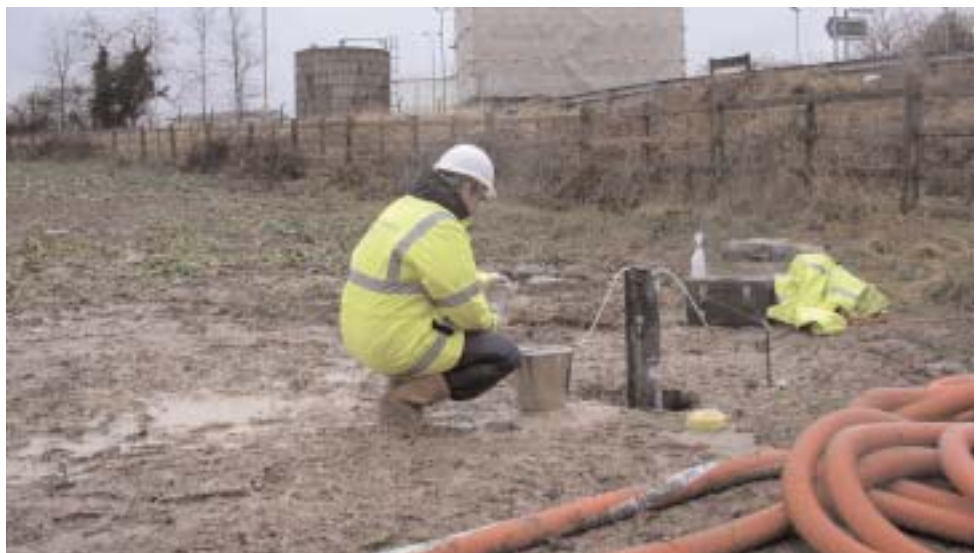
45 Three new observation boreholes have been drilled closer to the Buncefield site to provide early detection of any ground water pollution: Butlers Farm (between Buncefield and Bow Bridge Pumping Station); Breakspear House (south of Buncefield); and Hogg Lane (on the east boundary of Buncefield – see Figure 16). This is part of an ongoing monitoring regime that will provide further boreholes surrounding the site. They have each been sampled once, along with drinking water boreholes, and analysed for pollutants.

Figure 17 A new borehole at Cherry Tree Lane

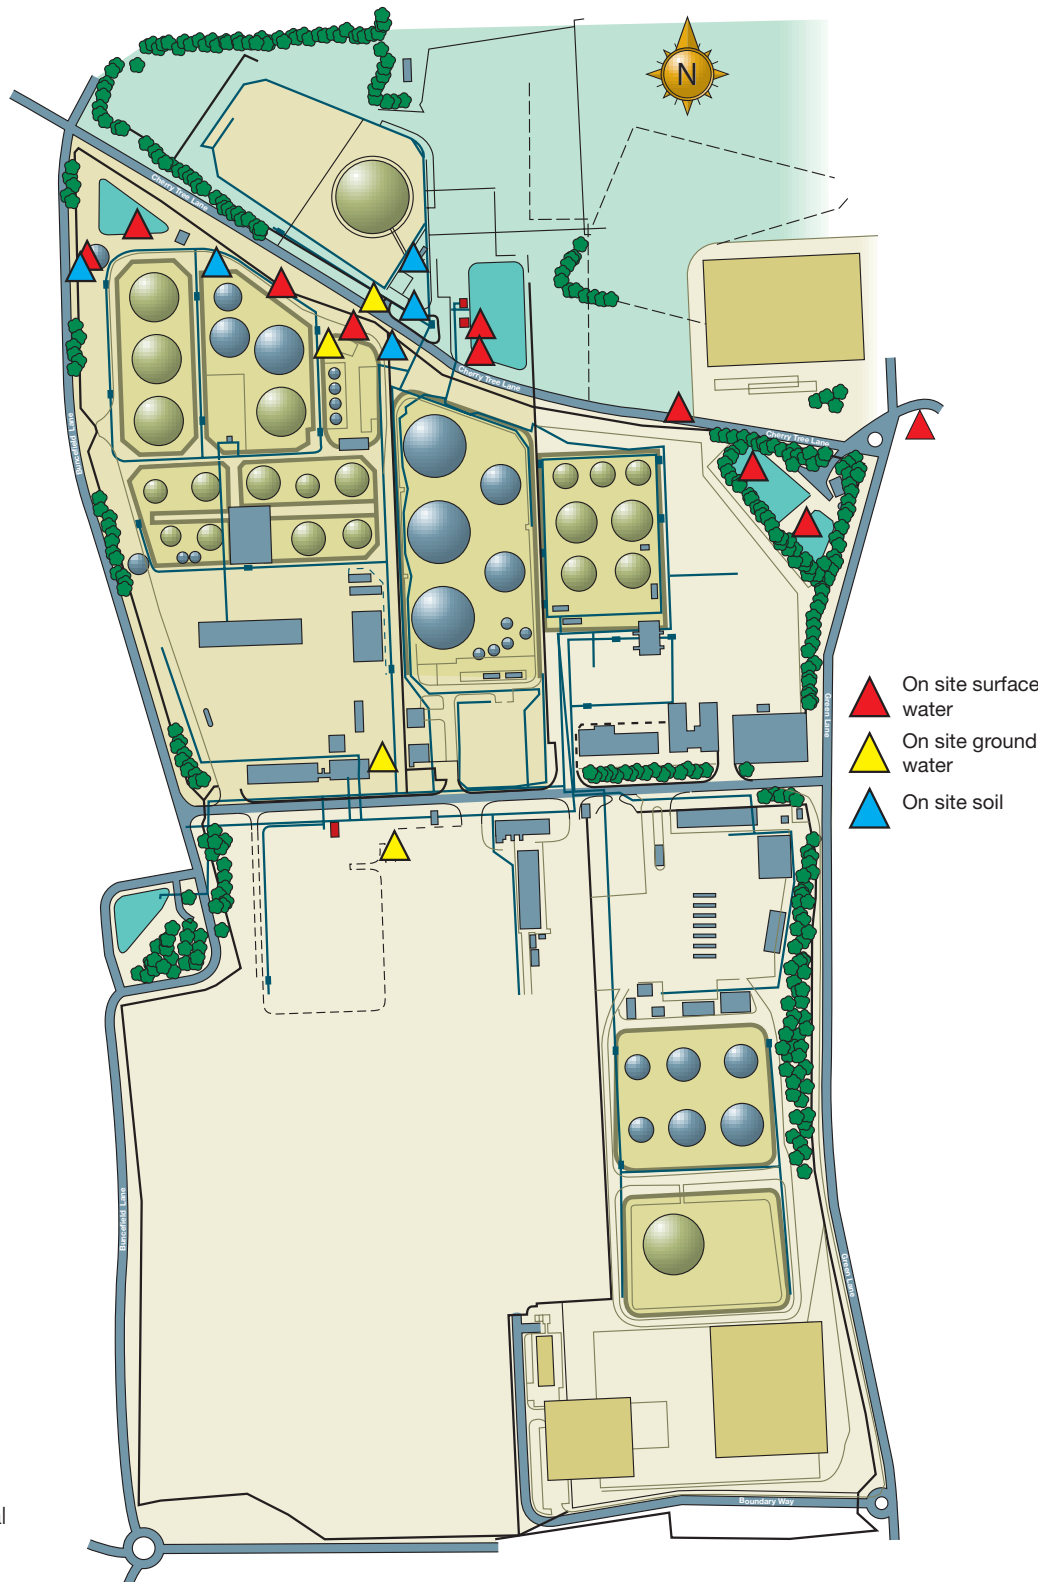
Figure 18 Location of trial pits

53 Investigations to assess the extent of land contamination started in February 2006 along Cherry Tree Lane. Trial pits were excavated at points along the Lane and on site and a number of samples taken for laboratory analysis. The locations of the trial pits are indicated in Figure 18.

54 The initial findings indicate that the surface layer of the soils, the top 30 cm approximately, was contaminated with fuel and fire-fighting products. No visible free product was detected in any of the trial pits at depth. PFOS, hydrocarbons and polycyclic aromatic hydrocarbons have been reported in the laboratory analysis.
