Buncefield: Why did it happen?

The underlying causes of the explosion and fire at the Buncefield oil storage depot, Hemel Hempstead, Hertfordshire on 11 December 2005

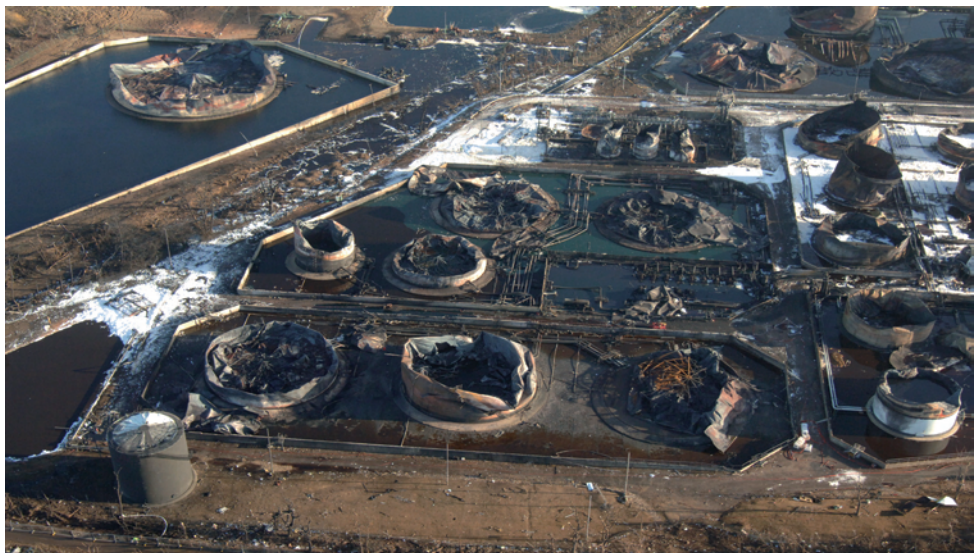
Figure 6 Buncefield after the incident: Tank 912 is in the centre foreground and Tank 12 is in the top left of the picture © Chiltern Air Support

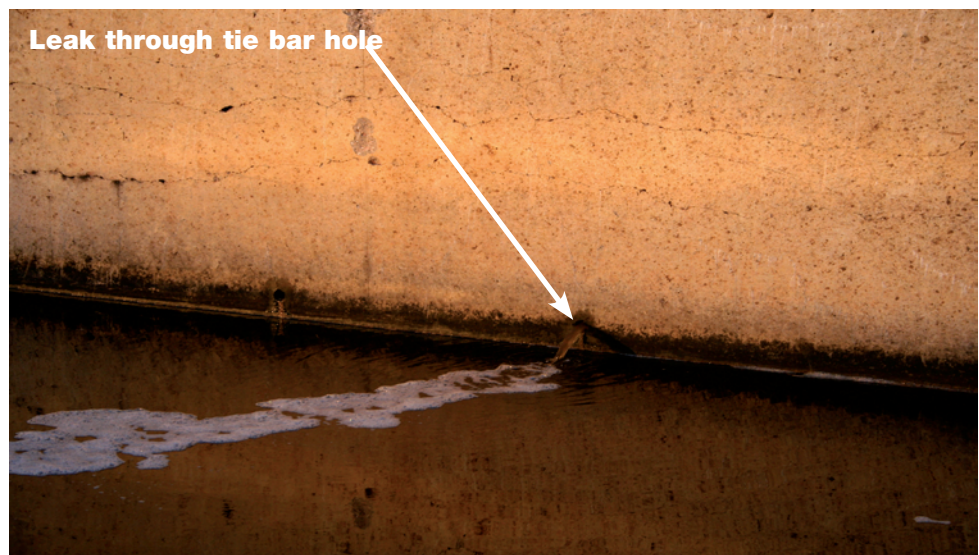
69 Another failure mode of the BPA bund was introduced at the construction phase. The shuttering (or formwork) used to hold the concrete in place before it set was held in place using tie bars (or tie bolts). Good practice requires either use of formwork techniques avoiding tie bolts or use of 'tie bar waterstops'. The BPA bund was constructed with tie bars penetrating through the bund and, although they were plugged and grouted, they were unable to resist the impact of the fire. Holes opened up, which were further pathways for leakage of fuel, foam and firewater from the bund.

Figure 7 Tank 12 after the incident showing liquid leaking through tie bar hole

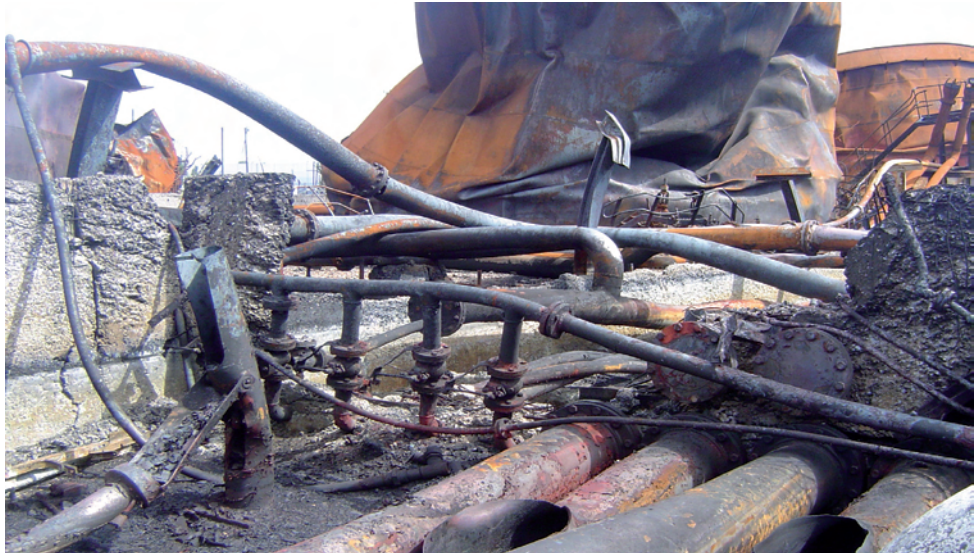
- catastrophic failure of the walls at pipe penetrations, likely due to thermal expansion of the pipework;

Figure 8 Catastrophic bund wall failure at pipe penetrations

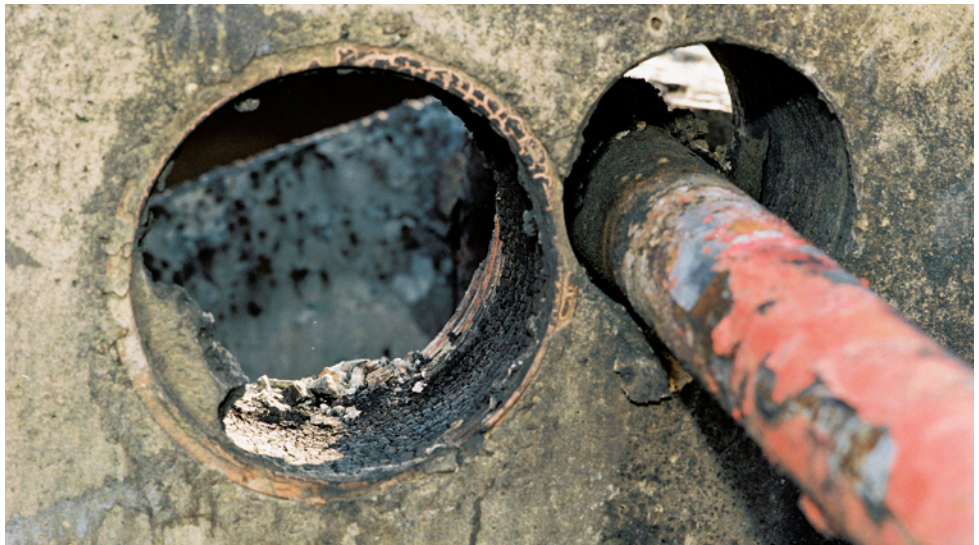
- some of the product pipes leading from the tanks ruptured and leaked so that there was an escape of fuel via damaged pipes through the walls and out of pipes in unbunded areas; and
- loss of seal between pipes and walls.

Figure 9 Loss of sealant between penetrating pipe and bund wall

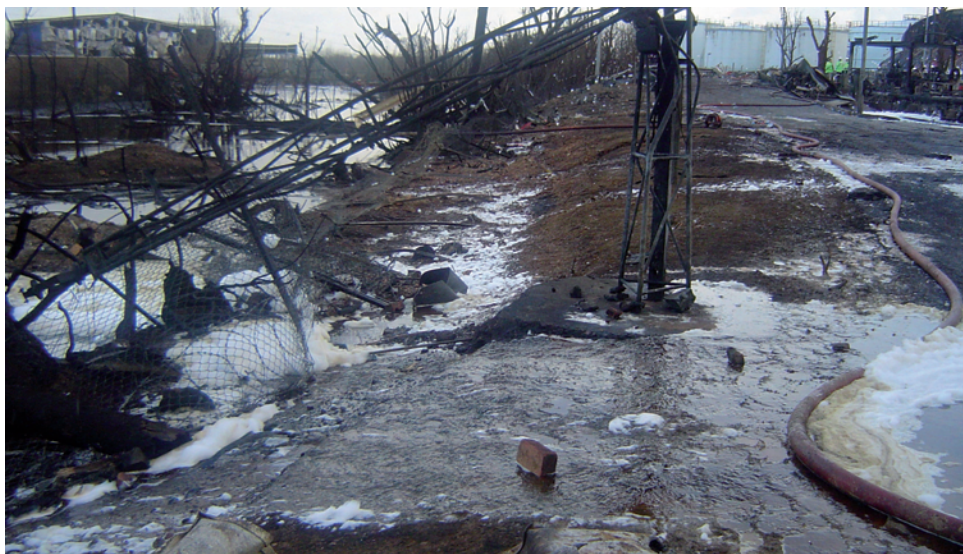
- There was no kerbing or boundary wall/mound to keep liquids on site and direct them into drainage systems. Once released, liquids could flow anywhere.

Figure 10 Fuel and firefighting liquids flowed off site

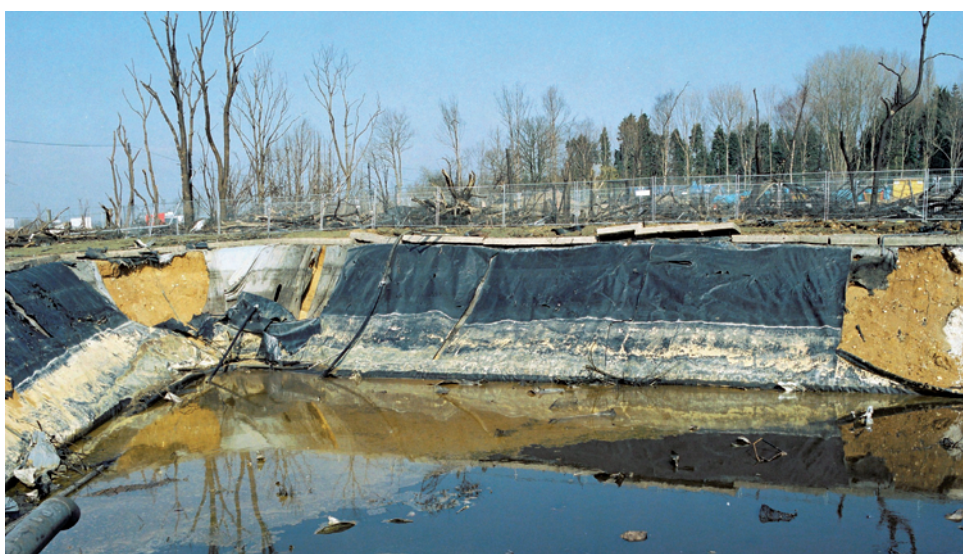
Figure 11 The firewater lagoon on the HOSL site after the incident

- The HOSL West lagoon was intended as a firewater supply, but was rendered useless as it received fuel draining from the site. It flooded the fire system pump house when it overflowed.
- There was a dependence on pumping liquids, which as a process is vulnerable to, for example:
 - inadequate pumping capacity;
 - failure of pumps on loss of power; and
 - inability to use pumps following release of flammable vapour.
- Some areas of unmade ground were not protected from liquids and one such area of the site included a soakaway.
- The effluent treatment plant included soakaways that were not identified in the safety reports or emergency plans.

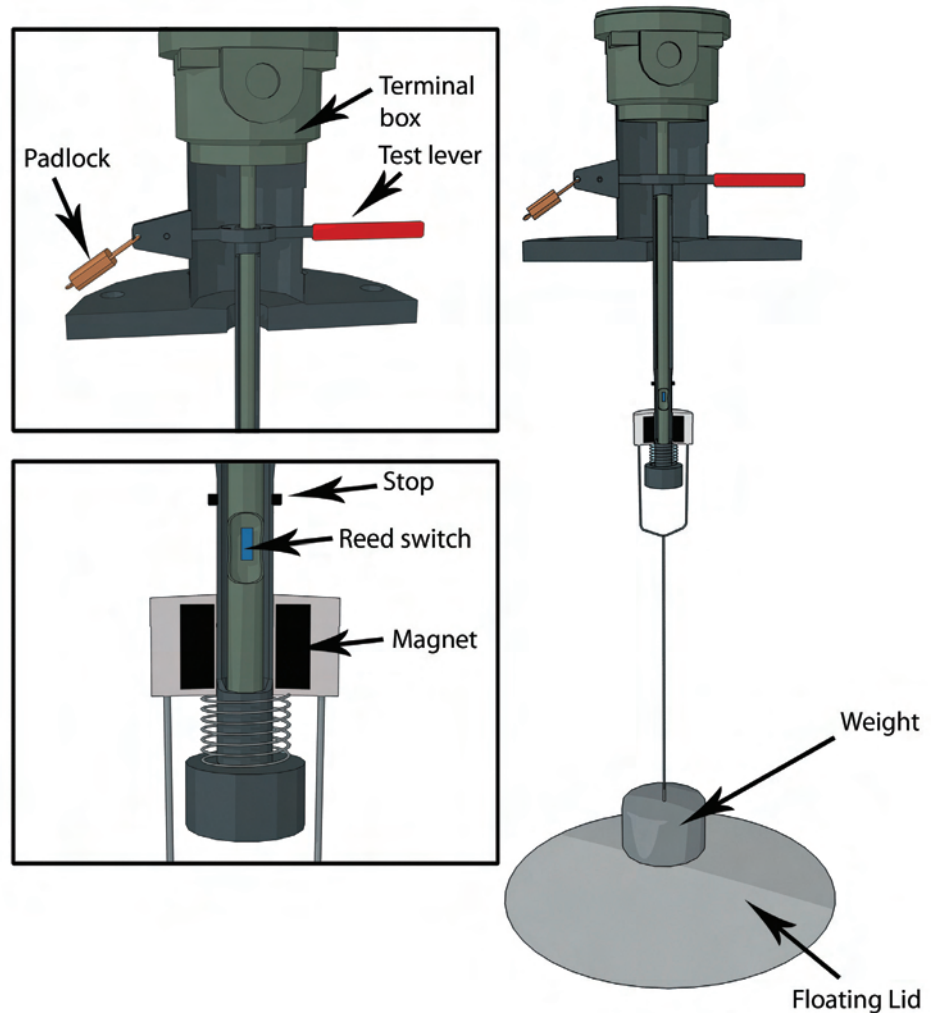
Figure 12 The working principles of the IHLS

- 1 The switch worked – ie activated the alarm circuit – when the floating internal deck (lid) contacted and raised the internal suspended weight. This in turn raised a magnet which activated a reed switch.
- 2 The check lever allowed the switch and the alarm circuit to be activated independently of the movement of the floating lid. In effect the checking action simulated exactly what should happen if the floating lid arrived at that point.
- 3 There were three positions for the lever. The horizontal position was the normal operating position. In this position the switch operates as expected, ie if the floating lid lifts the weight, so that it is no longer hanging from the switch, the reed switch changes state and this initiates an emergency shutdown. The IHLS installed in Tank 912 was designed so that a padlock should be used to secure the lever in the horizontal position.
