# IMPERIAL CHEMICAL INDUSTRIES HEAVY ORGANICS DIVISION

## SAFETY NEWSLETTER NUMBER 21

By Trevor Kletz

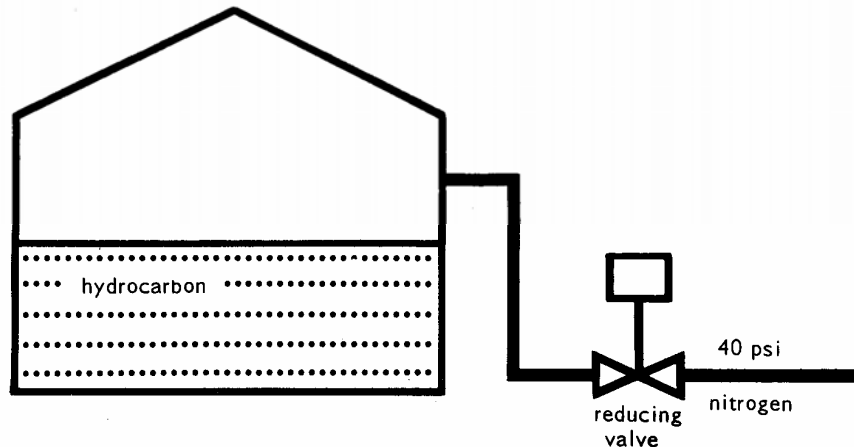
On one group of tanks the reducing valve on the nitrogen supply was installed at ground level.

Hydrocarbon vapour condensed in the vertical section of the line and effectively isolated the tank from the nitrogen blanketing.

The reducing valve should have been installed at roof height.

Check your tanks – there may be some more like this one.

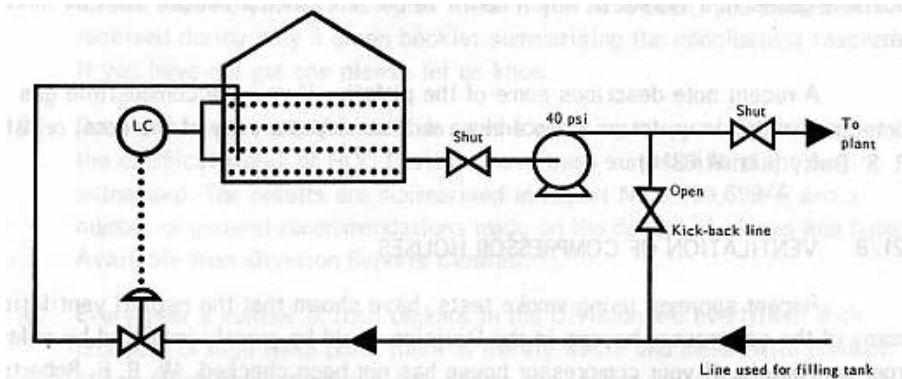
A pump body was overpressured and cracked, causing a spillage of flammable oil.

The tank was being filled. Its delivery pump was shut down, but the kick-back valve was open. When the high level trip on the tank closed the motor valve on the filling line, the pressure in the filling line rose to 300 psi and burst the delivery pump which normally operates at 40 psi.

Relief valve reviews and operability studies usually pick-up this sort of thing. In this case it was missed, perhaps because off-sites get less attention than the main plant. This incident — and others — show that off-sites should get the “full treatment”.

The pump body was made of cast iron, not a good choice for a flammable liquid, and not permitted by our current Engineering specification.

The kick-back line has now been run direct to the tank.
