IMPERIAL CHEMICAL INDUSTRIES HEAVY ORGANICS DIVISION

SAFETY NEWSLETTER NUMBER 30

By Trevor Kletz

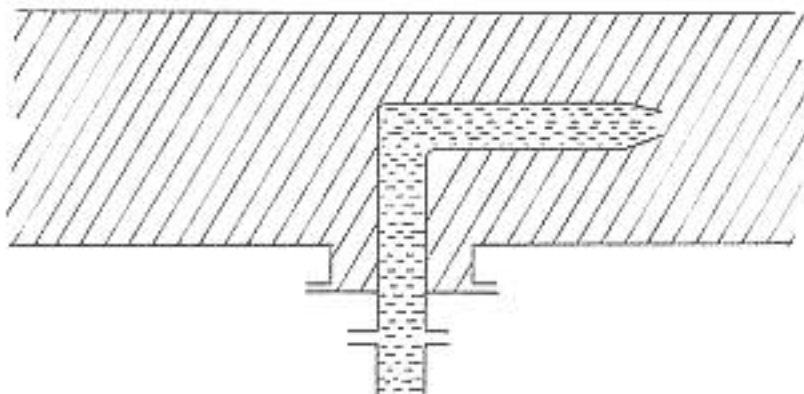
Newsletter 27, Item 1, pointed out that corrosion can occur when oil and water meet. This has caused a number of leaks some of which have fired and caused serious damage. If water has to be added to an oil stream, the water pipe should enter the centre of the oil pipe. Harland Frank suggests the following arrangement:

"The seat of the fracture would appear to have been in the gasoline hydro-treater. At this point in the processing, water is injected into the system. The corrosion tolerance is accepted at 0.050 inch per year, but the corrosion and erosion at this point in the process were much higher than expected for reasons not yet fully understood, but which include the presence of corrosive contaminants and an unfavourable flow pattern inside the pipe. These circumstances contributed to the excessive thinning of the pipe wall and its ultimate failure."

The dimensions of the branch and quill are chosen so that the injection pipe can be removed for inspection.

This arrangement is also suitable for the injection of Corrosion inhibitors, small quantities of additives etc.

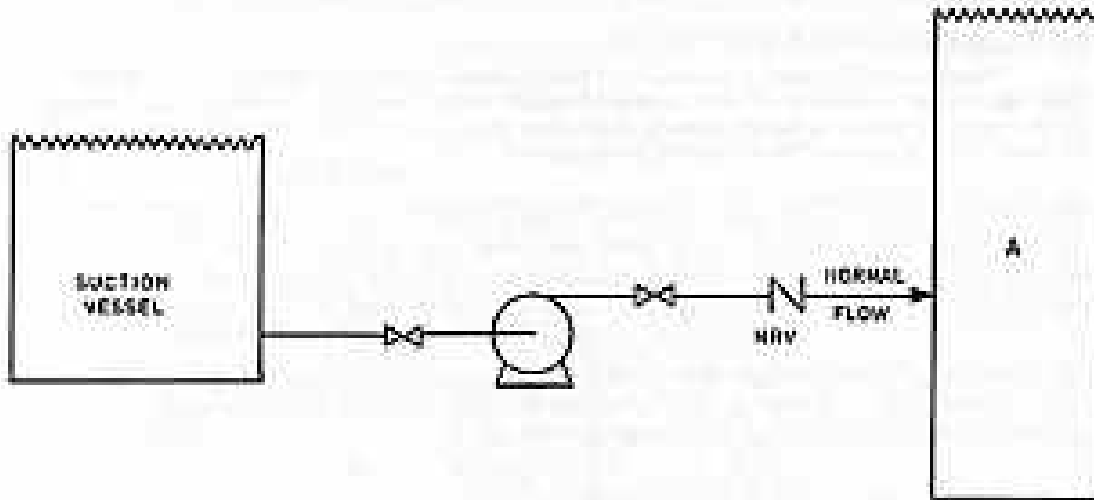
The pump tripped out. The non-return valve failed to work and the pump was driven backwards by the pressure and head of liquid in vessel A. The impellor disintegrated and the motor was damaged.

Whenever failure of a non-return valve could have serious consequences, the use of two in series should be considered. In many cases it will be possible to work out the probability of failure and see if duplication is worthwhile. The following example shows how to go about it.

Duplication of the NRV is, therefore, justified if it can be done for less than £150/year, or about £500 capital.

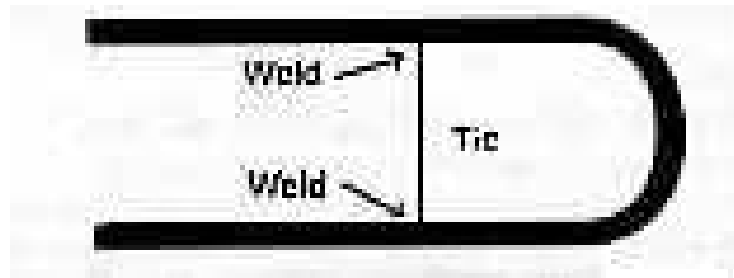
One engineer recalls an occasion when a similar incident nearly happened. A pipeline carrying very hot gas was designed in the shape of a 'U' so that it was free to expand. To make construction easier the plumbers welded a tie across the 'U' as shown below

When the pipeline was complete they forgot to remove the tie and the ladders covered up the ends of it.

Fortunately, while the plant was warming up for the first time, one of the start-up team noticed the tie and asked why it was there.
