IMPERIAL CHEMICAL INDUSTRIES PETROCHEMICALS DIVISION

SAFETY NEWSLETTER NUMBER 40

40/1 A FIRE IN AN EMPTY FLOATING ROOF TANK

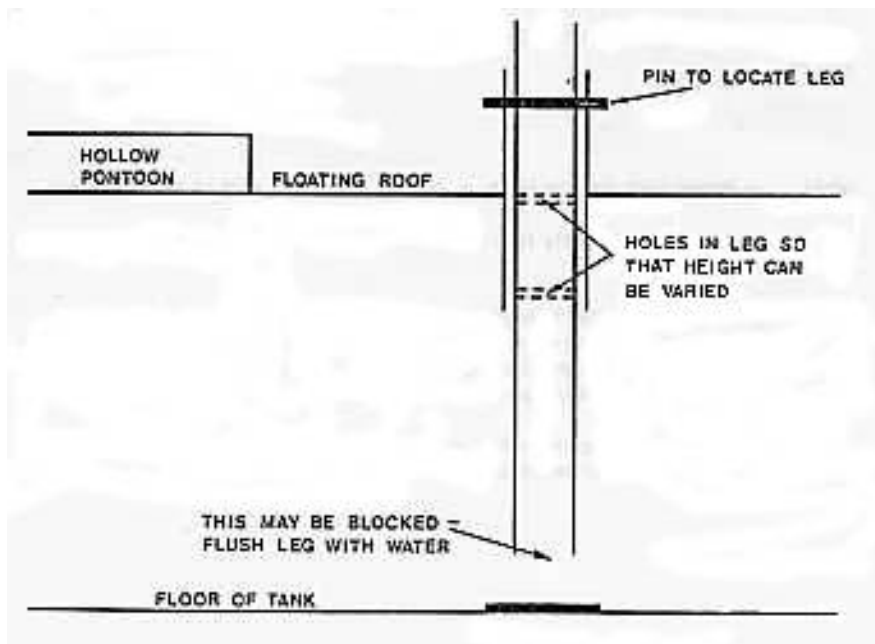
Fourteen days later a small fire occurred. About a gallon of petrol came out of one of the hollow legs which supports the roof when it is off float, and was ignited by a spark. The fire was put out with dry powder.

It is believed that the bottom of the hollow leg was blocked with sludge and that as cutting took place near the leg it moved and disturbed the sludge.

In future, before welding or burning is permitted on floating roof tanks, the legs should be flushed with water from the top.

On some tanks the bottoms of the legs are sealed. Holes should be drilled in them so that they can be flushed through.
