IMPERIAL CHEMICAL INDUSTRIES PETROCHEMICALS DIVISION

SAFETY NEWSLETTER NUMBER 42

42/1 SIX WAYS TO SUCK IN A TANK

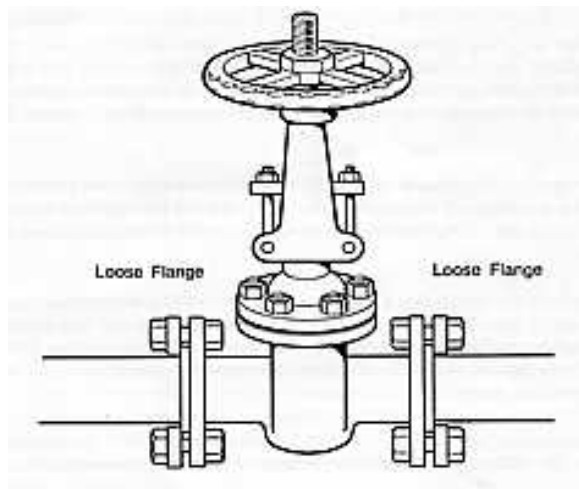
If you have any loose flanges on your plant there is one hazard of which you should be aware. If bolts are slackened off slightly, for example, as the first stage in the removal of a valve, there is nothing to hold the valve in position and it could swing over, injuring anyone who happens to be in the way. (**See 43/7**)

When the bolts are slackened there is nothing to prevent the valve falling over.
