IMPERIAL CHEMICAL INDUSTRIES PETROCHEMICALS DIVISION

SAFETY NEWSLETTER NUMBER 47

By Trevor Kletz

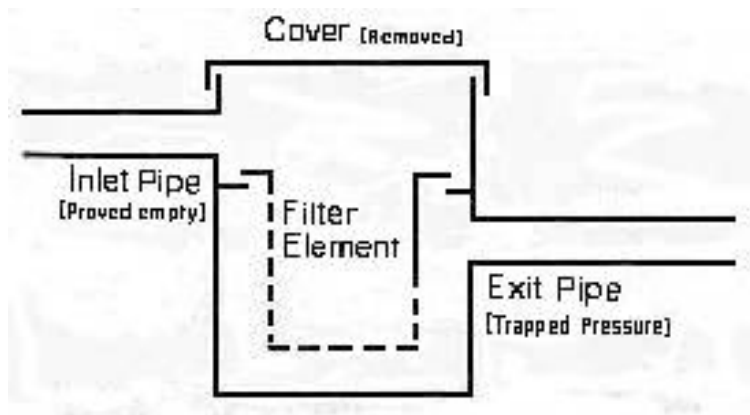
47/3 A FILTER IS THE CAUSE OF TRAPPED PRESSURE

A filter had to be dismantled for cleaning. The inlet side was isolated, emptied and proved clear. The operator, as usual, assumed that the exit side would also be clear as any liquid left in it would have passed backwards through the filter into the inlet side.

The operator therefore removed the top cover and then tried to remove the filter element. It was stiff,

so he tried to ease it out with a bar. It came suddenly, hitting the equipment overhead. -

There was trapped pressure on the exit side of the filter and this blew out the filter element. The filter was choked and so the pressure could not be released through it.

Before opening up a filter assume it may be choked and vent both sides. All filters should be fitted with drain and vent connections so that this can be done safely. A filter cannot be treated like a piece of pipe — it is more like a closed valve. This is particularly true if the filter has a real job to do and is not just there as a precaution to prevent damage to a pump.

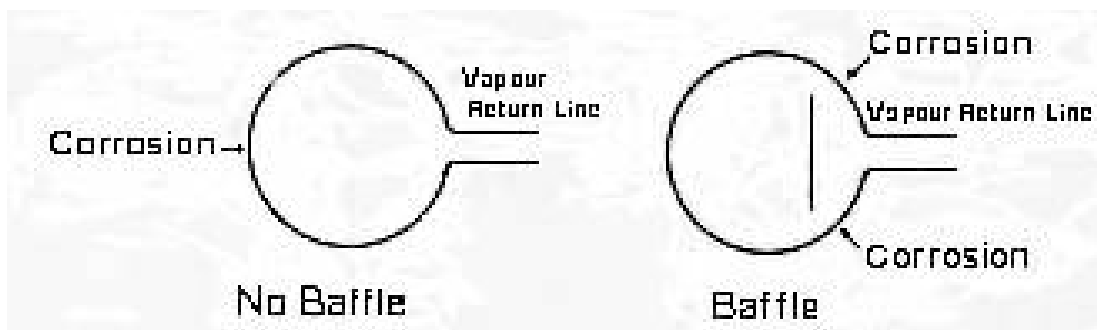
Corrosion was suspected on a distillation column. Ultrasonic thickness measurements were therefore made on the outside of the shell. These showed that although some corrosion had occurred, the thickness was still well above the design minimum.

Some months later, when it was possible to take the column out of use, the lagging was removed and it was discovered that part of the column was so thin that it could be flexed by hand.

The thin spot was immediately opposite the vapour return line from the reboiler. The thickness measurements had been made on the other side of the column where the staging and ladders made access more convenient.

1. Thickness measurements in distillation columns should be made at the points at which corrosion is most likely to occur. In the case described above, this was opposite the vapour return line. Often there is a baffle near the return line and corrosion is then most likely near the edges of the baffle.

The geometry of the column must be studied. -

2. During design, access ladders should be positioned to facilitate thickness measurements at the points where corrosion is likely to be heaviest.

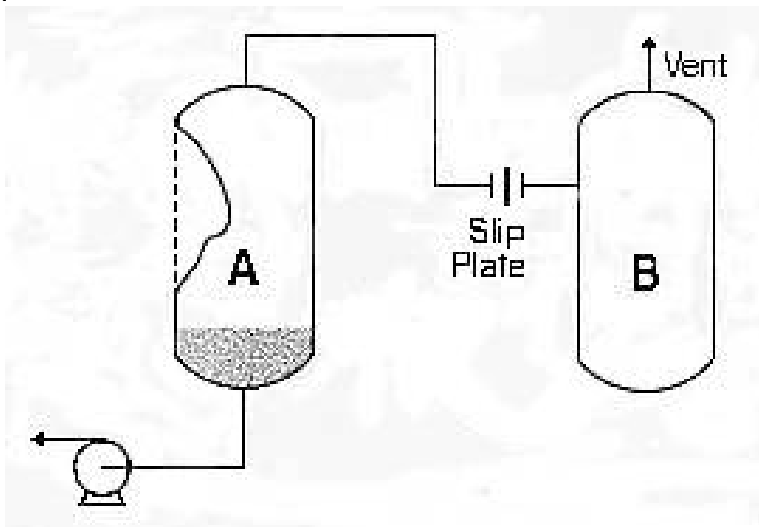
- (b) Newsletter 42, Item 1 described six ways in which storage tanks have been sucked in. Readers have now supplied another two.
 - (i) A tank was carefully cleaned out in preparation for the storage of a very pure material. In order to make sure that no dirt got in, somebody tied a polythene bag over the vent pipe. It was a hot day; there was a sudden shower of rain and this cooled the tank sufficiently to suck it in.

- (ii) Vessel A was vented through vessel B. Vessel B had to be prepared for entry so the line leading to vessel A was slip-plated off. When liquid was pumped out of Vessel A, it was sucked in.

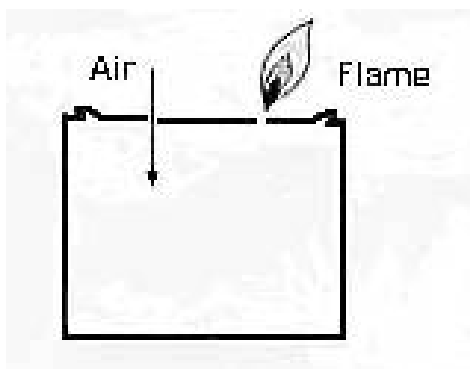
- (f) Newsletter 40, Item 3 described how a tank blew up in another company. The bottom man-hole was removed while the tank was still full of petrol vapour. Vapour came out and caught fire. As the vapour burnt, air was sucked into the tank through the vent until the contents became explosive and the tank then blew up.

Tom Hay recalls that as a boy he used to punch two holes in a golden syrup tin and then fill it with town gas through a rubber hose. The gas coming out of one hole was lit, and for a while a small flame burnt. Air was drawn in through the other hole until there was an explosive mixture in the can and then the lid blew off.
