IMPERIAL CHEMICAL INDUSTRIES PETROCHEMICALS DIVISION

SAFETY NEWSLETTER NUMBER 50

By Trevor Kletz

March 1973

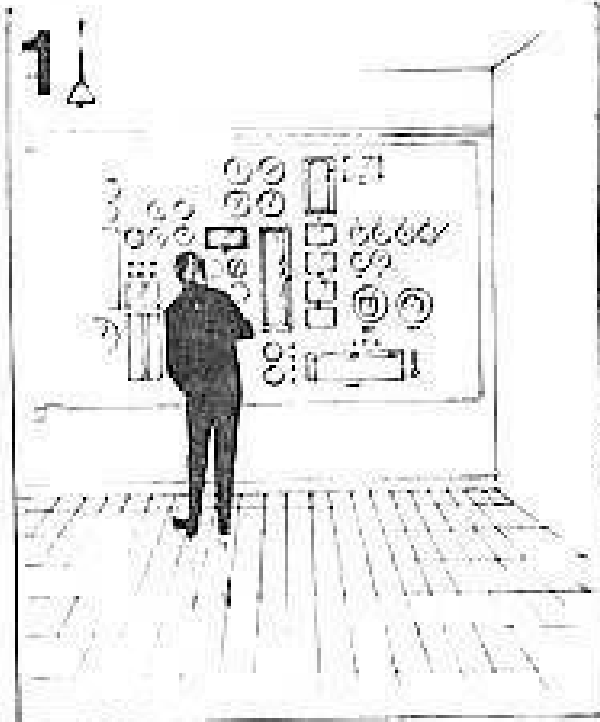
1
Morning. Operator noticed tank level was falling too fast. Assumed gauge was faulty and asked Instrument Section to check.

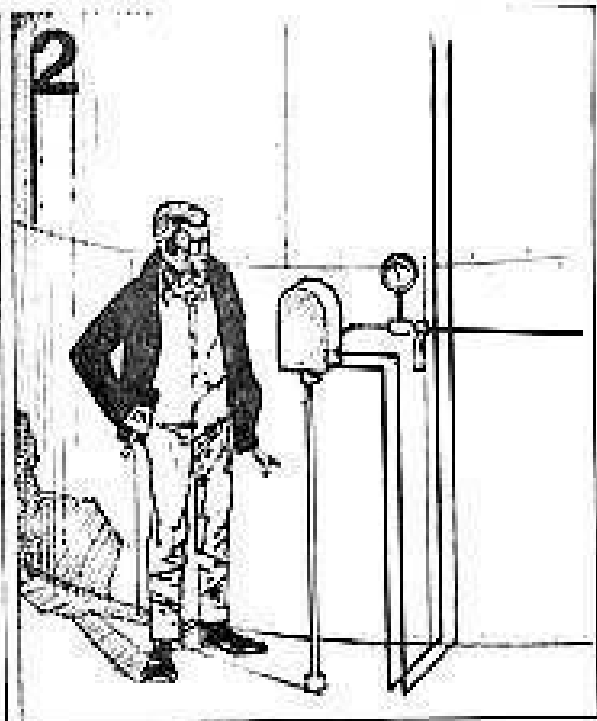
2
Afternoon. Instrument Section checked gauge and reported that it was O.K.

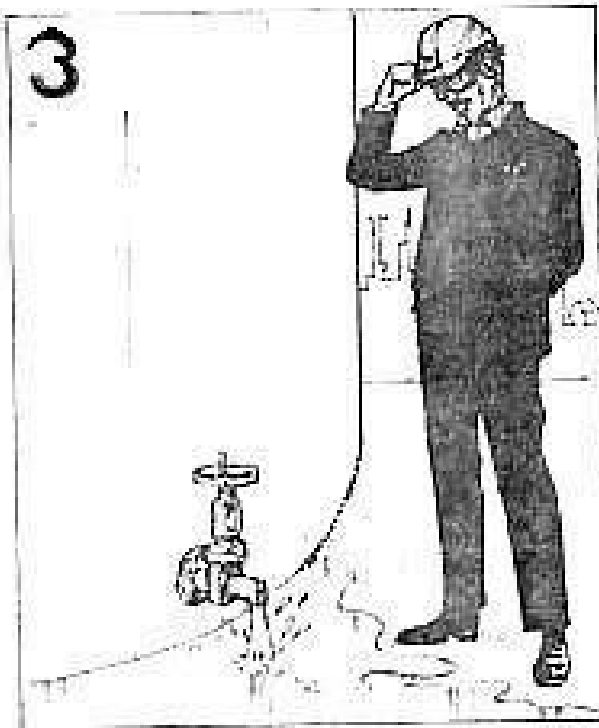
3
Afternoon. Operator looked around and found a leaking drain valve.
