**IMPERIAL CHEMICAL INDUSTRIES LIMITED**  
**PETROCHEMICALS DIVISION**

**SAFETY NEWSLETTER No. 54**

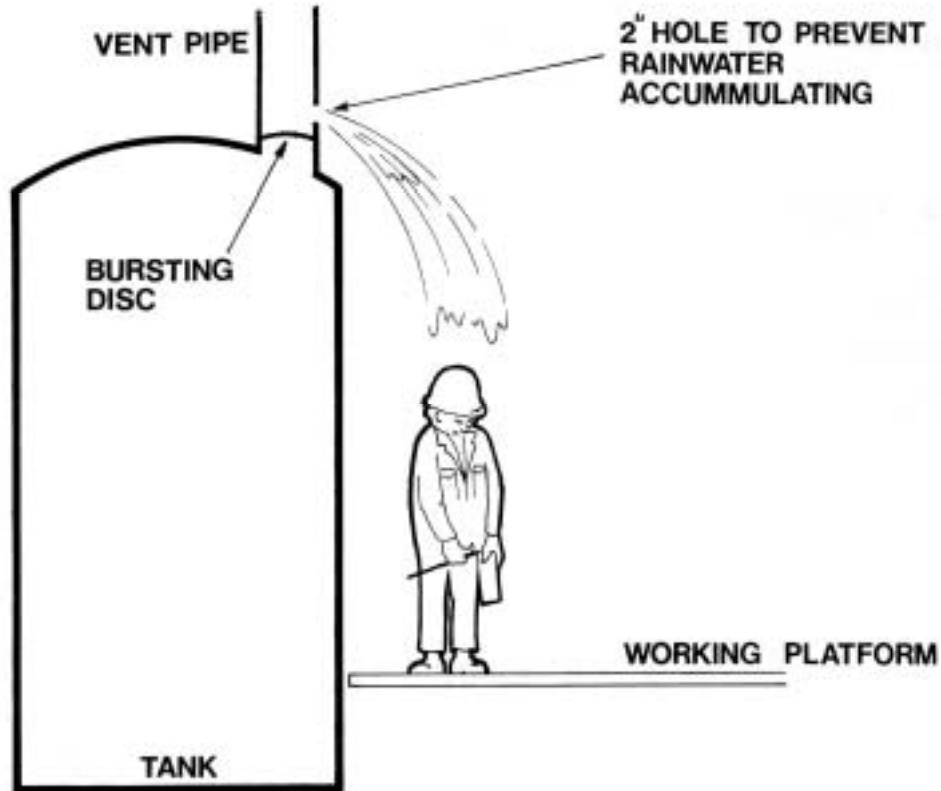
**54/4 A HOLE IN A VENT PIPE LEADS TO AN ACCIDENT**

When the bursting disc burst, a corrosive liquid came out of the 2 inch hole onto the man on the working platform.

To be fair, the vent pipe was designed to pass vapour, not liquid, but the possibility of liquid passing might have been foreseen. Fortunately the vent pipe was big enough to take the liquid rate.

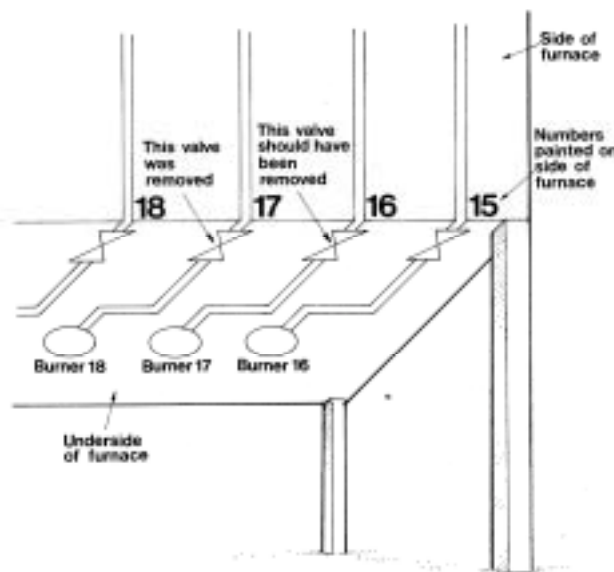
Two accidents have occurred as a result of poor or missing labelling. In the first a man was given a clearance to change a valve on burner No. 17 on a multi-burner furnace. The burners are underneath the furnace and the number of each burner is painted on the side of the furnace, as shown below. As the numbers were painted on the furnace a numbered tag was not tied onto the valve.

However, the fuel oil valve to burner No. 17 is in line with burner No. 16 and the valve to burner No

18 is in line with burner No 17. The man, who was a stranger to the plant, removed the valve from burner No. 18.

This incident could have been prevented by tying a numbered tag on the valve to be changed.
