**IMPERIAL CHEMICAL INDUSTRIES LIMITED**  
**PETROCHEMICALS DIVISION**

**SAFETY NEWSLETTER No. 57**

**57/1 WATER HAMMER AGAIN**

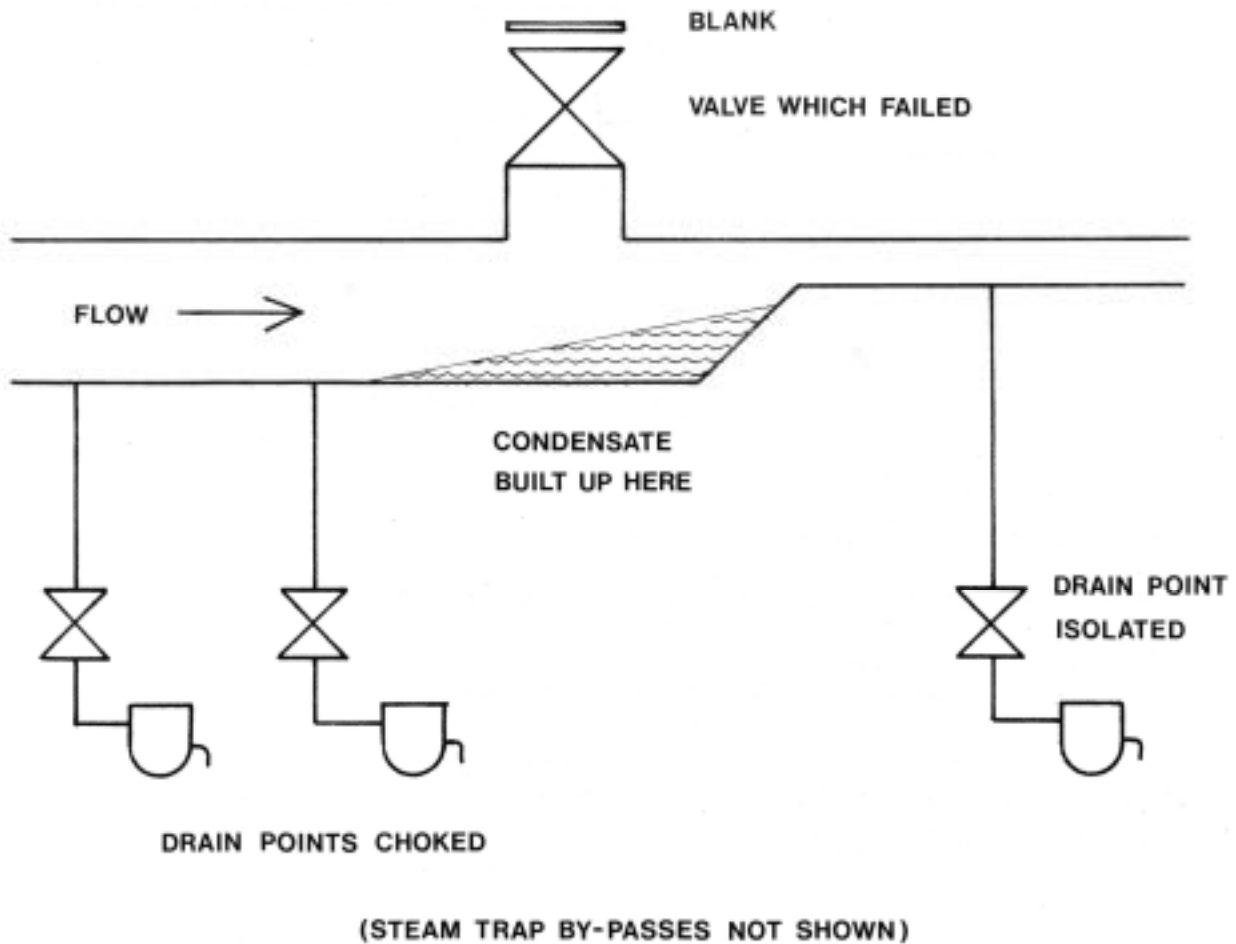
There was nothing wrong with the valve — the casting was of good quality — but two drain points upstream of the valve were partly choked with scale and the drain point downstream was isolated. In addition there was a reducer just after the valve, shaped as shown below, and this allowed condensate to accumulate.

The reducer should have been fitted like this:

Steam lines should always be designed so that they are self-draining; then it does not matter if one steam trap chokes.
