IMPERIAL CHEMICAL INDUSTRIES LIMITED
PETROCHEMICALS DIVISION

SAFETY NEWSLETTER No. 61

February 1974

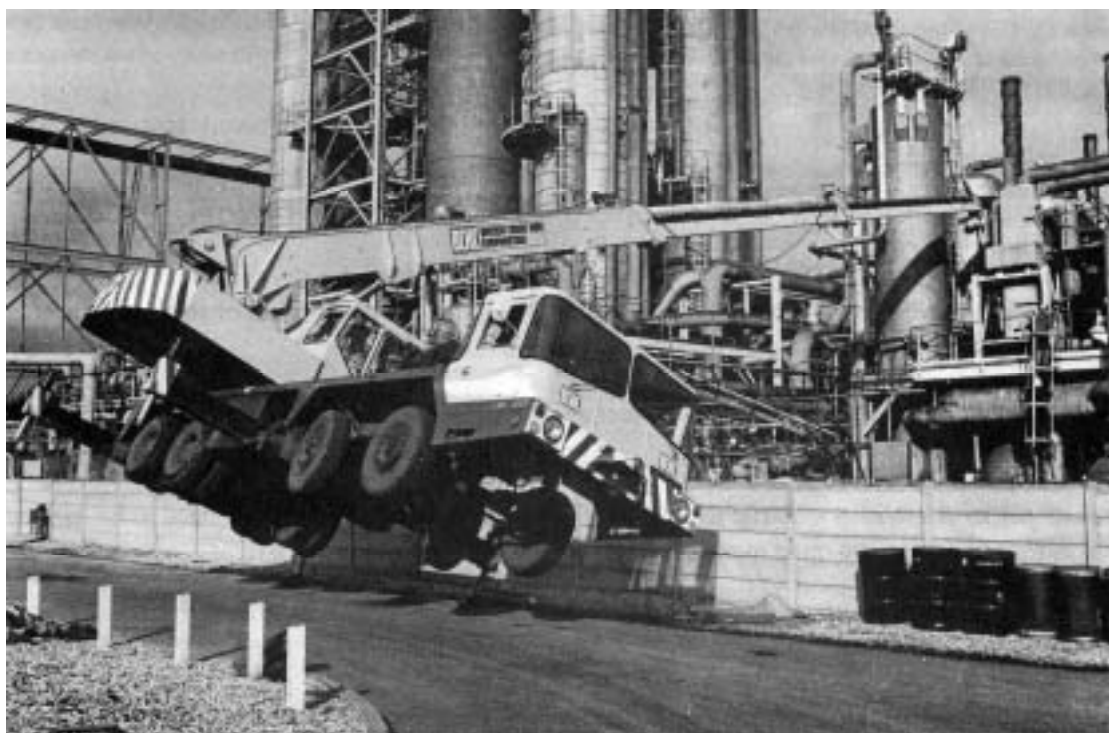
61/1 A CRANE TOPPLES ONTO A PLANT

In October last year, a 25 ton telescopic jib crane overturned onto a plant. The photograph illustrates the incident which was mentioned in Newsletter 59, Item 8 (b). A full account and recommendations are given in Report No. 0.200,795/A, available from Division Reports Centres.

A relief valve weighing 258 lb. was being removed from the plant when the incident occurred. The crane fell on to some process pipework and, to recover the machine, the plant was de-pressurised, thus interfering with production.

The crane was working with a jib length of 124 feet and the maximum safe radius for this jib length is 80 feet. The driver omitted to observe this and, in fact, went out to 102 feet radius. The crane was fitted with a safe load indicator of the type that weighs the load through the pulley on the hoist rope: it does not take into account the weight of the jib. Because of this, the driver got no warning of an unsafe condition and, as he lifted the valve, the crane overturned. Although the driver had been driving telescopic jib cranes for several years, he did not seem to appreciate the need not to exceed the maximum jib radius.

- 1The need for effective training of crane drivers;
- 2The need for an audible warning when the crane approaches unsafe conditions, such as a radius greater than that for which the machine has been designed;
- 3The need for all those concerned with lifting operations to be kept up-to-date with developments in the type of crane available. (A series of teach-ins covering this has since been held at Wilton)

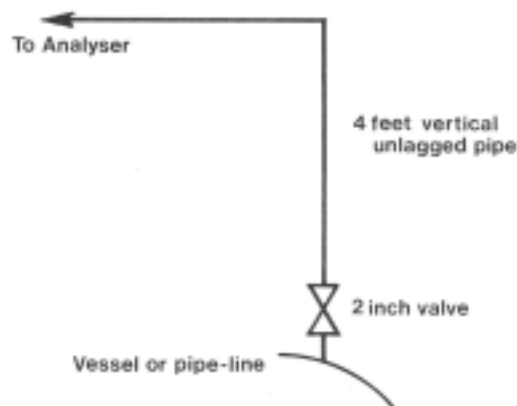
Finally the system shown below was installed.

The vapour condenses in the unlagged pipe and runs back into the vessel. The system is cheap and simple and has a much shorter response time than the more elaborate systems.

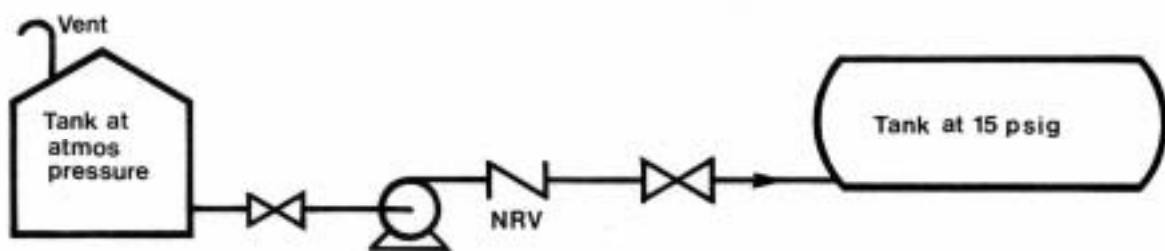
Another incident was described briefly in Safety Note 73/3 "Three Weeks in a Works". Naphtha is pumped at intervals from a tank at atmospheric pressure to one at 15 psig. For many years the practice was not to close any isolation valves but just to rely on the non-return valve in the pump delivery. One day a piece of wire got stuck in this non-return valve, there was a back flow of naphtha and the atmospheric pressure tank overflowed. Fortunately the spillage did not catch fire.

This is a good example of an accident waiting to happen. Sooner or later the non-return valve will fail and a spillage is then inevitable.

The pump delivery valve is now closed between each movement, and in addition there is a high level alarm on the atmospheric tank.

Of course, many non-return valves are in situations where it does not matter very much if they fail, or fail to shut-off completely. But if failure can affect the safety of the plant then the non-return valves should be listed and inspected regularly, say every year or two on clean duties, more often if there is rust or scale about.

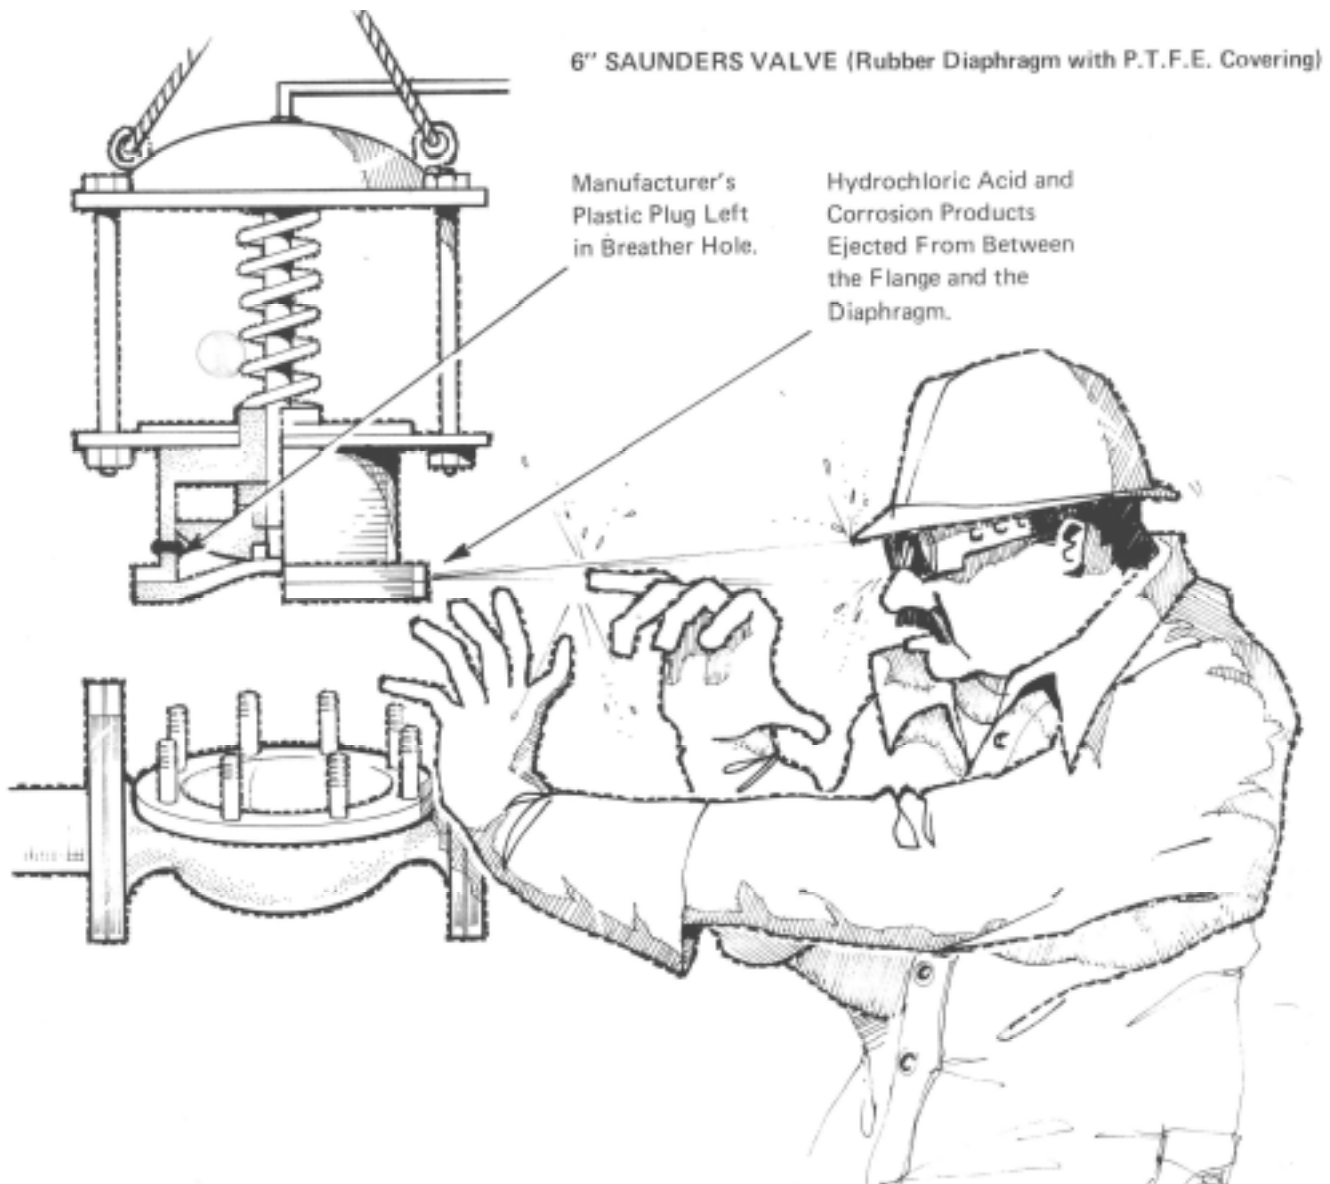
FITTER SPRAYED WITH HCL WHILST DISMANTLING VALVE

The pneumatic actuator on a 6" Saunders Valve required to be changed. The valve was isolated and the line drained of 36% hydrochloric acid. The head assembly, supported by a crane, was removed from the body by splitting the flange which holds the diaphragm. The head was off when acid and sludge shot out and sprayed the fitter. Goggles and prompt action saved him from all but very minor burns.

It was subsequently discovered that the P.T.F.E. covering to the rubber diaphragm had split, allowing acid to find its way into the bonnet, where it corroded the cast iron internal fittings giving off hydrogen. Gas pressure was built up in the bonnet because the manufacturer's plastic plug had been left in the breather hole and the combination of soft rubber and P.T.F.E. sealed the diaphragm to prevent release of pressure back into the valve body.

When the valve was dismantled, all that held the diaphragm to the flange was a film of paint which quickly ruptured, allowing violent ejection of the contents.

The moral of this is CHECK THAT THE BREATHER HOLES ARE CLEAR.
