IMPERIAL CHEMICAL INDUSTRIES LIMITED PETROCHEMICALS DIVISION

SAFETY NEWSLETTER No 64

April 1974

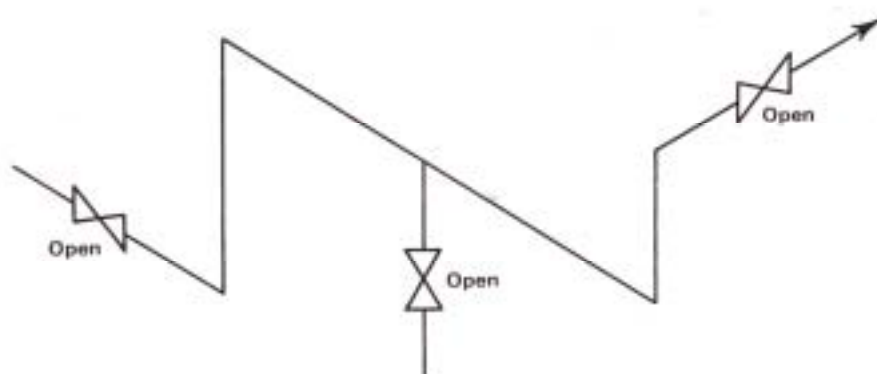
A serious fire occurred in one of our overseas companies because a plant was started up with a drain valve open. The drain formed part of a double block and bleed. The drain valve was left open because the two block valves and the drain valves were some way apart, and out of sight of each other.

If the two block valves and the drain valve had been near each other the operator would have seen that the drain valve was open when he opened the main valves.

The report on the incident describes it as an example “of the disastrous consequences of human error”. The report did not however suggest that people should not make errors. It accepted that, in this case, the layout of the valves made an error probable — the accident was the result of the work situation.

64/1 IN A DOUBLE BLOCK AND BLEED THE THREE VALVES SHOULD BE NEAR EACH OTHER

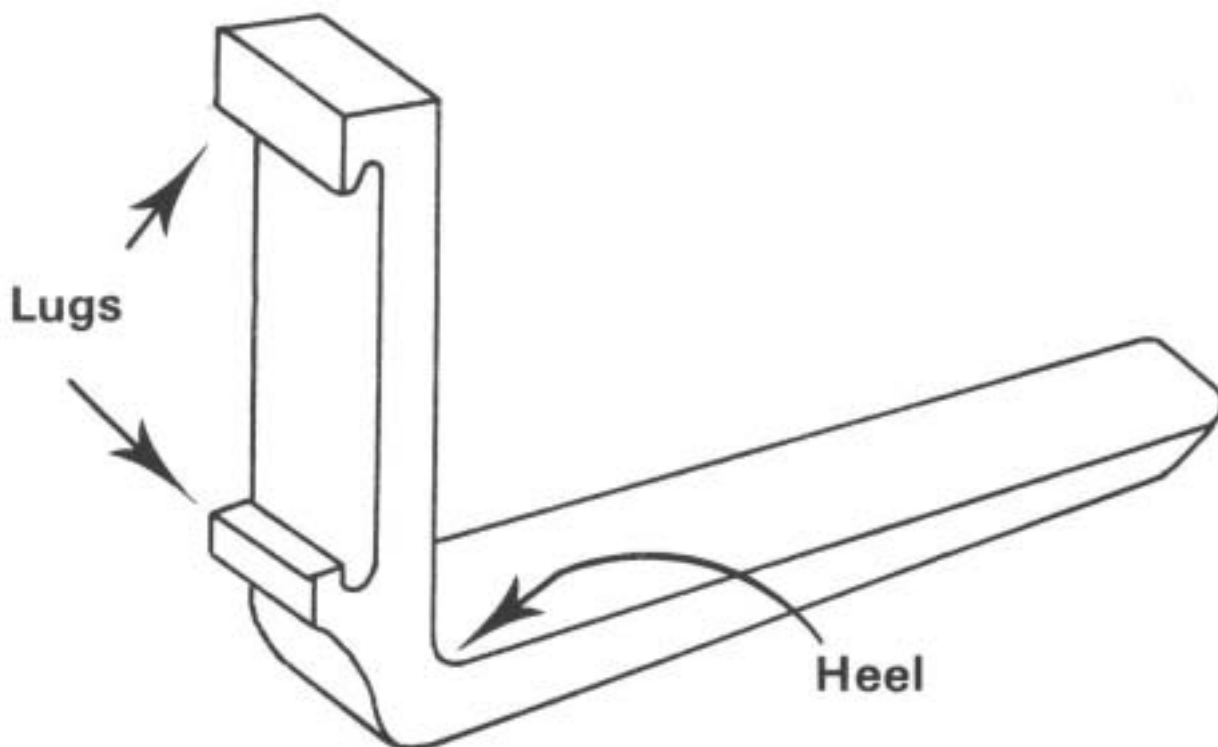
- 22 had cracks on the mast carriage
- 13 had cracks where lugs are welded to the forks (see figure)
- 9 had cracks at fork heels (ie., the corners of the forks).

- 11 were OK.
- 26 had cracks where lugs were attached to the forks.
- 5 had cracks at fork heels.

The need for regular inspection is shown by the following results from the routine examination of 66 fork lift trucks.
