# IMPERIAL CHEMICAL INDUSTRIES LIMITED PETROCHEMICALS DIVISION

## SAFETY NEWSLETTER No 69

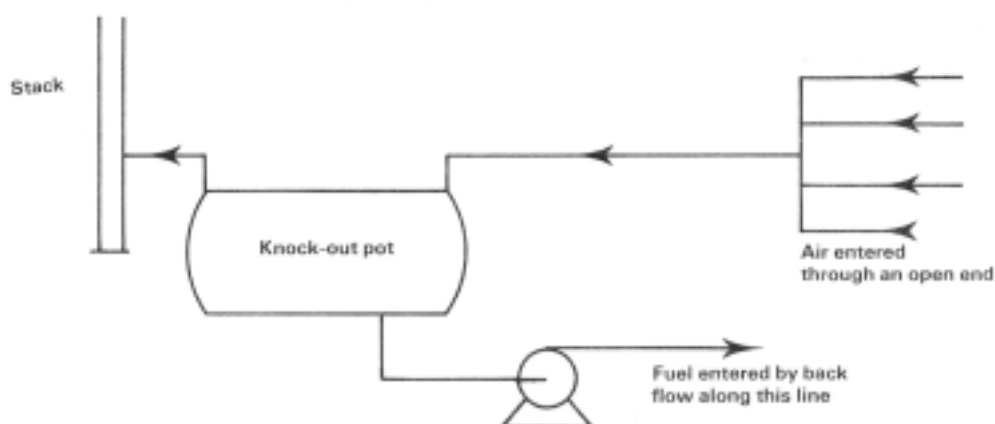
Now an explosion has occurred in a flare stack while the plant was shut-down for overhaul. Fortunately no-one was hurt and there was no serious damage.

Air got into the stack because some relief valves were removed, and, as the plant was shut-down, it was decided not to blank the open-ends.

Fuel may have got into the stack by back-flow through the pump-out line and pump on the knock-out pot. In addition, the knock-out pot was not freed from hydrocarbons with the same thoroughness as on a normal running plant.

The source of ignition may have been traces of pyrophoric iron sulphide.

We should treat stacks like other pieces of equipment and never allow air to enter unless we are sure that any fuel present has been removed and all sources of fuel have been isolated by slip-plates or physical disconnection.

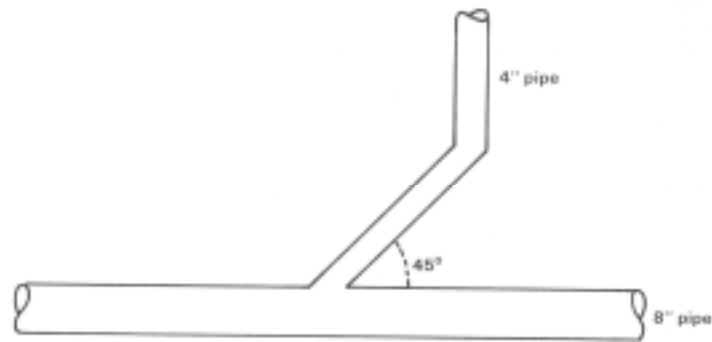
A 4 inch branch had been fitted into an 8 inch pipe at an angle of 45°. The line was subject to vibration and failed by fatigue.

Failure was due to poor mechanical detail at the junction of the two pipes, and to the fact that the 4 inch branch was much thinner than the 8 inch pipe. In particular,

- (A) The abrupt change of section, the oval shape of the hole in the parent pipe and dissimilar wall thicknesses resulted in a stress intensification factor of 9.33. The stress concentration could have been reduced by using weldolets or forged reduced offtake tees. Other, less satisfactory, methods are to use gussets, compensating rings, flanged connections or butt welding to a thick-walled branch slab.
- (B) The smaller line should have been better supported so that no undue strain was imposed on the weld.
- (C) The reasons for the vibration should have been investigated.

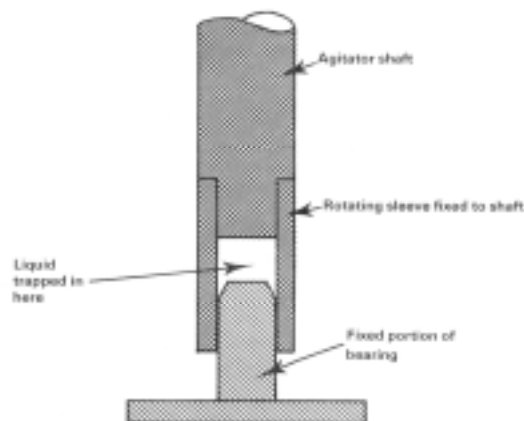
Another Company has reported that a man was overcome by poisonous fumes while working in a vessel which had been cleaned and isolated and had been open for 17 days.

The man was working on a stirrer and probably disturbed some liquid which was trapped in the bearing.
