IMPERIAL CHEMICAL INDUSTRIES LIMITED

PETROCHEMICALS DIVISION

SAFETY NEWSLETTER No. 82

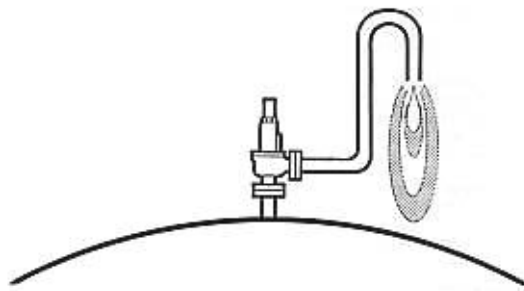
The relief valve lifted because the tank was overfilled and the vapours ignited at a furnace 350 feet away. According to the National Fire Prevention Association Quarterly, October 1956, p. 77, the relief valve tail pipe was fitted with a return bend to keep out rainwater.

This caused flames to impinge on top of the tank and the metal got so hot that it lost its strength and burst, even though the pressure was only 15 psig. The sudden failure of the tank produced a huge ball of burning vapours which killed the fire-fighters, though they were 300-400 feet away. **Spectators 1,200 feet away were injured.**

It is important to make sure that this cannot occur. Drain holes should be located or shaped so that flames coming from them do not impinge on plant equipment. {See also Newsletter 84/5(b) and (c)}.

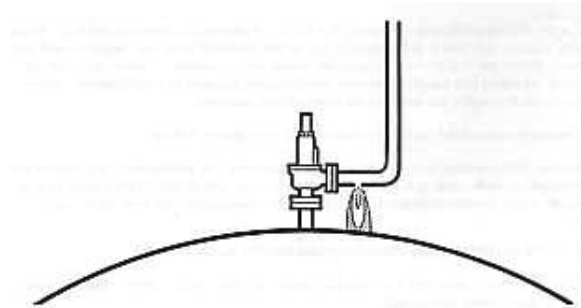
It seems incredible that a relief valve tail pipe could be designed in this way and another report is more likely to be correct. According to this version a small drain hole on the relief valve tail pipe allowed a small flame to impinge on the vessel and weaken it.

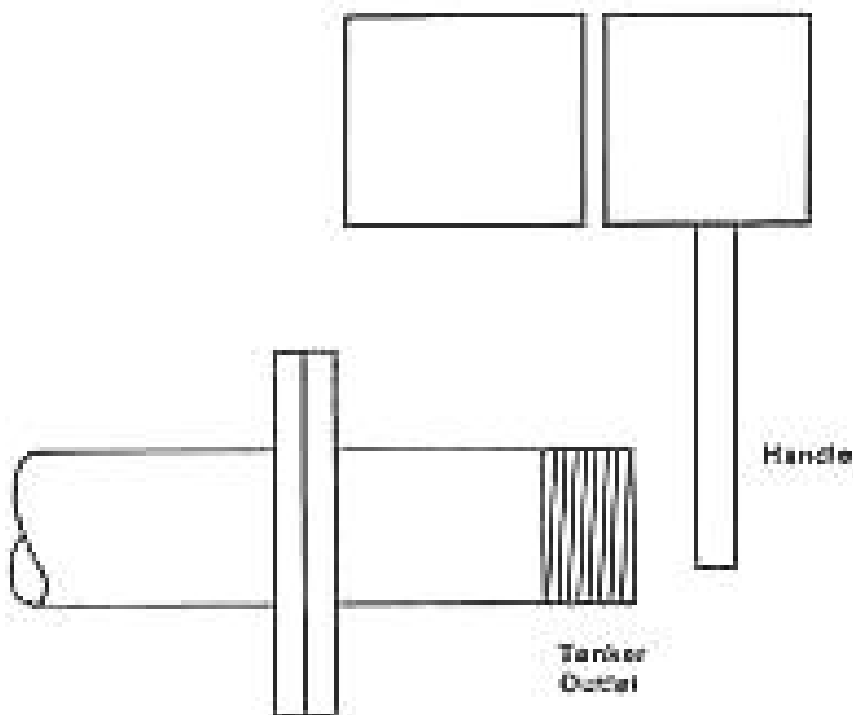
On many occasions road and rail tank wagons have been driven away before the filling or emptying

A handle is fixed in front of the point on the tanker to which the hose is connected. To attach the hose this handle has to be moved to one side. This movement of the handle puts the brakes on and they cannot be released until the hose has been removed and the handle put back to its original position.

The device costs less than £50 and it is being fitted to all ICI Wilton road tankers. A variation is being designed to fit above the manhole lids of tankers which are top filled. It will then be impossible to drive the tanker away before the manhole lid has been closed.
