IMPERIAL CHEMICAL INDUSTRIES LIMITED

PETROCHEMICALS DIVISION

SAFETY NEWSLETTER No.85

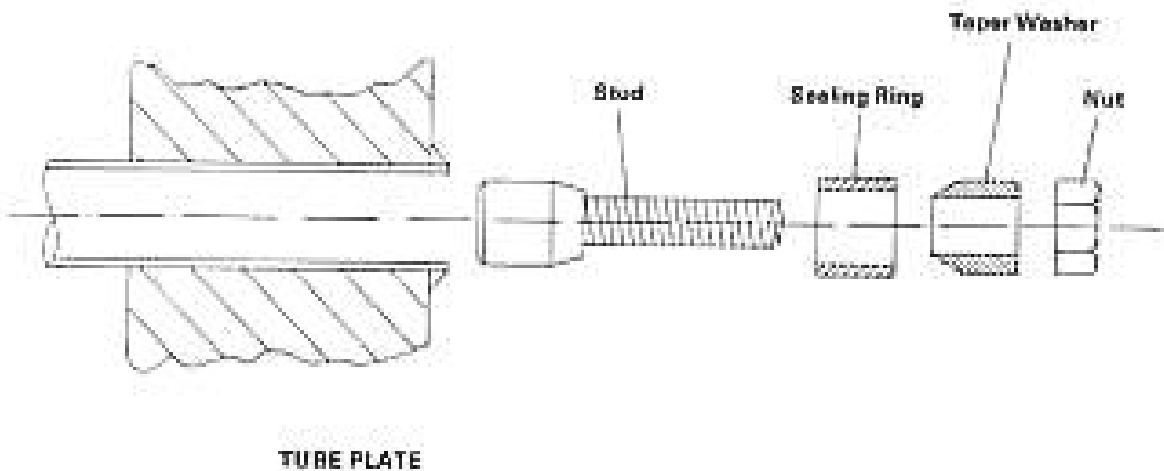
When plugging tubes it is as well to remember that one day the plugs may have to be removed. A type of plug which is easy to remove is illustrated in the drawing overleaf.

1. The tube is sealed by assembling the plug and tightening the nut until the sealing ring is crimped onto the tube.
2. The tube is vented by slackening the nut and tapping the stud forward into the tube.
