IMPERIAL CHEMICAL INDUSTRIES LIMITED

PETROCHEMICALS DIVISION

SAFETY NEWSLETTER No.87

87/1 THE STORY OF A TANK FIRE

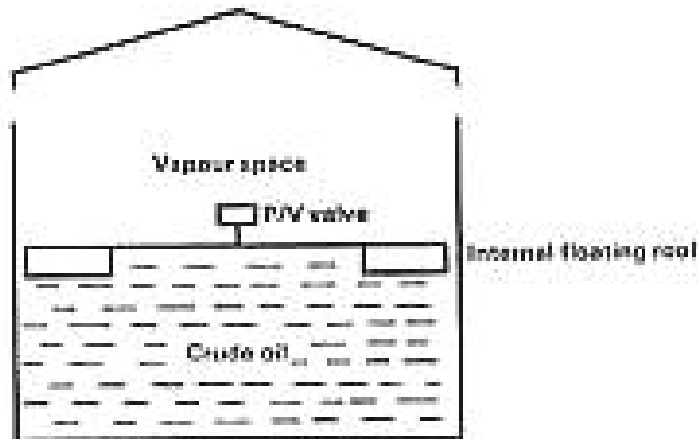
As a result of a late change in design the level at which the floating roof came off-float had been raised but this was not marked on the drawings which were given to the operators. As a result, without intending to, they took the roof off-float. The pressure-vacuum valve opened, allowing air to be sucked into the space beneath the floating roof.

When the tank was refilled with warm crude oil at 37 °C, vapour was pushed out into the space above the floating roof and then out into the atmosphere through the vents on the fixed roof tank.

This vapour was ignited at a boiler house some distance away. Many people were surprised that the vapour travelled so far without dispersing, but there was some damage to the boiler house and this supports the view that ignition occurred there.

The fire flashed back to the storage tank and the vapour burned as it came out of the vents.

Pumping was therefore stopped. Vapour no longer came out of the vents, air got in and a mild explosion occurred inside the fixed roof tank. This forced the floating roof down like a piston and some of the crude oil came up through the seal past the side of the floating roof and out of the vents on the fixed roof tank.

- 1 Keep plant modifications under control and keep drawings up to date (see Newsletter 83).
- 2 Do not take floating roof tanks off-float except when they are being emptied for repair.
- 3 Keep bund drain valves locked shut. Check regularly to make sure they are shut.
- 4 Plan now how to get rid of fire-fighting water. If the drains will not take it, then it will have to be pumped away. (See Newsletters 39/2 and 42/6).
- 5 During a fire keep in close touch with the firemen and tell them what you propose to do. A copy of the full 7-page report is available on request.

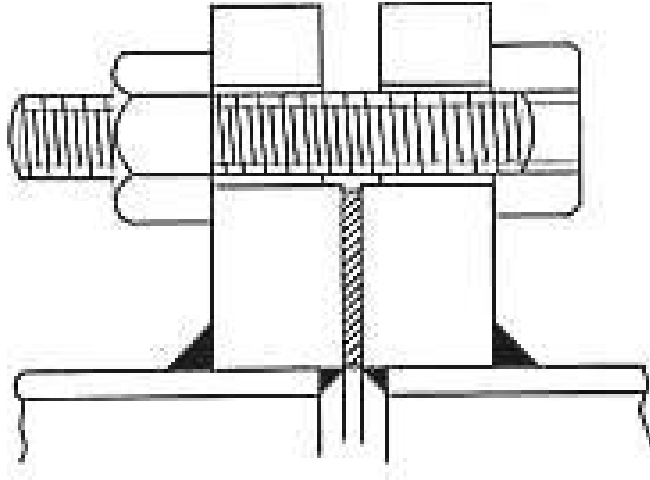
When a plant came back on line after a long shutdown it was found that some of the flanges had been secured with stud bolts and nuts instead of ordinary bolts and nuts, and that some of the stud bolts were located so that there was more protruding on one side than on the other. In some cases one of the nuts was secured by only two or three threads.

Nobody knows why this had been done. Probably one nut was tighter than the other and, in attempting to tighten this nut, the whole stud was screwed through the second nut. Whatever the reason it produced a dangerous situation as the pressure on different parts of the flange was not the same.

In addition, stud bolts should not be indiscriminately mixed with ordinary bolts or used in their place, as they are often made of different grades of steel and produce a different tension.

On the plant concerned, the eight-bolt joints the bolts were changed one bolt at a time. Four-bolt joints were secured with clamps until the next shutdown.
