IMPERIAL CHEMICAL INDUSTRIES LIMITED
PETROCHEMICALS DIVISION

SAFETY NEWSLETTER No.91

This Newsletter reports a number of incidents which occurred because insufficient thought was given before issuing a clearance certificate or preparing equipment for maintenance.

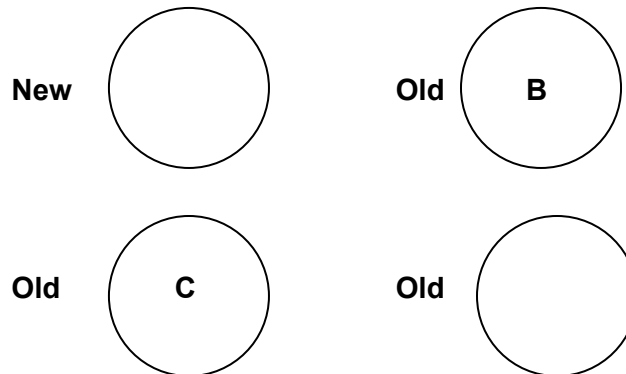
There were three pieces of equipment on a plant and a fourth piece under construction. They were actually crystallisers, but might have been pumps, heat exchangers or anything else. Two of them were labelled B and C, but the label on the third was missing and the label on the fourth had not yet been fitted.

A man was asked to remove an instrument (actually a radioactive level controller) from item A. He went out onto the plant and saw the labels on B and C. He assumed that the other old crystalliser was A and that the new one, which still had scaffolding round it, would be D. He therefore removed the level controller from the old unlabelled crystalliser.

Unfortunately, the original items were labelled B, C and D and the new one was labelled A. When the plant was built, space was left for a possible future crystalliser and the letter A was left for it. Work was started on item D with the level controller still in position. Fortunately, the mistake was discovered before anyone was injured.

All equipment given to maintenance must be clearly labelled. If there is no permanent label it must be identified by tying a numbered tag on to the equipment and putting the tag on the clearance certificate (permit-to-work).

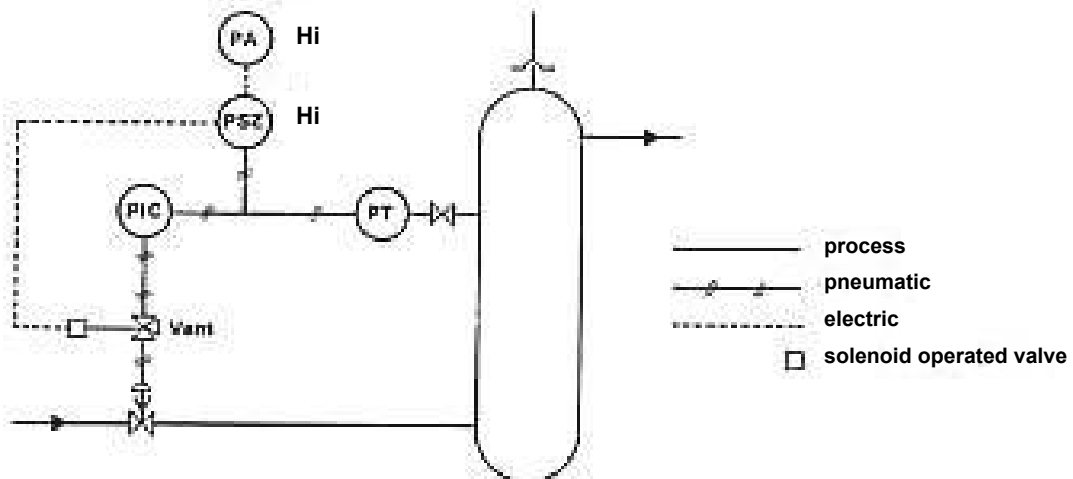
91/ 7 WHAT IS WRONG WITH THIS TRIP SYSTEM?

The pressure in the vessel is measured by the pressure transmitter (PT) and controlled by the pressure indicator controller (PIC) which adjusts the setting on the motor valve.

If this control system fails to work and the pressure rises above the set point, then the high pressure switch and trip (PSZ^{Hi}) operates to close the motor valve. At the same time the high pressure alarm (PA^{Hi}) operates.

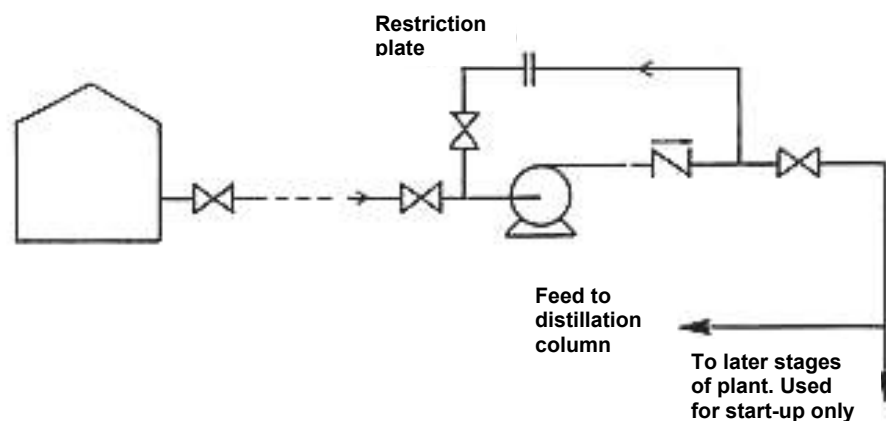
Here is an example of such a plant. An operability study team leader visited one of our overseas companies to assist in a study. The design team queried the need, as the plant was so similar to the one back home. They agreed to a trial study on one line; the line selected was the feed line to the plant from the storage tank.

Twelve points which had been overlooked came out of the study. Here are four:-

If the pump stops, the back flow will occur through the kick-back line. The non-return valve should be downstream of this line.

If the pump stops, back flow may occur through the start-up line. Should there be a non-return valve in this line?

No provision had been made for slip-rings or spectacle plates so that the pumps can be isolated by slip-plates for maintenance.

The restriction plate in the kick-back line might be replaced by a flow controller to save power.
