**IMPERIAL CHEMICAL INDUSTRIES LIMITED**  
**PETROCHEMICALS DIVISION**

**SAFETY NEWSLETTER No.92**

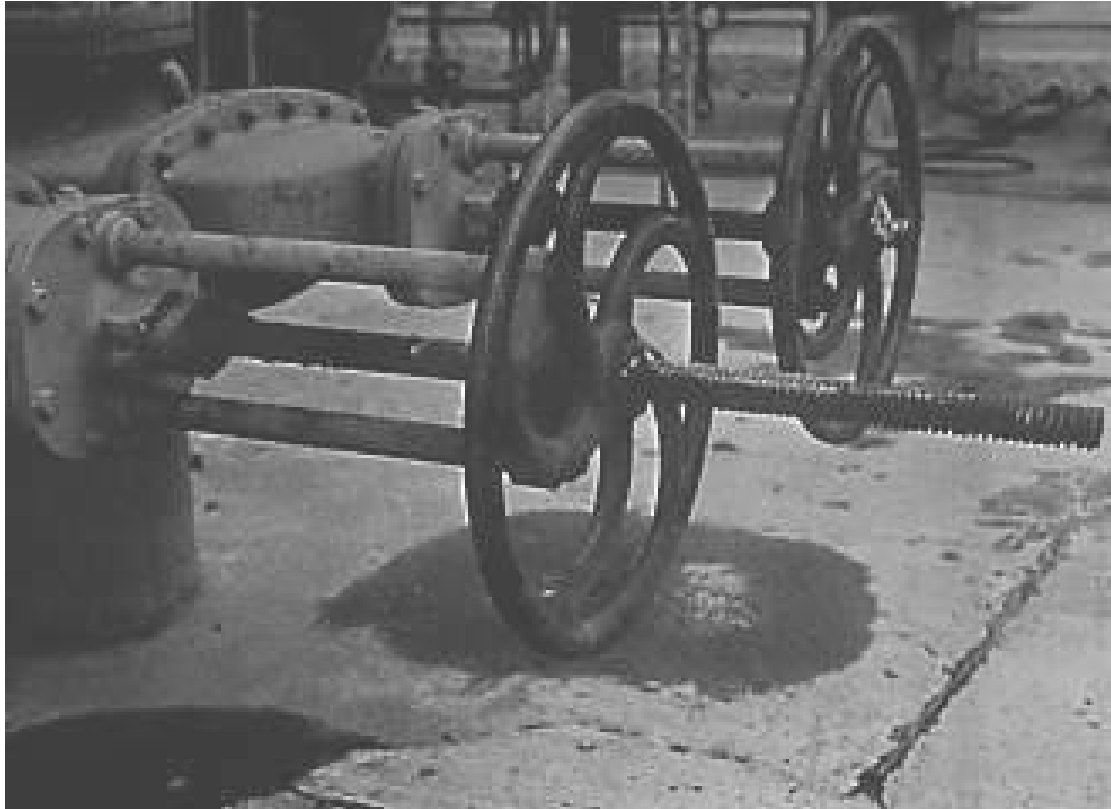
**92/1 IS ONE OF THESE VALVES CLOSED?**

Both valves are open. The spindle on the far valve has been knocked off by a lorry.

Despite this incident we like to use rising spindle valves whenever possible as normally it is easy to see whether they are open or shut.

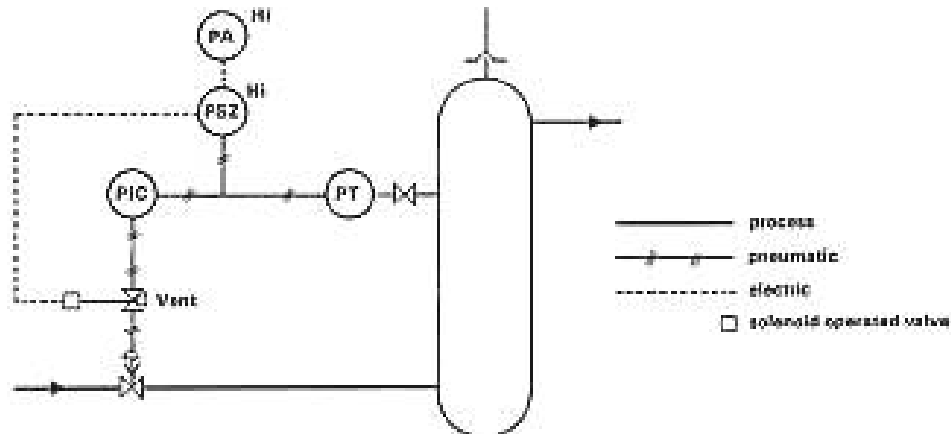
## 92/4 THE ANSWER TO THE PROBLEM IN OUR LAST ISSUE WHAT IS WRONG WITH THIS TRIP SYSTEM?

The pressure in the vessel is measured by the pressure transmitter (PT) and controlled by the pressure indicator controller (PIC) which adjusts the setting on the motor valve.

If this control system fails to work and the pressure rises above the set point, then the high pressure switch and trip (PSZ<sup>Hi</sup>) operates to close the motor valve. At the same time the high pressure alarm (PA<sup>Hi</sup>) operates.

This trip system is almost useless.

The most likely causes of the pressure in the vessel getting too high are:

- 1 Failure of the pressure transmitter (PT). If this occurs the trip will not know there is a high pressure in the vessel.
- 2 Motor valve sticks open. In this case the trip will know that there is a high pressure in the vessel and will send a signal to the motor valve, but the motor valve will not respond.
- 3 Failure of the pressure indicator controller (PIC). In this case the trip will work.

The trip will therefore operate on only about one-third of the occasions when we want it to operate. Such a trip is not worth having. It may do more harm than good as we may expect it to operate and not watch the pressure so closely.
