IMPERIAL CHEMICAL INDUSTRIES LIMITED

SAFETY NEWSLETTER No.93

SOME ACCIDENTS WHICH HAVE RECURRED AFTER TEN OR MORE YEARS

November 1976

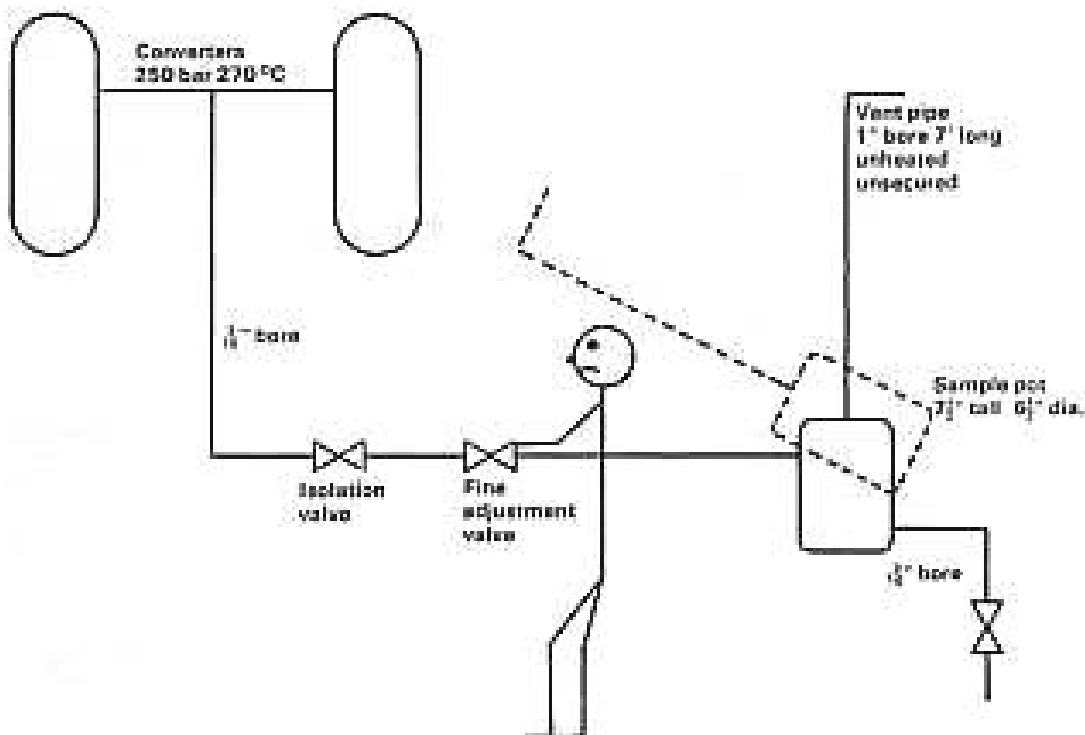
The sample pot was filled by opening the isolation valve and cracking the fine adjustment valve. Both valves were then closed and the sample pot drained into the sample can.

Two weeks after this system had been installed, the operator was unable to get a sample and informed his chargehand. Suspecting a choke — the raw material and product both melted at 20°C — the chargehand tried to clear it by opening the isolation valve and drain valve and then gradually opening the fine adjustment valve so as to get a blow straight through. The vent pipe suddenly moved and hit the chargehand on the head; he died later from his injuries.

The sample pot and vent line were not clamped and were free to rotate by partially unscrewing the flange on the inlet pipe. It had been intended to clamp them but this had been overlooked.

The sample line and pot were heated but the vent line was not. It is believed that there had been a choke somewhere in the system and that when it cleared the sudden rush of gas caused the vent pipe to move backwards.

The main recommendation was that plants handling materials which are solid at ambient temperatures should be adequately heated.
