# **IMPERIAL CHEMICAL INDUSTRIES LIMITED**

## **PETROCHEMICALS DIVISION**

### **SAFETY NEWSLETTER No.97**

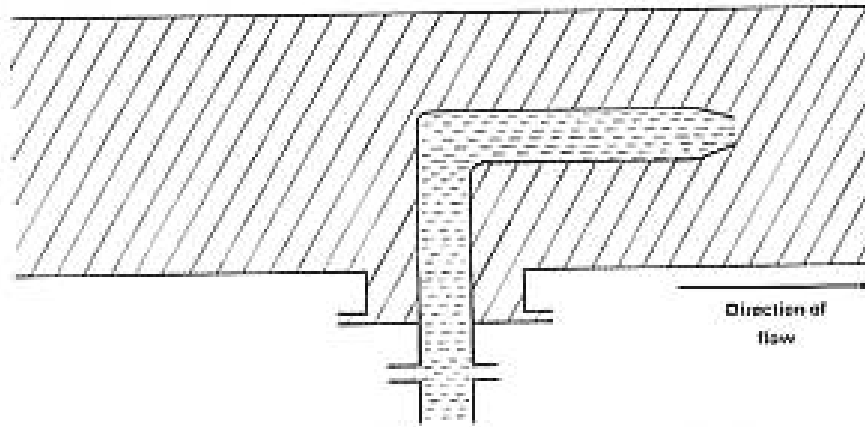
Newsletters 30/1 and 27/1 described the correct way to inject water or an aqueous solution into an oil line in order to ensure good mixing. The following diagram is taken from Newsletter 30/1.

Another company installed a system like this but nevertheless experienced severe corrosion of the main pipe. A split occurred and hot oil was sprayed over the plant.

The incident occurred because the nozzle was installed pointing the wrong way — upstream instead of downstream. The two liquid streams met head on and the aqueous solution was forced against the side of the main pipe.

Last year, in Petrochemicals Division, a similar device was installed the wrong way round, but fortunately it was spotted soon afterwards.

Whenever possible equipment should be designed so that it cannot be assembled incorrectly. It should be impossible, for example, to interchange reciprocating compressor suction and delivery valves.

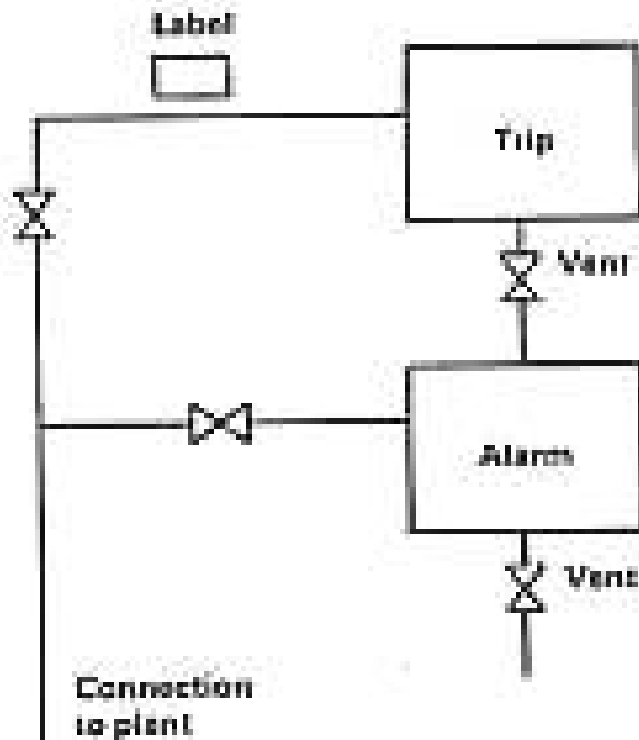
They are arranged on the plant as shown below. There is no label on the alarm but a small one on the trip.

An instrument artificer was asked to test the alarm. The procedure is to isolate the alarm, open the vent to blow off the pressure and note the pressure at which the alarm sounds.

By mistake the artificer isolated the trip. When he opened the vent valve, the pressure fell, the trip operated and the plant was shut-down. It took 36 hours to get it back to normal.

It would be easy to blame the artificer but we all make mistakes like this occasionally (see Safety Newsletter No 86). In this case the chance of a mistake could be reduced by:

- (a) Better labelling
- (b) Putting trips and alarms further apart.
- (c) Painting trips and alarms different colours.

**Note:** Trips and alarms should be connected to the plant by separate impulse lines if there is any possibility of choking. See Safety Newsletter No 90, page 24.

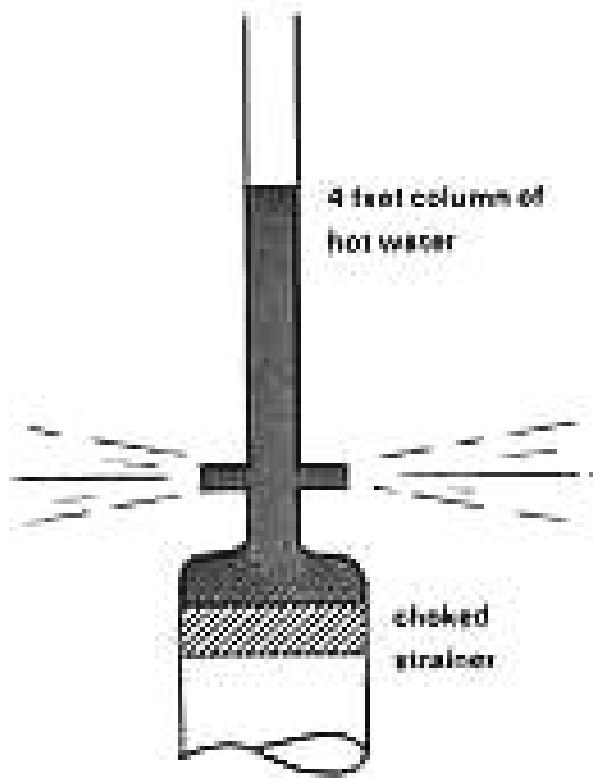
A choked strainer had to be removed (in another company). Above the strainer was a column of hot water no more than four feet tall. It was decided to break the joint above the strainer and let the water run out. It came out with such force that two men were sprayed and scalded.

People are often surprised by the pressure produced by a column of liquid. Eight feet of water will produce 4 psig — enough to cause liquid to spread out up to 8 feet horizontally through a joint that has been cracked open.

A rough rule of thumb — if the column of liquid is x feet tall, it may spray x feet through a broken joint.

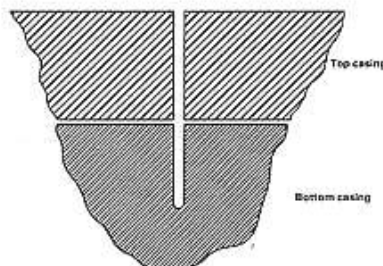
The top casing of a turbine is located on the bottom casing by two 3/8 inch dowels, which are designed to move freely. There are blind holes in the bottom casing and open holes in the top casing.

When the top casing was removed, one of the dowels stuck to it, perhaps because water or dirt had got into the hole. When the top casing was replaced the dowel did not slide easily into the lower hole — perhaps there was some sealing compound in it or perhaps it was compression of the air. Whatever the reason, when the cover was tightened the dowel was ejected and hit the fitter above the right eye.

Perhaps the dowel should have been screwed into the bottom casing or perhaps a groove should have been machined in the dowel.

It is good practice when putting a peg into a hole to make sure first that the hole is clear and deep enough to receive the peg.
