No. 104

IMPERIAL CHEMICAL INDUSTRIES LIMITED
PETROCHEMICALS DIVISION

104/1 ANOTHER STORAGE TANK FAILURE

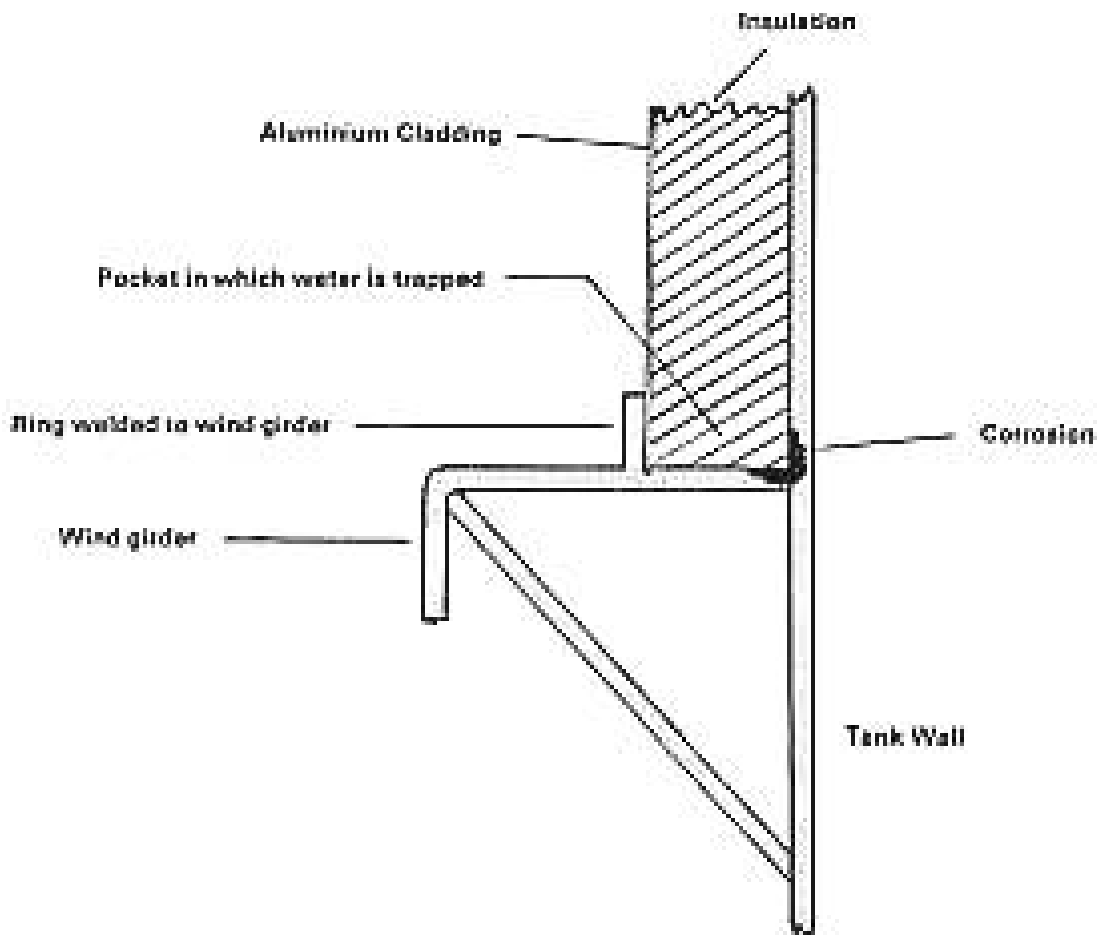
When the tank was built the insulation contractor welded a vertical strip of metal on to the wind girder to provide a support for the insulation. Water collected in the channel formed in this way and caused corrosion. A large crack appeared, about 10 feet long.

As it is almost impossible to clean a tank which has contained heavy oil — see Newsletter 82/5 — the leak was sealed with resin and the tank emptied and filled with water. The tank was then repaired by welding a strip over the crack and the corroded region.

Newsletter 100/4 recommended that the bottom 200 mm of a tank should be left free of insulation so that it can be inspected for corrosion. A strip above a wind girder or any other place where water may collect should also be kept free of insulation.

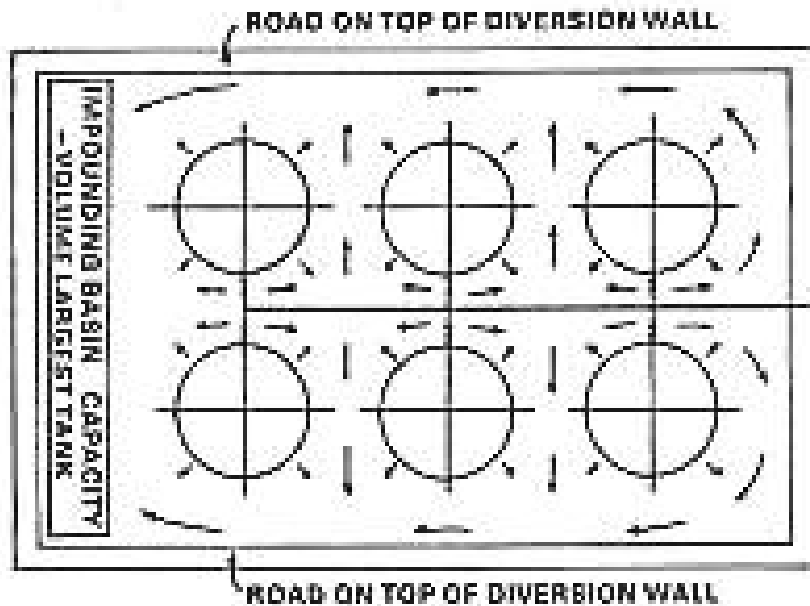
As shown, this will not save a lot of land, but if we can use the same basin to serve another group of tanks on the far side, and even ones above and below, then there will be savings. It may mean spending a little more at the start to save money later.

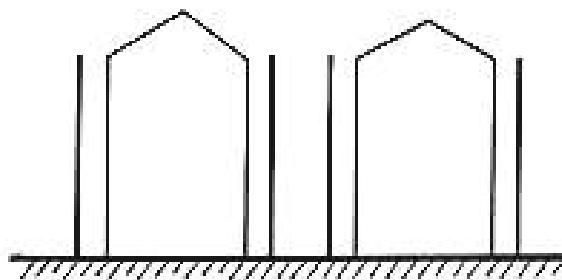
However, this system has disadvantages. If the material in the tank is flammable — and if it was not we would probably not want a full-size bund — small leaks may produce an explosive mixture in the space between the tank and the bund. Water may collect in the space, causing corrosion, and inspection will be difficult. It may be necessary to roof the space between the tank and the bund.
