No. 107

**IMPERIAL CHEMICAL INDUSTRIES LIMITED
PETROCHEMICALS DIVISION**

107/1 RAPID VAPOURISATION OF WATER RUPTURES A VESSEL

January 1978

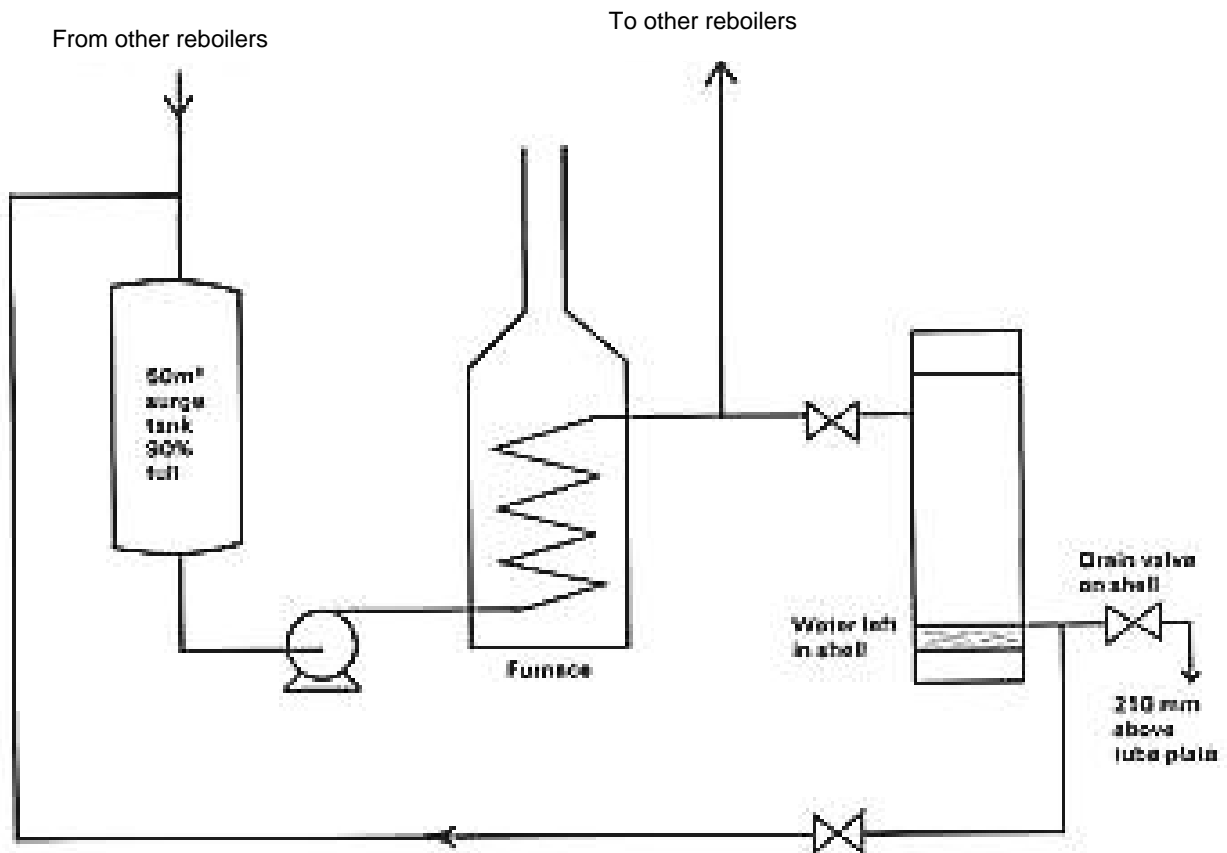
A furnace supplied heat transfer oil to four reboilers. One was isolated for repair and then pressure tested with water. The water was drained out of the shell using a drain valve on the exit line located 210 mm above the level of the bottom tube plate. This left a layer of water in the reboiler. When it was brought back on line the water was swept into the heat transfer lines and vaporised instantly and this set up a liquid hammer.

The top of the surge tank, bursting pressure 450 psig, was blown off in one piece and the rest of the vessel was split into 20 pieces. The hot oil formed a fine mist-like cloud which ignited immediately forming a fireball 120 metres in diameter.

To prevent a recurrence the Company concerned recommends:

- 1 Adequate facilities must be provided for draining water from heat transfer and other hot oil systems.
- 2 If possible, oil should be used instead of water for pressure testing.
- 3 Surge vessels should have adequate ullage.

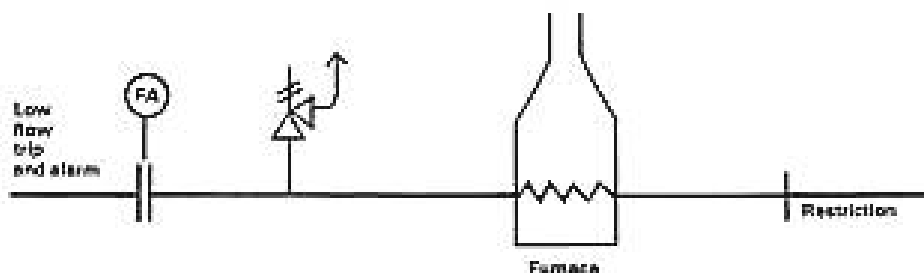
In the first incident, which happened a few years ago, a furnace was protected by a relief valve in the inlet line. A restriction developed after the furnace and the relief valve lifted and took most of the flow. The flow through the furnace tubes fell to a low level so that they overheated and burst.

The low flow trip and alarm did not operate as the flowmeter was placed upstream of the relief valve and the flow through it was normal.

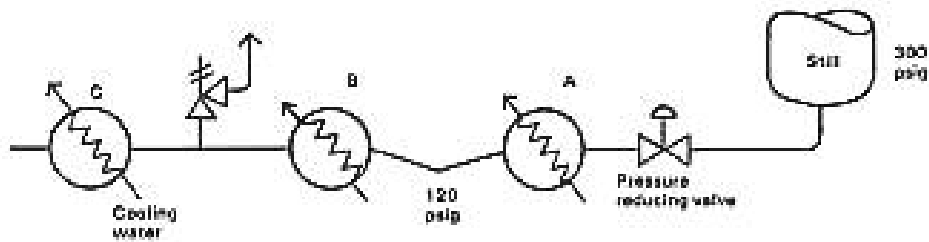
The second incident occurred on the bottom line of a distillation column containing cold liquefied gas.

The two heat exchangers A and B are designed to withstand 150 psig and a relief valve is fitted in the position shown to protect them from the still pressure if the motor valve opens fully.

A leak in exchanger C, coinciding with a low pressure in the process line, caused a slug of water to enter the process line and form a plug of ice in a dip in the line between A and B. As a result, A was blocked in, isolated from its relief valve and overpressured.

Whenever a vessel may be isolated from its relief valve by ice, solidified process material, catalyst dust or any other cause, then a relief valve must be placed on the vessel itself, or alternatively, the vessel must be made capable of withstanding the full pressure to which it can be subjected.

In the present case the latter would probably have been the easiest course to adopt at the design stage. It would not have cost much more to make A and B capable of withstanding 300 psig.
