No. 113

WHAT'S IN A NAME?

PETROCHEMICALS DIVISION

113/1 SOME MISLEADING NAMES

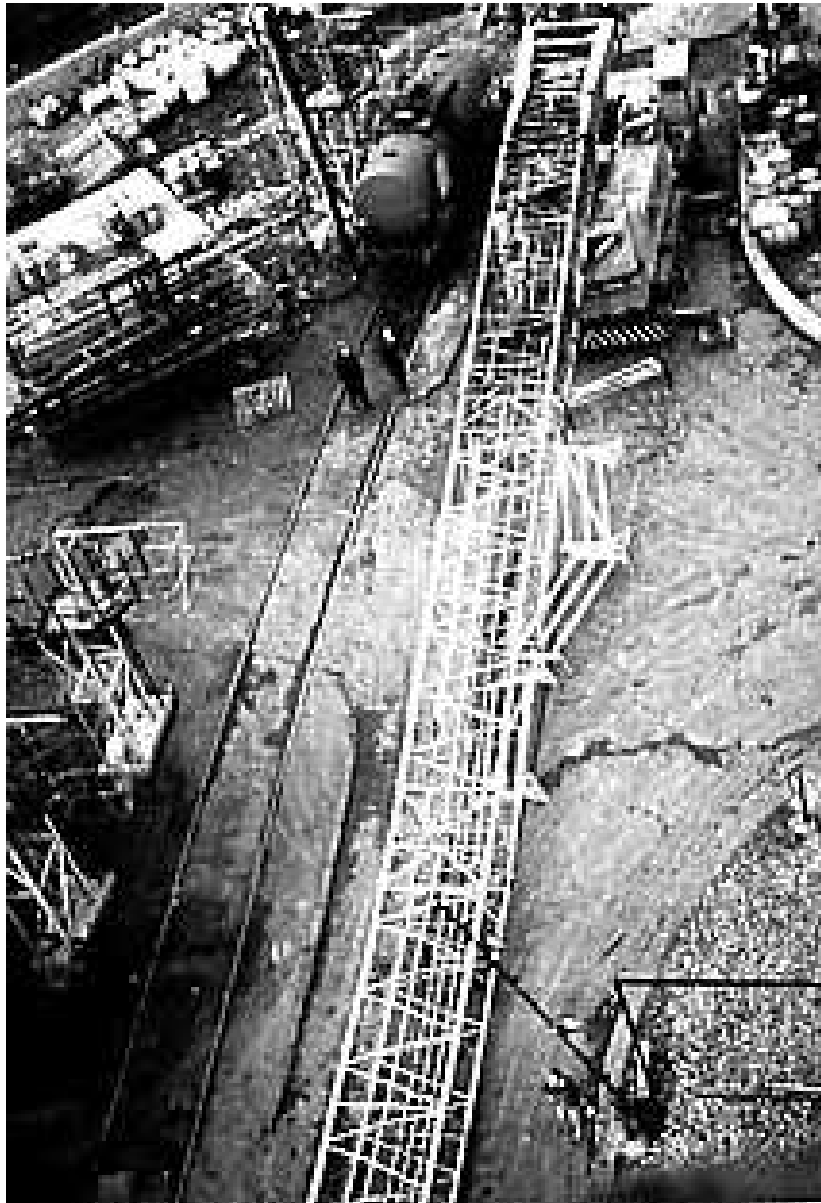
Photographs from Our Archives No.1

The Mond Division Safety Report for April 1978 reports that a crane was left overnight with its jib raised and was blown over by a strong wind. Fortunately, it fell without damaging any plant.

The photograph above shows an overhead view of a similar incident which occurred in the Division in 1965; again by great good fortune the crane fell along a road and did not damage any plant. The jib was 150 feet tall.

For each crane a minimum parking radius is specified and cranes should not be left overnight with their jibs at a smaller angle to the vertical.
