No. 116

A RANDOM SAMPLE OF ACCIDENTS

**IMPERIAL CHEMICAL INDUSTRIES LIMITED
PETROCHEMICALS DIVISION**

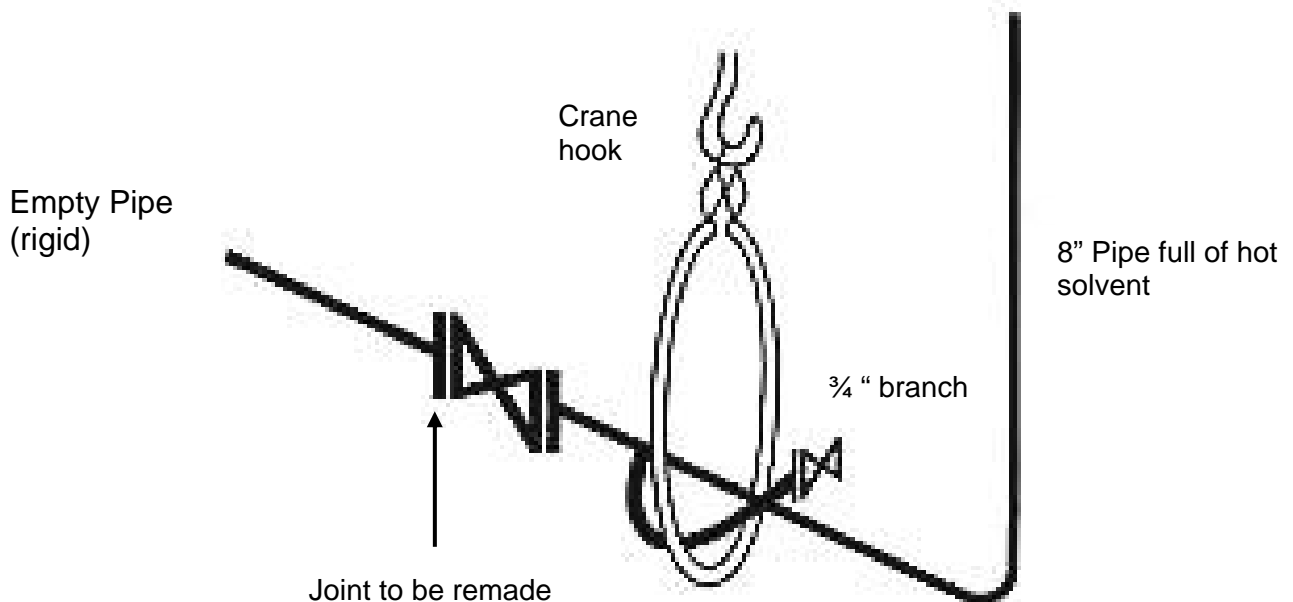
There was a bad leak when a 3/8 inch branch broke off and allowed a heavy solvent, saturated with C₄ hydrocarbons, to escape.

A joint on an 8 inch line had to be remade. The two sides were 3/8 inch out of line and as there was a crane on the job, it was used to lift one of the lines. The strap pulled on the branch and broke it off.

It is not a good idea to use a crane for a job like this on a live line.

If anything like this happens again - and one day it will - remember that the cloud might catch fire and therefore:

Call the Fire Brigade - so they are ready if it does.

If you have to enter the cloud, do so protected by water sprays from the Fire Brigade. I can lend you some American slides which show how this should be done.
