No. 118

LEAKS CAUSED BY USE OF THE WRONG
FITTINGS

IMPERIAL CHEMICAL INDUSTRIES LIMITED
PETROCHEMICALS DIVISION

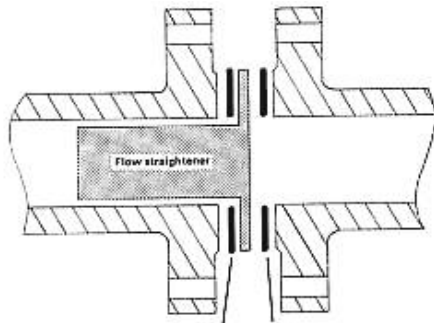
The leak occurred because a rubber gasket had been used in a flow measuring assembly instead of a spiral wound gasket. The flow measuring assembly was a relatively new design and had been sent to a workshop for calibration. Following their normal practice, the workshop staff installed a rubber gasket between the assembly and a flow straightener before calibrating the assembly with water. They then returned the assembly to the plant with the rubber gasket still present and the flow straightener held in position by adhesive tape.

Rubber Spiral wound

gasket gasket

The plant staff did not realise that there was a rubber gasket in the assembly and assumed that the assembly as a whole was suitable for use under plant conditions. No part of the flow straightener extends outside the pipe flanges and it was not easy to see that there was an insert between them. The whole assembly was installed in the plant and after five days on line the leak occurred.

The report recommends that all pipeline inserts (such as slip-plates, slip-rings and bursting discs as well as unusual inserts such as flow straighteners) should be identified by tags.
