Safety

NEWSLETTER

Shut-downs and Upsets

Imperial Chemical Industries PLC
Petrochemicals and Plastics Division

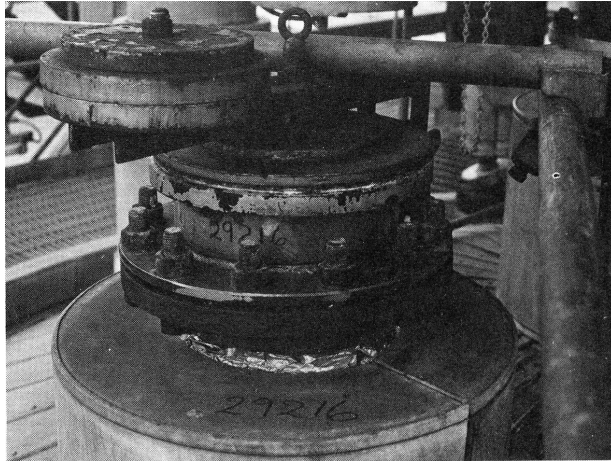
It shows part of a scaffold erected on a plant. One of the horizontal poles has been secured immediately above a dead weight relief valve. Had the relief valve been required to lift the pole would have prevented it. This would not matter in the middle of a shut-down but ancillary work often starts when the plant is still online and continues after the start up. Those are periods when perhaps the relief valve is more likely to be needed than when steady operation has been established
