# Safety

# NEWSLETTER

Imperial Chemical Industries PLC  
Petrochemicals and Plastics Division

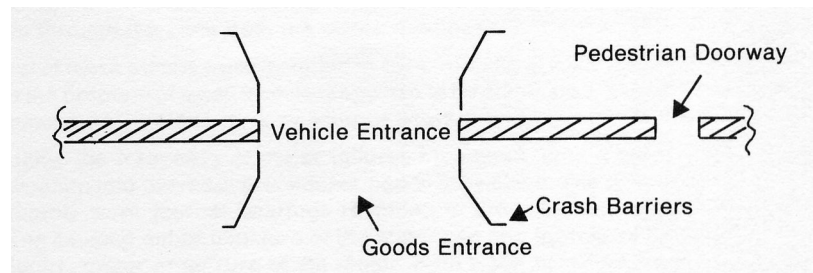
Collisions with doors or with door jambs frequently occur. Pedestrians are often injured as they emerge from a doorway and appear unexpectedly in the path of a fork lift truck being driven in the opposite direction.

So will crash barriers designed to prevent people from 'sliding round' the corner of a doorway. Additionally, the reduction in maintenance costs for damage to the doorways will often more than pay for the cost of installing a barrier.

Pathways should be arranged so that as much chance as possible is given to drivers to see any obstructions in good time. It will help if a separate door can be provided for pedestrians.
