# Safety

# NEWSLETTER

In this Issue  
**LIVE WIRES?**

Imperial Chemical Industries PLC  
Petrochemicals and Plastics Division

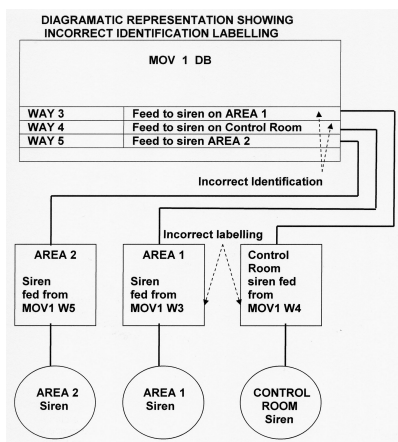
It was noticed that one of the three fire alarms on the plant was not working following the daily alarm test. A clearance certificate was issued and after isolating the power supply by removing the fuses, the electrician and his supervisor proceeded to open the starter in order to find the fault. With the door of the starter open they checked the incoming supply with a test meter and the supply was found to be live.

What had happened was soon revealed. All three starters are fed from the same fused distribution board (See Figure 1) and marked with pen on green PVC tape showing its source of supply. The label on the front of the distribution board was marked in felt pen indicating which siren was fed from each way (3, 4 and 5). The electrician, wishing to isolate the power to the Area 1 siren removed the fuses from way 3, but, as can be seen from Figure 1, the labels are incorrect and the fuses were actually removed from the Control room siren.

This incident emphasises the need to test electrical isolations by an approved test instrument before electrical work is commenced. Before mechanical work is carried out, the start-button should be pressed to check that the supply is truly isolated. Temporary labels should be replaced (these can fall off, fade or get obliterated) by permanent labels, rechecking the source of supply before fitting.
