ASSEMBLING, DISMANTLING, CONNECTING

An Engineer’s Casebook No. 64 — Pipe Freezing for Isolations on Oil Systems

IMPERIAL CHEMICAL INDUSTRIES LIMITED
PETROCHEMICALS DIVISION

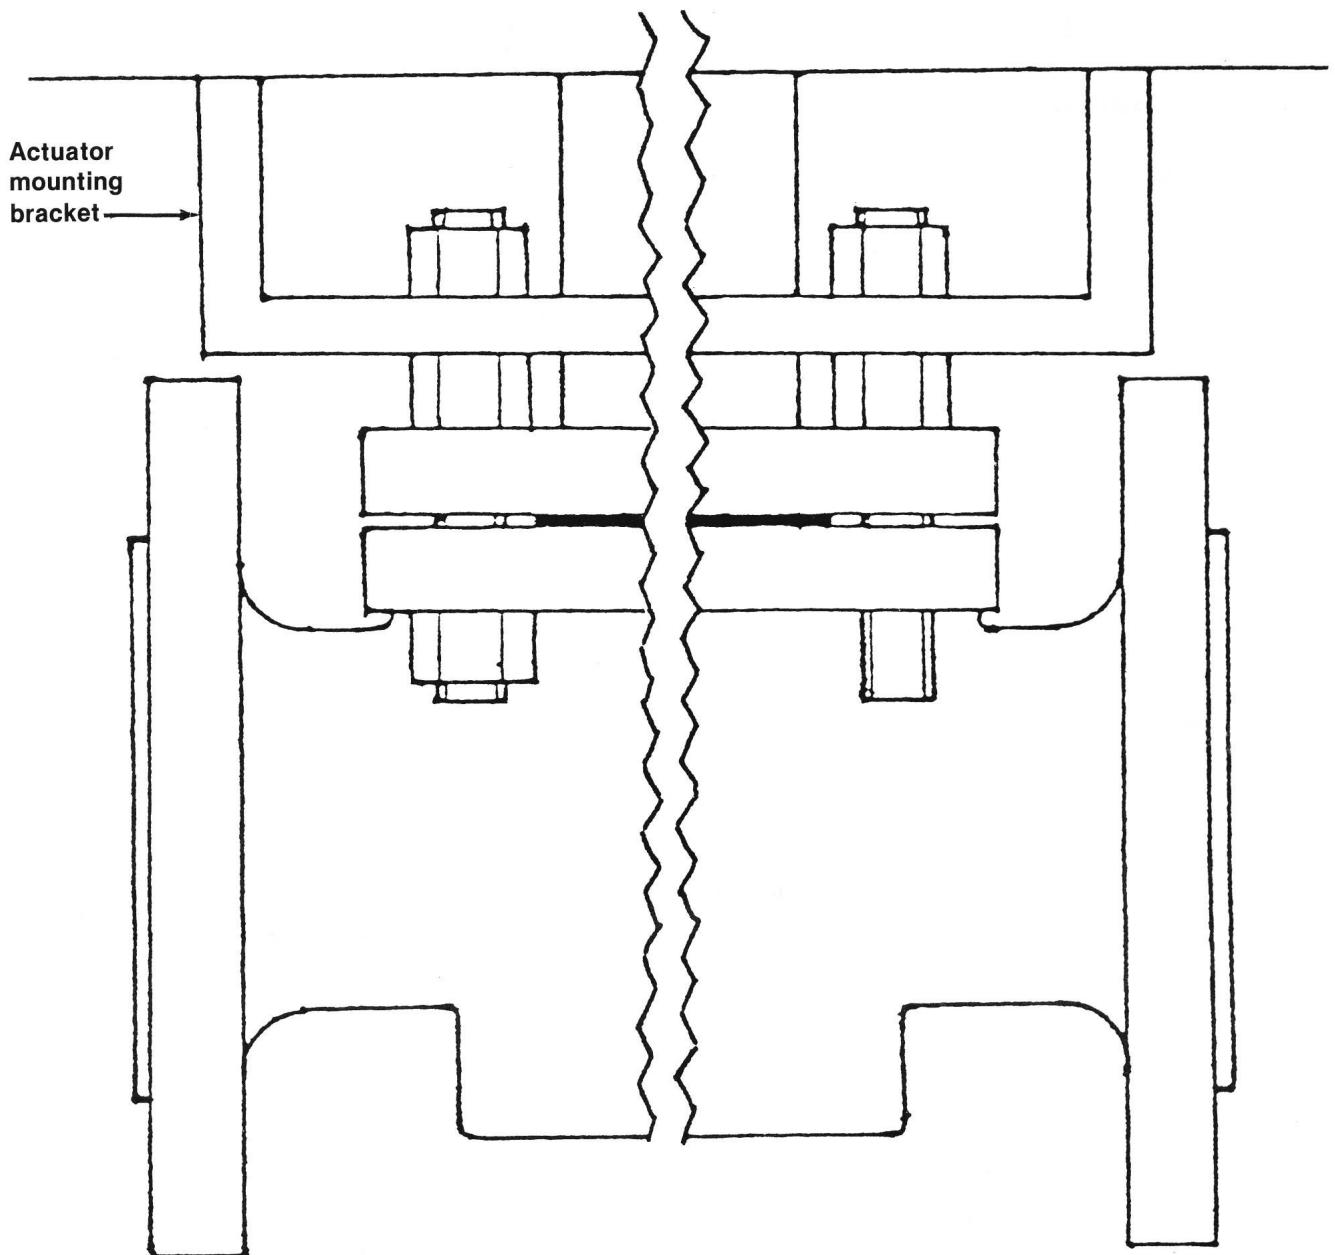
Fig. 1. PLUG VALVE AS SUPPLIED TO PLANT

Another and newer plant uses a large number of actuated plug valves. As supplied, the method of securing the actuator to the valve body was such that it was still possible to withdraw the bonnet bolts by mistake (see Fig. 1), though the design was, in fact, different to that in the incident referred to earlier.

Type A. Stud bolt through clearance hole in valve body secured by nut

Type B. Stud bolt through tapped hole in valve body

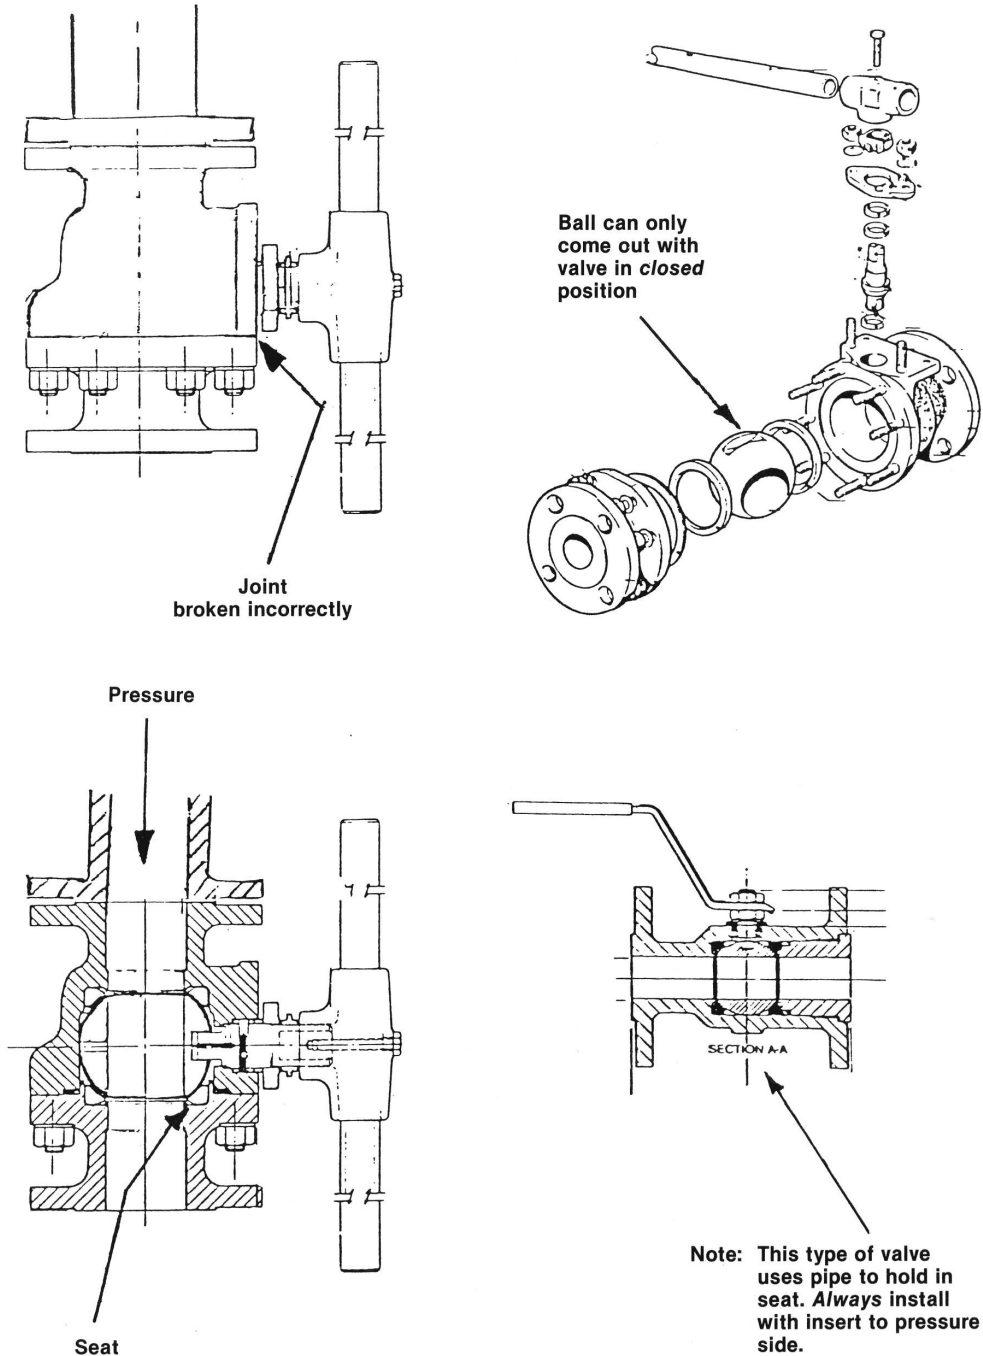
Fig. 3

In another company it was desired to inject radioisotope tracer into an ethylene pipeline in order to calibrate a meter. The injection point was a 1/2" branch fitted with an 'OBL' ball valve. The team carrying out the tests found that their equipment did not fit the exposed flange, but matched another flange, closer to the valve. As they undid this, the ball blew out, releasing a large cloud of gas. Fortunately the gas was isolated elsewhere and the release dispersed before it created a major hazard (the main was adjacent to a roadway). Figure 3 shows why they thought that they could break the joint where they did and why the ball blew out.

This incident was almost a carbon copy of one at a glass factory, where 5 tonne of propane was released via a 2" Weir Pacific ball valve. Because the smaller flange "closer to the valve" matched the one on the hose, the joint was slackened in preparation for fitting a hose to drain the tank. On this occasion the release was not immediate and occurred when no-one was present.

Do you have any valves of this type — there are many makes — if so, what precautions have you taken to avoid incorrect dismantling by maintenance personnel who may not be familiar with the valve design. Some people wire the bolts "to make them different" and thus alert the unwary. Where such confusion can arise, perhaps manufacturers should be persuaded to re-design the valves using one of the many "different" bolt type fasteners now available, which require special tools, making it more difficult to dismantle the valve *in situ*.
