No. 155

SOME SIMPLE INCIDENTS

IMPERIAL CHEMICAL INDUSTRIES LIMITED
PETROCHEMICALS DIVISION

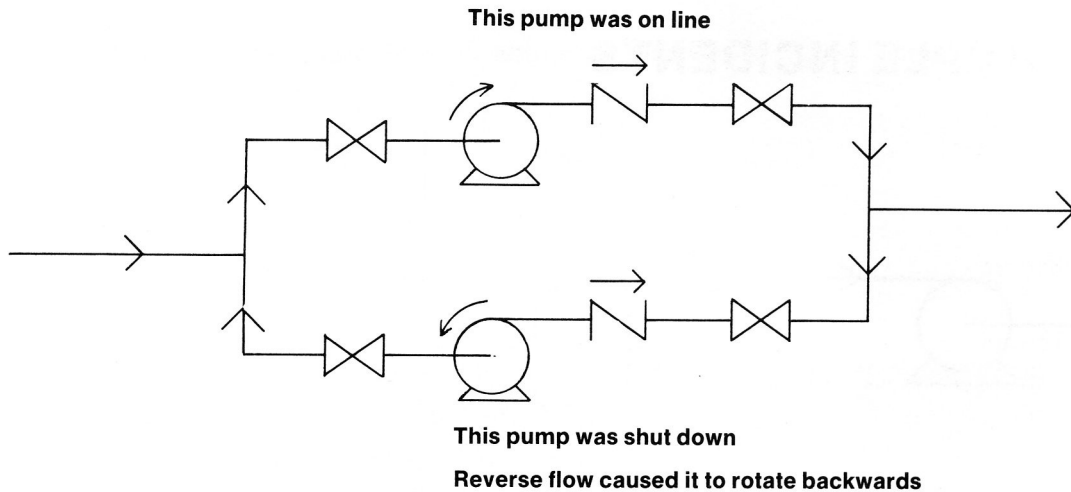
155/1 A PUMP MOVED WHILE UNDER REPAIR

A pump was shut down and given to maintenance for attention to the gearbox. As the line contained a slurry, the suction and delivery valves were left open to prevent solids settling out near them.

A fitter removed the coupling guard and tried to turn the coupling by hand. It was too stiff. He fitted a ring spanner to one of the coupling nuts and tried again. The coupling started to turn, bruising the fitter's hands. **Back flow through the pump had caused it to rotate.** There was a non-return valve in the line, but it must have been faulty.

Before any work is done on a pump, even though the process side is not being opened up, the suction and delivery valves should be closed and locked shut.

To prevent solids settling out in a line which contains a slurry, the line should be flushed out with clean liquid or blown clear with nitrogen.

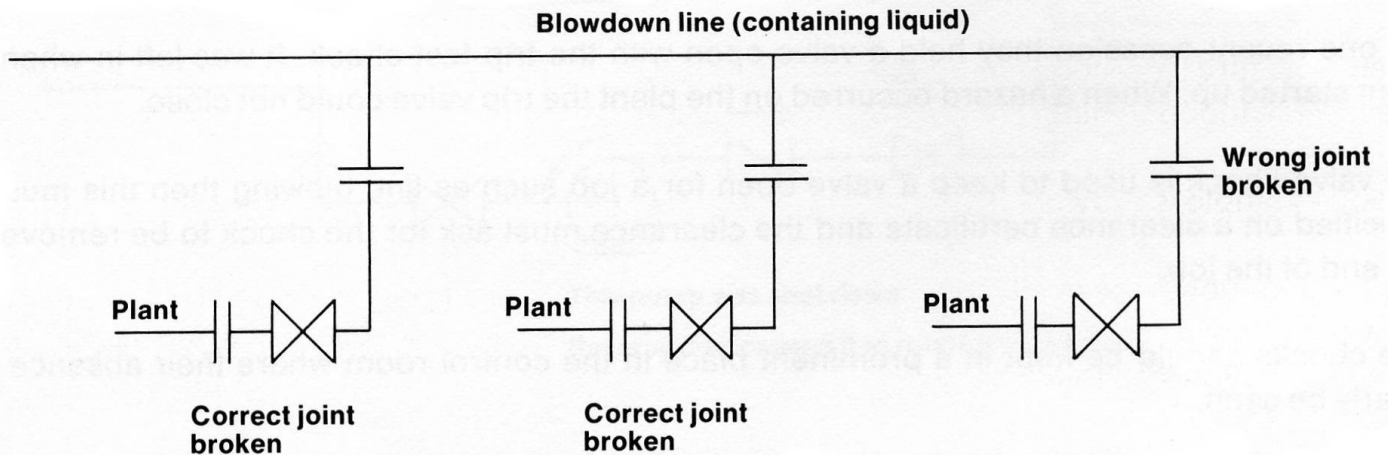
155/5 INSTEAD OF BREAKING AN UNUSUAL JOINT, A MAN BROKE THE USUAL JOINT

The valve is a blowdown valve and is one of several in a row.

The joints on the blowdown side of the valves are regularly broken and slip-plated, often with the plant on line.

However the plant was shut down and swept out and the job to be done was an unusual one, to break joints on what is usually the live side of the valves.

The fitter broke the correct joints on several valves. He then reverted to his normal practice and broke the joint on the blowdown side of a valve. The blowdown line contained some liquid displaced from the plant and the fitter was splashed.

The correct joint should, of course, have been marked with a numbered tag.

The incorrect chalk marks did not help. A tag would have made the error less likely.

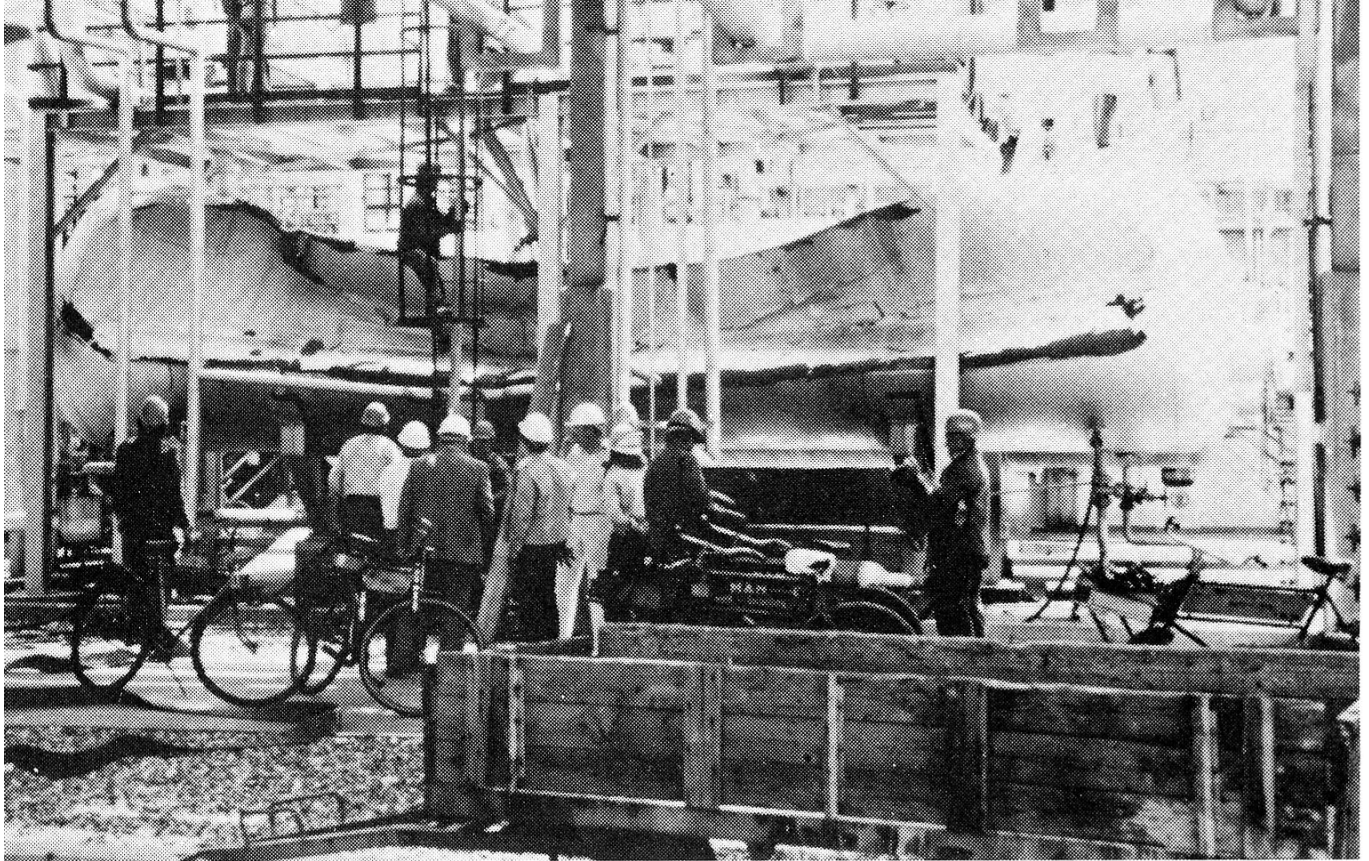
HOW TO SQUASH A PRESSURE VESSEL

The photograph shows a pressure vessel — actually a blow down drum — which was sucked in. It belonged to another Company.

The vessel was out of service and isolated. The drain line was removed and a steam lance inserted. The condensate ran out through the drain line.

The steam was isolated and *45 minutes later* the drain valve was closed. Fifteen minutes later the vessel collapsed.

Forty-five minutes was not long enough for all the steam to condense.
