# CAREFREE INSPECTION

## No. 153 CHECKS AND INSPECTIONS

**IMPERIAL CHEMICAL INDUSTRIES LIMITED**  
**PETROCHEMICALS DIVISION**

## 153/1 A SAFETY DEVICE WAS NOT INSPECTED – AND FAILED

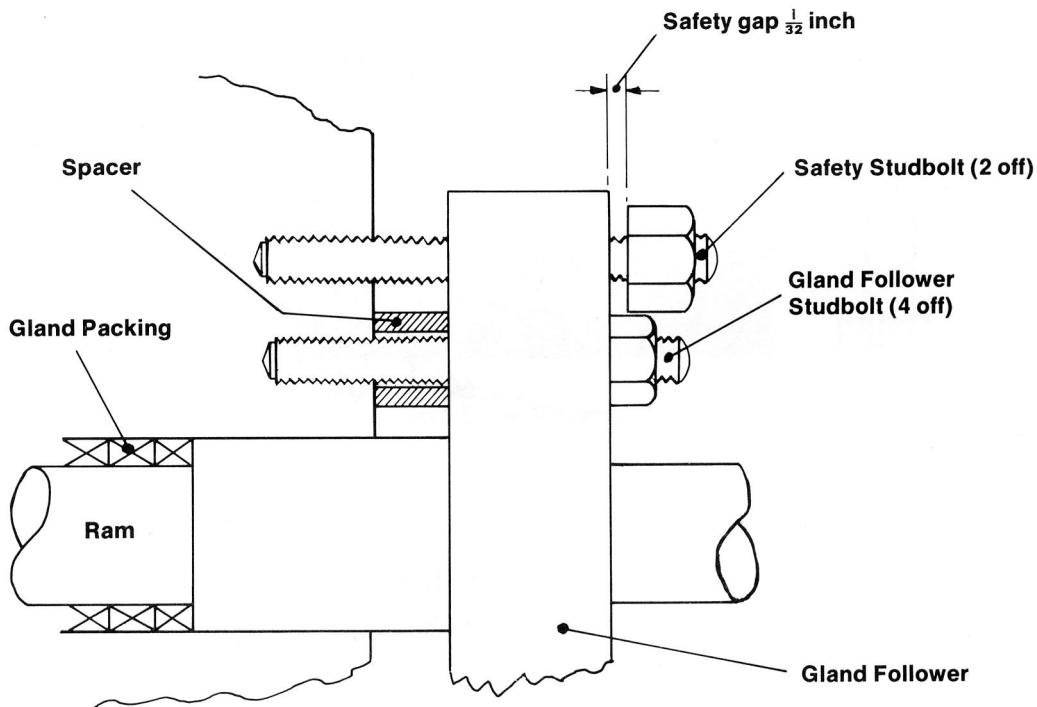
In addition changes were made to the design of the gland followers. Two safety studbolts were fitted as well as the four gland follower studbolts. The safety studbolts are intended to hold the gland follower in position if the gland follower studbolts break.

The safety studbolts are set  $\frac{1}{32}$  inch clear of the gland followers to prevent them being subjected to pulsating loads.

Nearly 25 years after the original failure, two gland followers studbolts failed again. *One of the safety studbolts also failed* and there was a leak of hydrocarbon.

It was then found that the gland followers and the underside of the safety studbolts were rough so that they were touching. The safety gap between them was too narrow or non-existent and its size was not checked regularly.

Why did the gland followers studbolts fail? It was found that they had been overtightened and that when the glands were repacked, all the old packing had not been removed. This increased the stress on the studbolts.

*All safety equipment needs regular checking*

*The reason for the setting of a safety device needs to be known.*
