SAFETY NEWSLETTER

No. 146

MAINTENANCE MISUNDERSTANDINGS

IMPERIAL CHEMICAL INDUSTRIES LIMITED
PETROCHEMICALS DIVISION

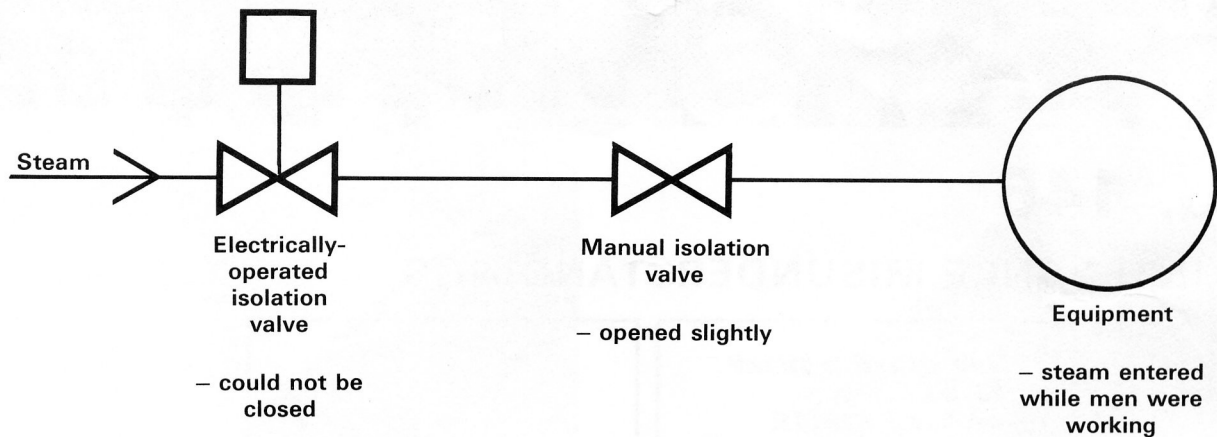
The manual valve was closed to isolate the equipment and a clearance certificate issued for work to be done on the equipment. Later a second clearance certificate was issued for two jobs:

The clearance certificate did not make it clear that job (1) should be completed and the electrically-operated valve closed before starting on job (2), as otherwise the equipment would not be isolated.

Job (1) required scaffolding and so the fitter decided to carry on with job (2) while the scaffolding was being erected. To fit the extended spindle the fitter had to open the manual valve slightly and this defeated the isolation of the equipment. Steam entered the equipment on which men were working.

Three clearances should have been issued — the first for the repair of the electrically-operated valve.

When this job was complete and handed back, a second clearance should have been issued for the modification of the manual valve.

When this was complete and handed back, a third clearance should have been issued for the work on the equipment, a job that would normally be done under double isolation.

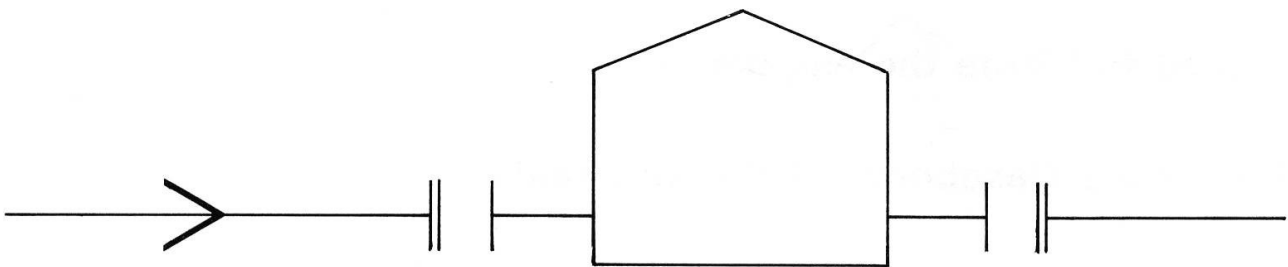
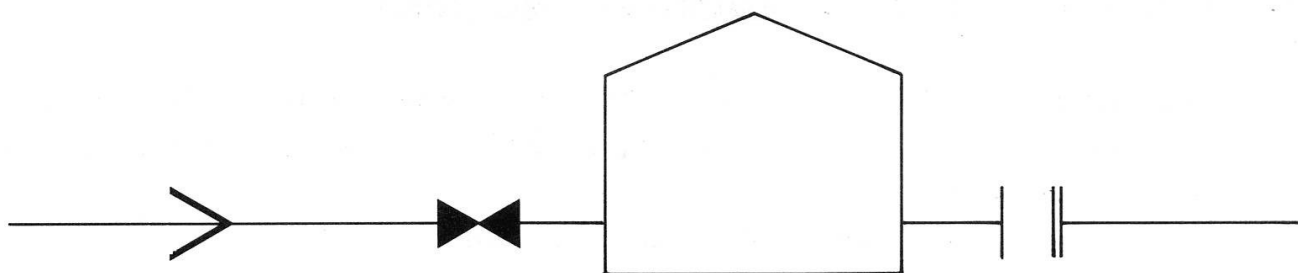
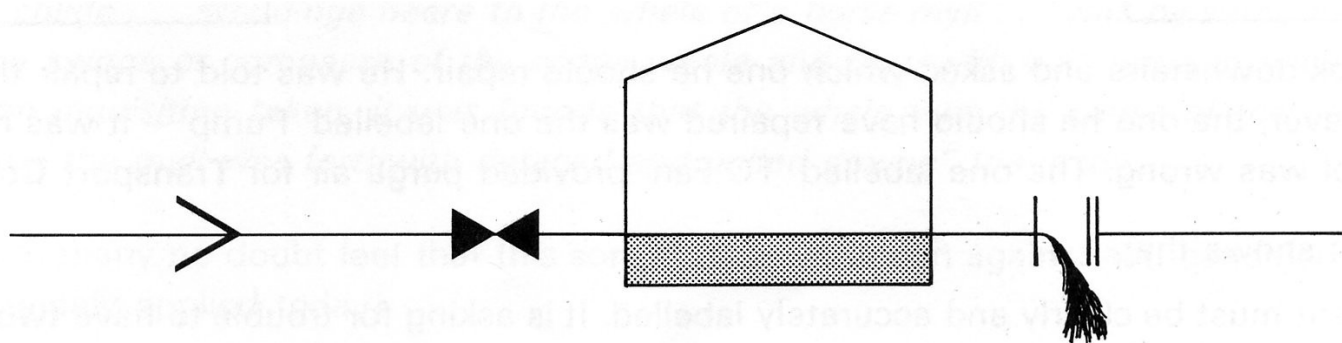
A tank was taken out of service for extensive repairs and was disconnected by removal of the inlet and exit valves.

inlet valve was replaced but the exit valve could not be replaced immediately as the type required was not in stock.

The inlet valve was left slightly open or was leaking. When the inlet line was in use, *a month later*, for a movement to another tank, product entered the tank and ran out of the open end. Five tonnes were spilt and although it was recovered from the tank compound, it was fit for use only as fuel oil.

The inlet line to the tank should have been slip-plated once it was realised that the exit valve could not be replaced immediately.

The clearance certificate expired, as usual, after a week but was simply allowed to lapse. It should have been handed back and signed off and this would have drawn attention to the fact that the job was only half complete.

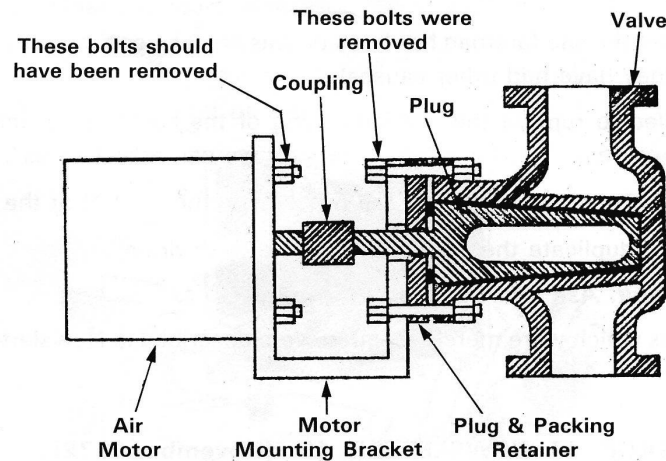
A remotely operated valve, in another Company, was used to isolate equipment which was under maintenance. To make sure the valve was not opened at the wrong time, it was decided to remove the compressed air motor that operated the valve — the usual procedure.

Unfortunately the men removing the motor removed the bolts holding the valve plug in place instead of the bolts holding the motor. The plug blew out and propylene at 150 psig escaped. The cloud of vapour exploded, killing 6 men and causing extensive damage.

If the valve closes on an air failure then it would have been sufficient to have disconnected the air line. If, however, it opens on air failure, removal of the motor is necessary.

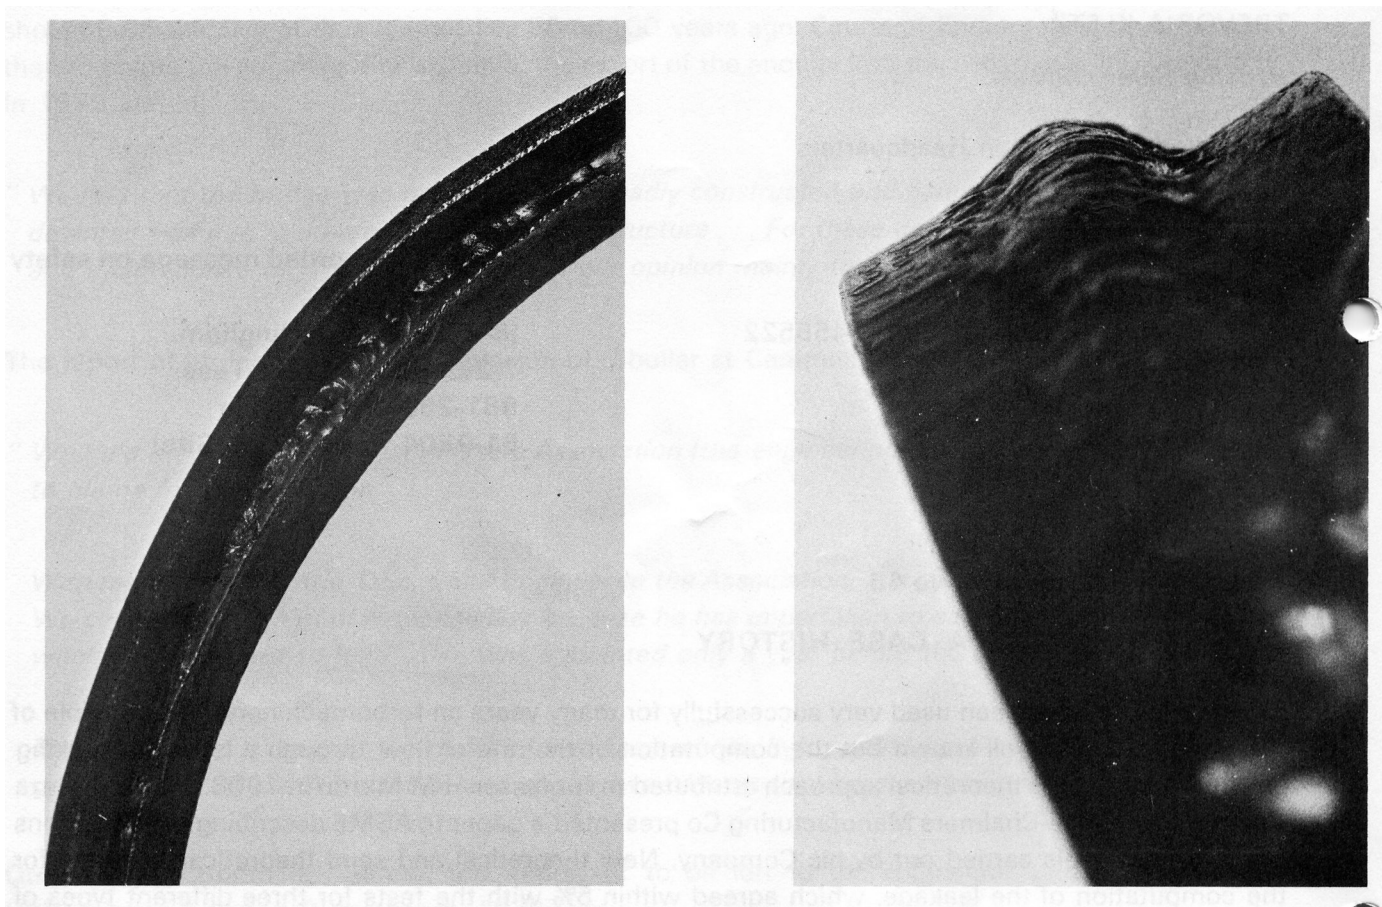
Photographs from Our Archives No.6

These pictures show a piece of 8 inches bore stainless steel pipe which was installed in a plant constructed about 1965. A short length of the pipe has been cut out to show one of the welds. It is seen that the two pipe ends did not fit exactly and they have been welded together with a step between them! The weld was then covered with lagging.

This example illustrates the point made in my paper, "Safety Aspects of Pressurised Systems", (copy on request) that many pipe failures are the result of errors in construction (or of a failure to specify precisely what is required) and that detailed inspection after construction is more important than ongoing inspection during the life of the plant.
