SAFETY

No. 145

IMPERIAL CHEMICAL INDUSTRIES LIMITED

PETROCHEMICALS DIVISION

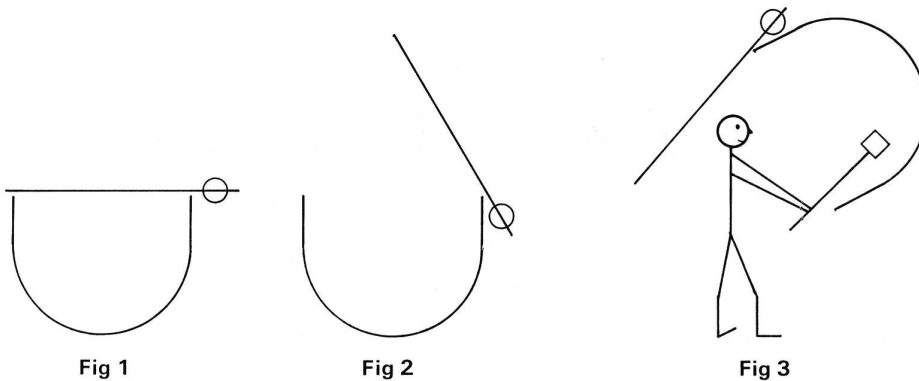
Figure 1 shows a catalyst mixing vessel about 1 m³ capacity, which is fitted with a hinged, counterweighted lid, 1.2 m by 1.5 m. To empty the vessel the lid is opened (Figure 2) and then the vessel and lid are tilted (Figure 3) so that the contents can be shovelled out; the men emptying the vessel thus stand underneath the lid.

One day the lid fell off, catching one of the men.

- 1 The lid fell off because the welds between the lid support arms and their bosses cracked.
- 2 Cracking was caused by high-stress, low-cycle fatigue, probably arising from the opening and closing of the lid.
- 3 The stress in the welds was higher than in the original design because of modifications carried out in 1972. The effect of these modifications was not foreseen.
- 4 The strength of the welds and other parts of the lid support arrangements was deficient because the welding of replacement parts, fitted in 1979, was not designed and fabricated to a high enough standard.
- 5 A situation in which men need to work underneath a heavy suspended object is not ideal. Apart from the failure which occurred, the securing mechanism might have failed.

Once again we see the need for modifications to be properly designed and for repairs to be carried out to a specified standard. In addition, equipment in which failure of a lid or other movable parts

could cause injury or damage should be registered for regular inspection, either as part of the lifting gear registration system or as part of the vessel registration system.

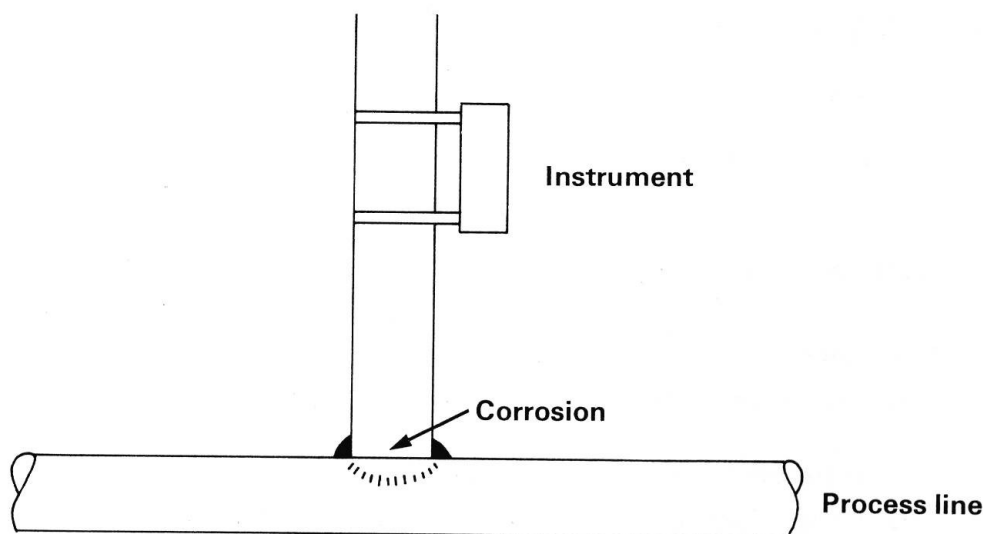
After a leak of liquefied flammable gas had occurred, it was found to have come from a length of 2 inch diameter pipe which had been welded onto a process line as a support for an instrument.

Water collected in the 2 inch pipe and corroded the process line until — 4 years later — it leaked.

Supports for instruments should not normally be welded onto process lines. Look out for any on your plant and if you find any, ask the maintenance team to look at them to see if they should be repaired or replaced. Pay particular attention to hollow supports, such as lengths of pipe, in which water can collect.
