NEWSLETTER

No. 141

SOME REACTIONS THAT WENT WRONG

IMPERIAL CHEMICAL INDUSTRIES LIMITED
PETROCHEMICALS DIVISION

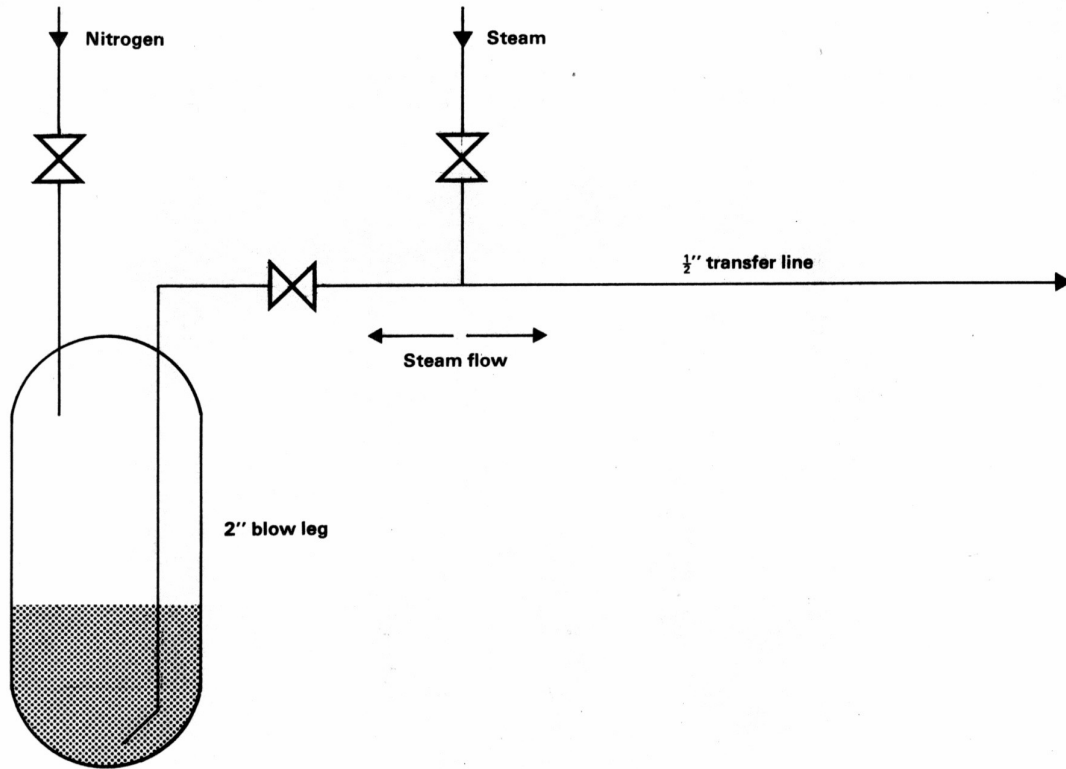
A completed batch was being egged into another vessel when the transfer line choked. The operator cleared the transfer line with steam, using a connection supplied for this purpose. He steamed both into the reactor and into the transfer vessel.

The steam raised the temperature of the reactor so that a runaway reaction occurred and the reactor exploded. Fortunately, no-one was hurt but damage was extensive.

A few years ago the size of the transfer line was reduced from 2 inches to 1/2 inch to prevent frothing. Although frothing stopped, the transfer line now choked from time to time and the chokes were cleared with steam.

There were no detailed instructions for steaming. The operator assumed that the blow leg might have choked, and steamed it. He did not realise that heating the contents of the reactor would be dangerous.

- Frothing has been prevented by a change in recipe and the transfer line has been restored to 2 inches.

- The steam connection has been redesigned so that steam cannot pass into the reactor. (A rotating bend on the steam line faces up to the transfer line but cannot be joined to the blow leg).

The process is an old one. It has been in use for about 50 years, and over that time the plant and process have changed. If an operability study had been carried out it would have drawn attention to the consequences of adding steam to the reactor and this could then have been prevented by plant design or clear instructions.

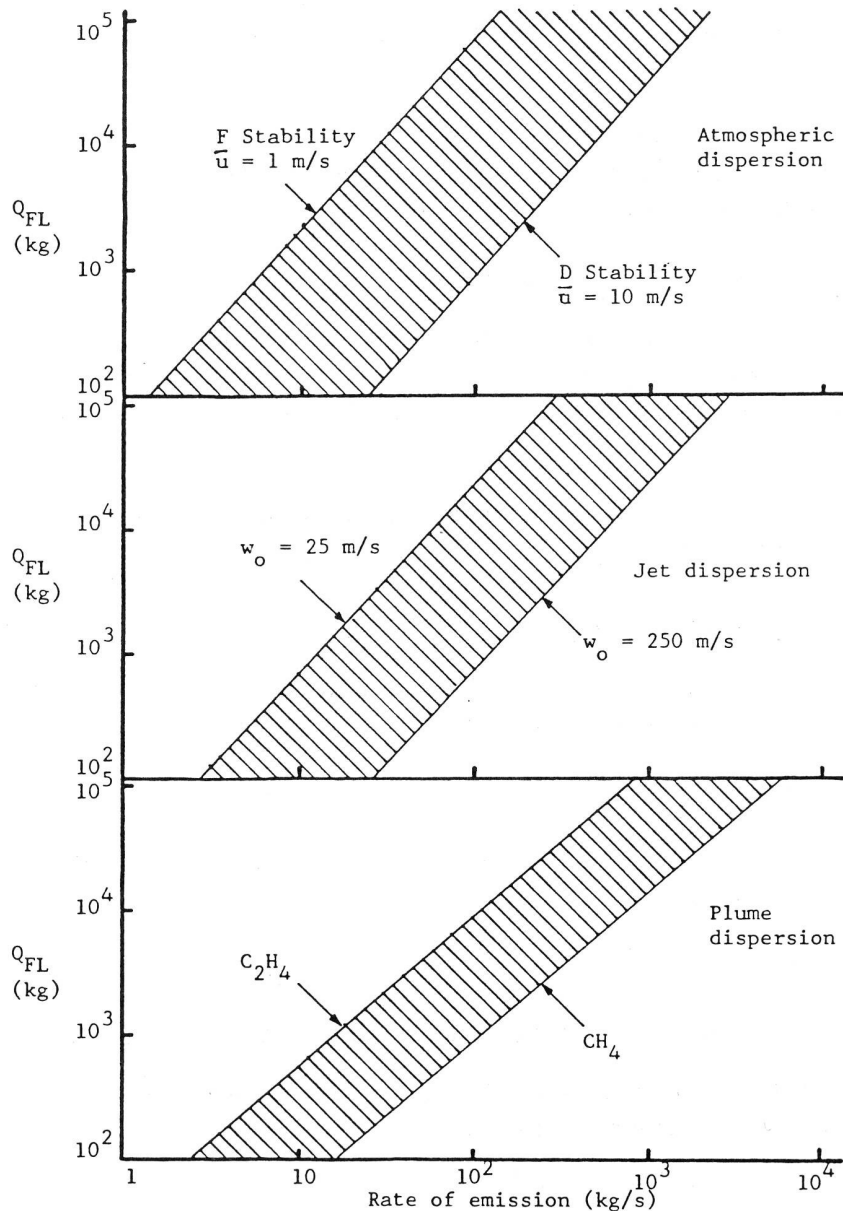
The horizontal axis gives the rate of leakage in kg/sec and the vertical axis the quantity of material in kg between the flammable limits.

The centre diagram is used for leaks which disperse by jet mixing. For this to occur the gas has to leak out as a jet under pressure. Exit velocities (w_0) between 25 and 250 m/sec are considered.

If the gas is not under pressure, or if the jet loses its energy by striking the ground or other equipment, then the vapour is dispersed by the wind and the top diagram should be used. Wind speeds (\bar{u}) between 1 and 10 m/sec are considered.

The bottom diagram is used for gases lighter than air which disperse by buoyancy.

An interesting feature of the diagrams is that even with very high leak rates (100 kg/sec or 360 t/hr) the size of the cloud is only 20 — 50 tes under unfavourable conditions, much less if the wind speed is high or the exit velocity high.
