# SAFETY INFORMATION

## No. 137 PREPARATION FOR MAINTENANCE AND ENTRY

**IMPERIAL CHEMICAL INDUSTRIES LIMITED  
PETROCHEMICALS DIVISION**

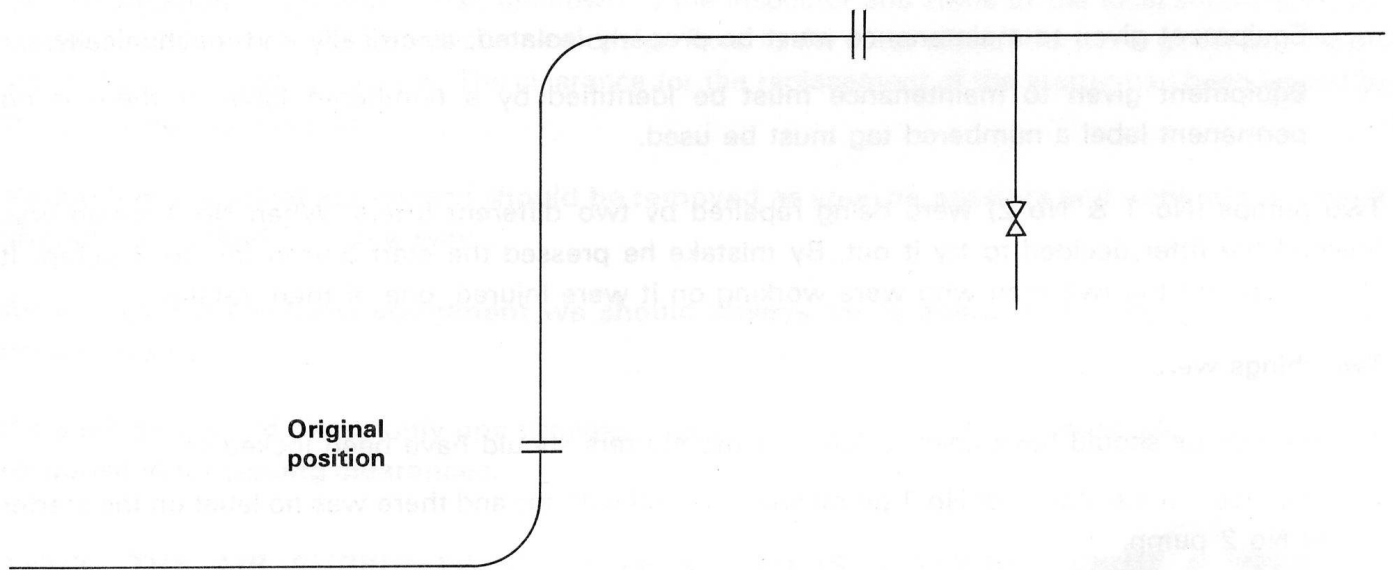
The diagram shows the original position of a slip-plate that had to be withdrawn whenever there was a change of product on a plant that operates in campaigns. Liquid collected above the slip-plate and sprayed out when the joint was broken. The slip-plate point has now been moved to the position shown and a drain line added. The report on one of the spraying incidents recommends that during operability studies we should try to identify equipment that needs to be maintained with the plant online and how this can be done.

**Reminder:** Newsletter 82/4 recommended that slip-plate positions should be at high points rather than low points.
