No. 136

SOME INCIDENTS WHICH OCCURRED BECAUSE THE LESSONS OF THE PAST WERE FORGOTTEN

IMPERIAL CHEMICAL INDUSTRIES LIMITED
PETROCHEMICALS DIVISION

June 1980

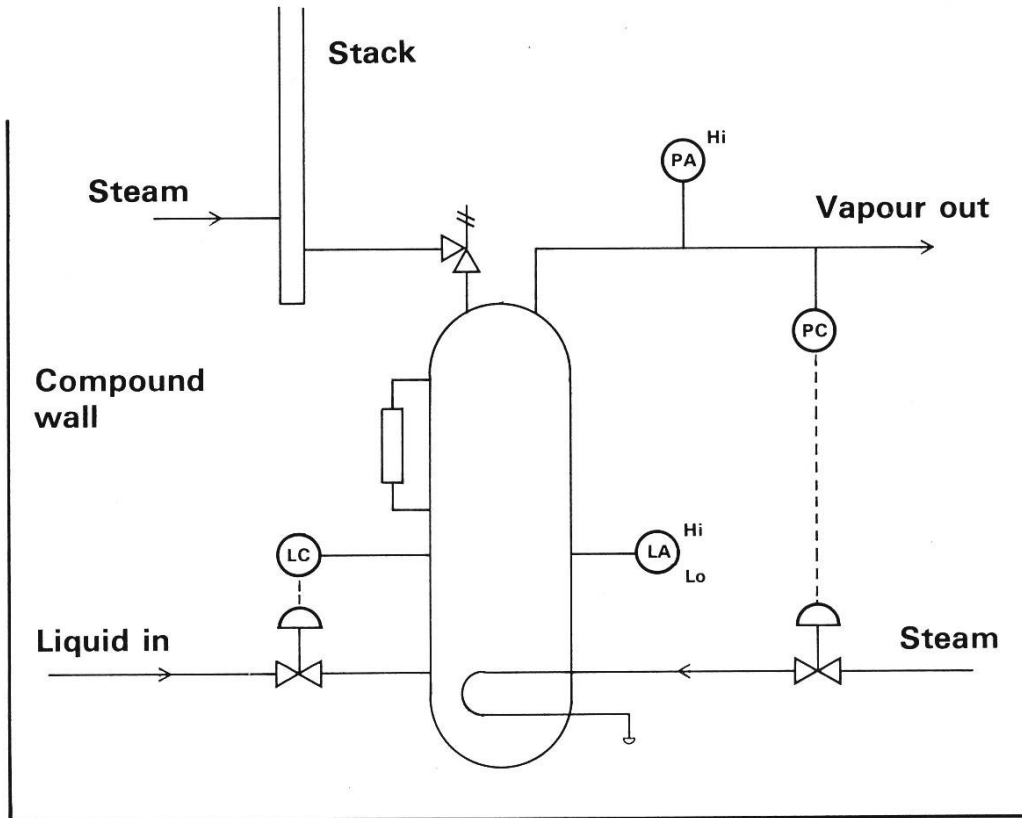
A small vaporiser and vent stack are located inside a brick compound, about 4 m long by 2.5 m wide by 3 m high. The instrumentation is shown below.

The circumstances leading up to the incident are not 100% clear but it seems that the level controller failed, so that the vaporiser filled with liquid which passed through the relief valve into the stack which then overflowed. The steam supply to the vaporiser froze but this may have occurred after the spillage due to contact with cold LPG.

- 1 The high level and high pressure alarms failed to operate. They were not tested and were not included in the alarm test schedule. When the schedule was drawn up, these alarms were forgotten, because they were on a small unit which is not always in use, on the edge of the plant. This is another example of the point made in Newsletter 132 -

- 2 **There was no gas detector in the compound.** One is now being installed.

- 3 The walls round the vaporiser make it more difficult for leaks to disperse and the walls should be demolished.

4 There was a level glass on the vaporiser. **Level glasses should not be used for LPG and other liquids which are handled above their boiling points.** See Safety Note 72/20.

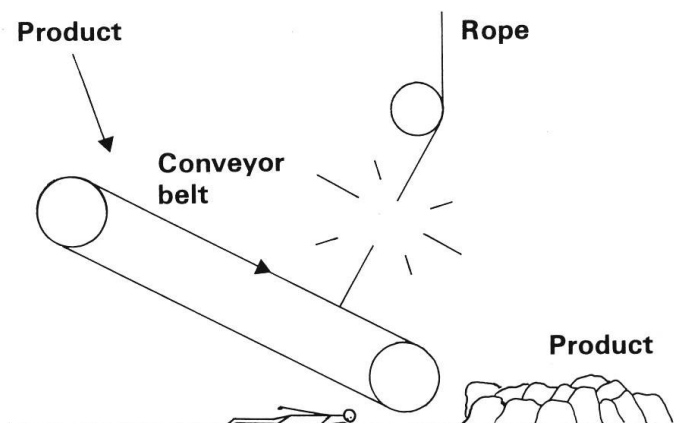
In one of our overseas companies a solid product is moved into a store on a conveyor belt. As the store fills, one end of the conveyor belt is gradually raised by a wire rope.

One day an electrician was not available so the timer was by-passed by holding a switch down with a bent welding rod.

Two hours later, after a change of shift, the belt reached the top position. **The limit switch did not operate as it was also by-passed.** The motor continued to turn. The rope broke, the belt fell and killed a man who was working underneath.

1 **Do not by-pass trips and other protective equipment without written authority and then in an authorised way.** The man who by-passed the timer probably did not realise that he was also by-passing the limit switch.

2 **Do not stand or work underneath equipment which is supported only by a rope.**

3 Do not rely on single ropes. Use a second rope or some other device to catch the belt if the main rope fails.

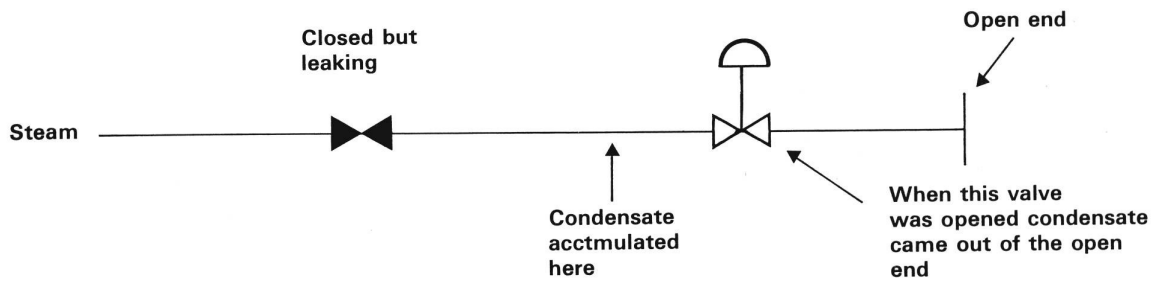
A man opened a trip valve on a steam turbine which was dismantled for repair. The isolation valve was leaking, hot condensate had accumulated behind the trip valve and when it was opened the man was scalded on the forehead.

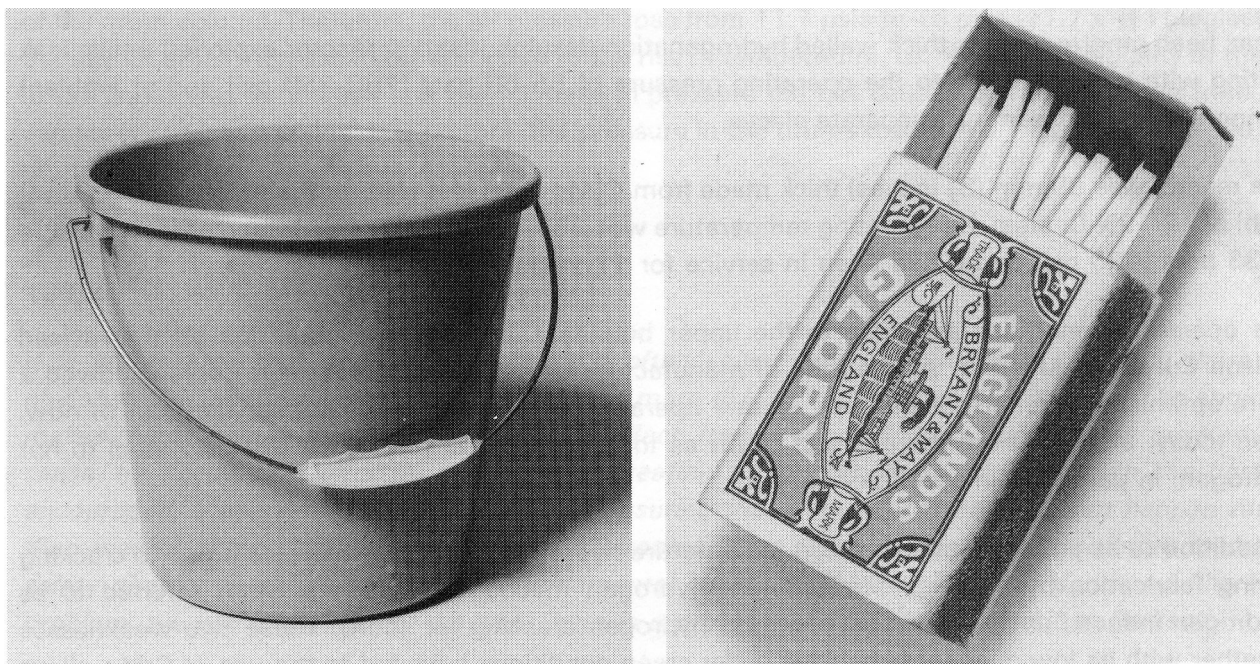
WHICH OF THESE IS MORE HAZARDOUS — on plants which handle flammable liquids?

The bucket is more hazardous because if flammable liquid is placed in a bucket there is always an explosive mixture above the surface and sooner or later a source of ignition will set it alight.

Matches will ignite a flammable mixture only if they are struck when a flammable mixture is present — and in a well-run organisation flammable mixtures occur very rarely.

I am *not* suggesting that we allow matches in the Works. Obviously we must do what we can to get rid of all known sources of ignition. But I do suggest that we take as much care to get rid of buckets and other open containers — used for flammable liquids — as we do to get rid of matches.
