# SAFETY NEWSLETTER

No. 135

## SOME LESS OBVIOUS HAZARDS

IMPERIAL CHEMICAL INDUSTRIES LIMITED  
PETROCHEMICALS DIVISION

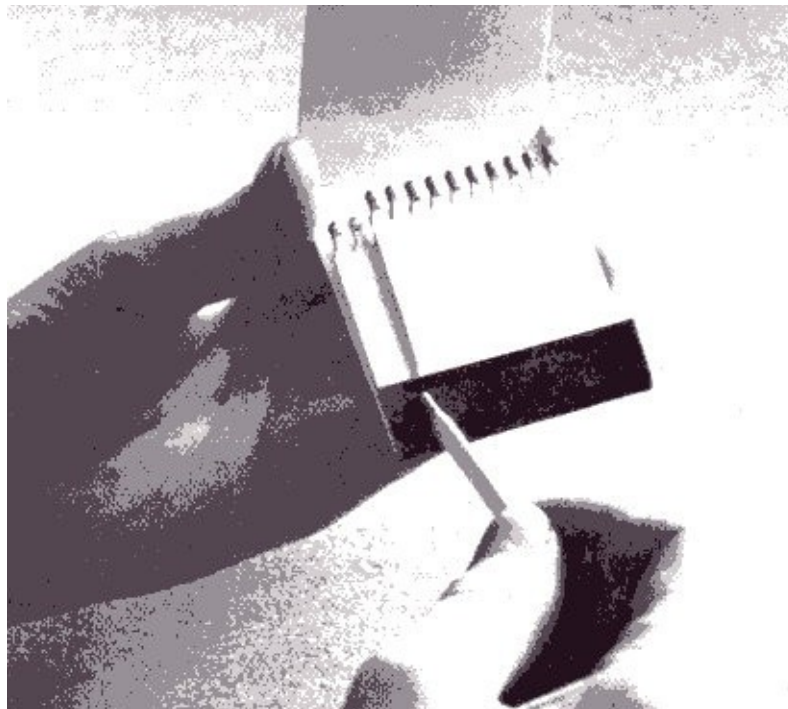
When lighting a match it is easy to set the rest of the book of matches alight. Some people might say that the users should be instructed to close the cover before striking a match. A better solution is shown below. The match is struck on the back of the book and it does not matter whether or not the cover is closed.

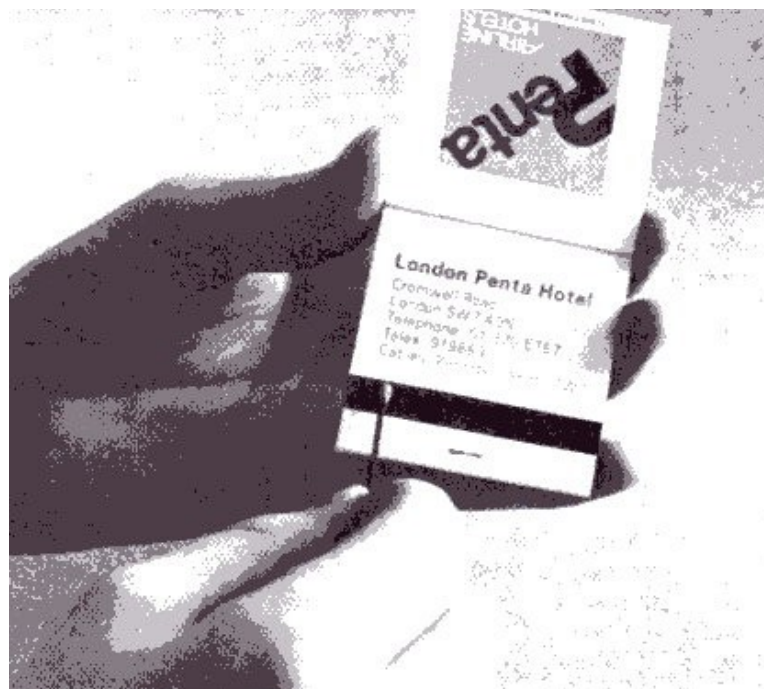
The good design costs no more than the poor design.
