No. 131

SOME OPERATING ERRORS

IMPERIAL CHEMICAL INDUSTRIES LIMITED

PETROCHEMICALS DIVISION

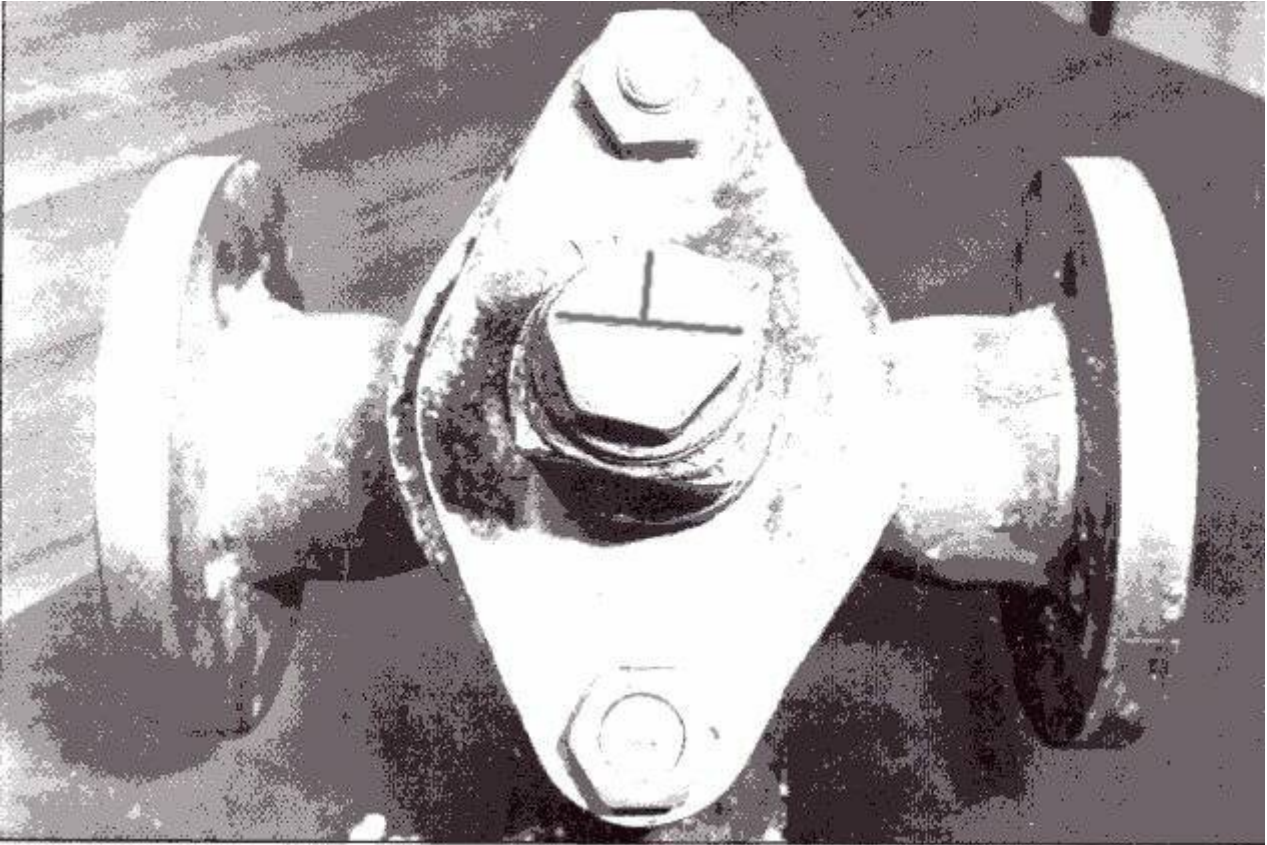
131/1 A SIMPLE, UNAUTHORISED MODIFICATION TO A VALVE CAUSED AN EXPLOSION.

The photograph shows a 3-way cock on which the centre bolt has been marked in order to show the cock position, presumably because the marks on the plug are hard to see.

Originally the marks on the bolt corresponded with those on the plug, but at some time two washers were inserted underneath the bolt, it could not be screwed in as far as before and the marks no longer corresponded.

Nearly all the operators on the plant set the cock according to the markings on the centre bolt. It was thus set wrongly, a process stream was directed to the wrong vessel and ultimately this caused formation of an explosive by-product — and an explosion.

Beware of do-it-yourself modifications

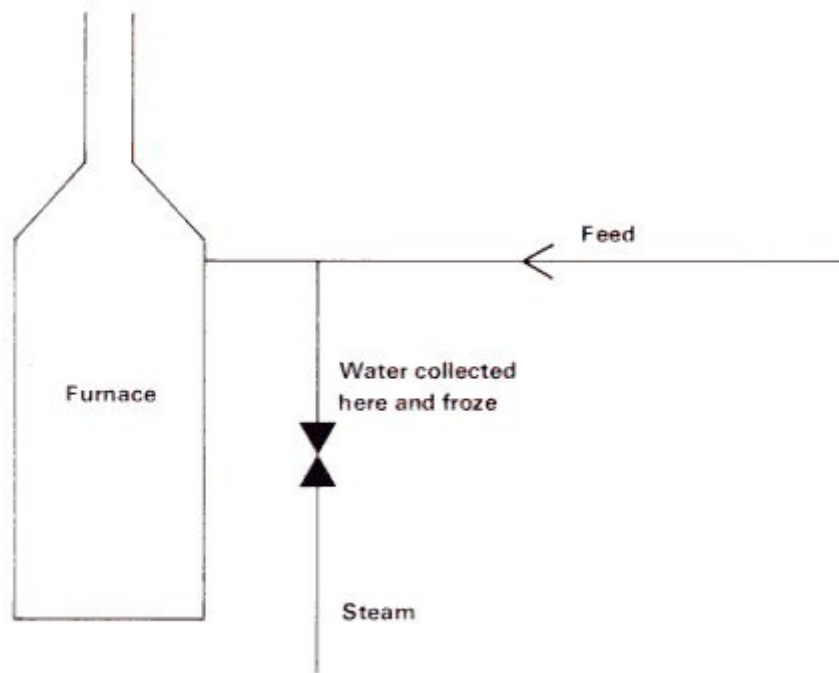
131/5 ANOTHER FAILURE OF A DEAD-END

Another company have described another incident. The feedline to a furnace was provided with a permanent steam connection for use during de-coking. The connection was on the bottom of the feedline and the steam valve was not close to the feedline. Water collected in the vertical section of the steam line above the valve, froze during cold weather and ruptured the line, allowing oil at a

pressure of 30 bar to escape. Fortunately it did not ignite.

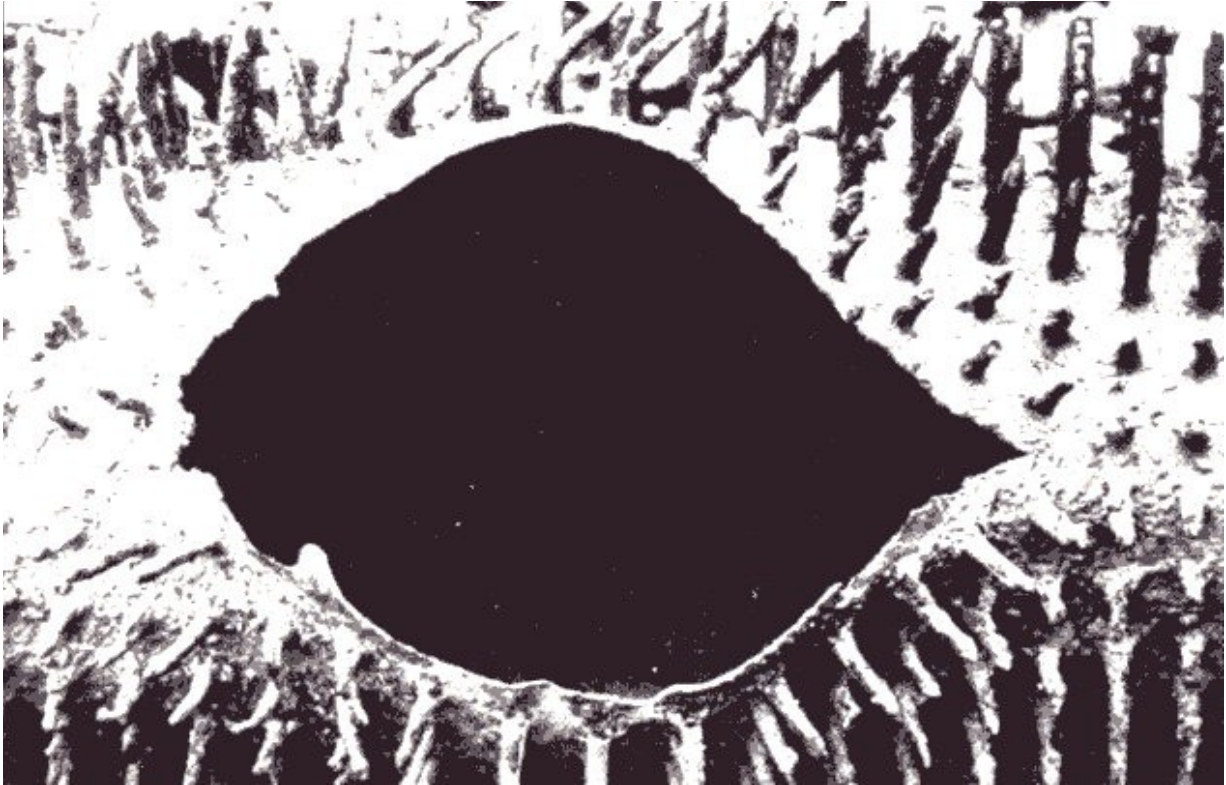
Photographs from Our Archives No.5

This is not a monster from Dr. Who but a convection bank tube on a furnace after a failure which occurred in July 1969. The furnace was destroyed and neighbouring equipment was damaged.

The failure was not due to gross overheating but to prolonged slight overheating during periods when maximum output was required. This led to a creep failure.

The tubes were overheated because there were not enough instruments on the furnace for its condition to be monitored and because the operators did not fully understand the way furnace tubes behave if they are overheated.

Suppose a furnace tube has been designed to operate at 500°C but has been heated to 550°C for six weeks: then we have used up half its life, and though we keep it at 500°C thereafter, it may burst after a total life of five years.
