SAFE INDUSTRIAL PRACTICES

No. 127

MORE ABOUT MODIFICATIONS AND INSTRUMENTS

IMPERIAL CHEMICAL INDUSTRIES LIMITED
PETROCHEMICALS DIVISION

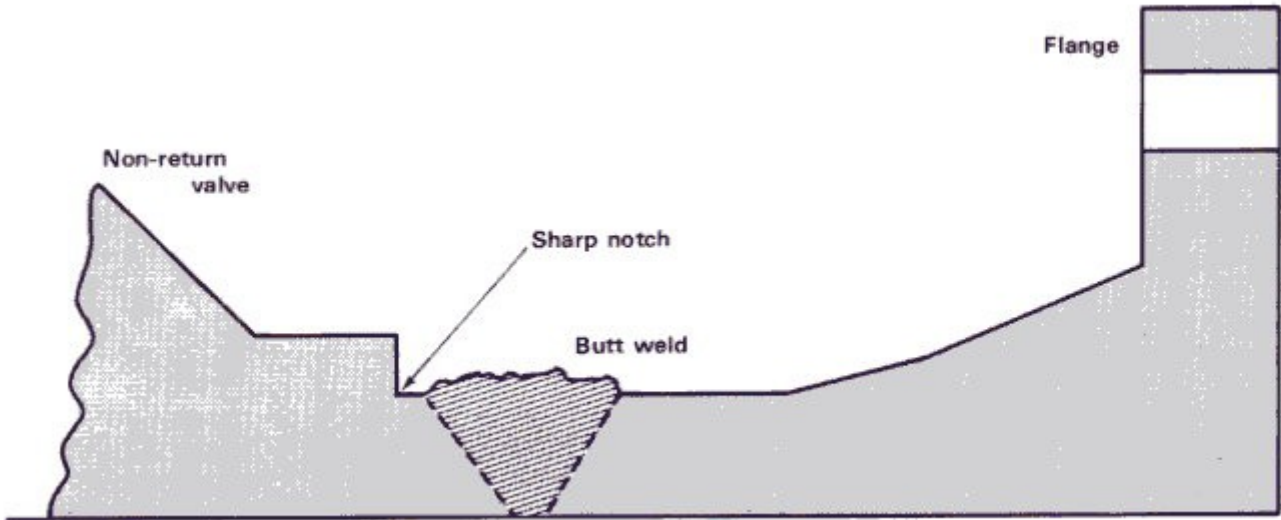
A non-return valve on the delivery line from an injector cracked and leaked. It was then found that there was a sharp notch on the body, close to a weld. This caused a fatigue failure.

How did such a design come to be adopted?

The non-return valve was originally designed to take screw-on flanges but the design was modified so that weld-neck flanges could be used. The hub diameter of a weld-neck flange is less than that of a screw-on flange. The stub of the non-return valve forging was therefore turned down to match, leaving a sharp discontinuity.

The non-return valve should have been tapered, at a gradient of 1 in 4, as shown below.

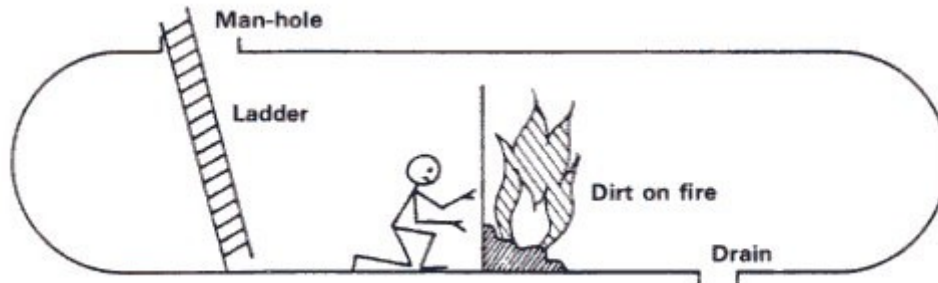
A vessel was divided into two halves by a baffle which it was decided to remove. The vessel was cleaned out, inspected and a permit issued for a man to enter the left-hand side of the vessel to burn out the baffle. It was impossible to see into the right-hand half but as the left-hand half was clean and as no combustible gas could be detected it was assumed that the other half was also clean.

While the welder was in the vessel some deposit in the right-hand half caught fire. The welder got out without serious injury but bruised himself in his haste.

If a part of the vessel cannot be inspected and seen to be safe, then we must assume the vessel contains hazardous materials.

If the previous contents were flammable, we must assume there is some flammable material out-of-sight.

If the previous contents were poisonous, we must assume there is some poisonous material out-of-sight and breathing apparatus must be worn for entry.

Gas tests alone are not conclusive. There may be some sludge present which gives off gas when heated or disturbed.

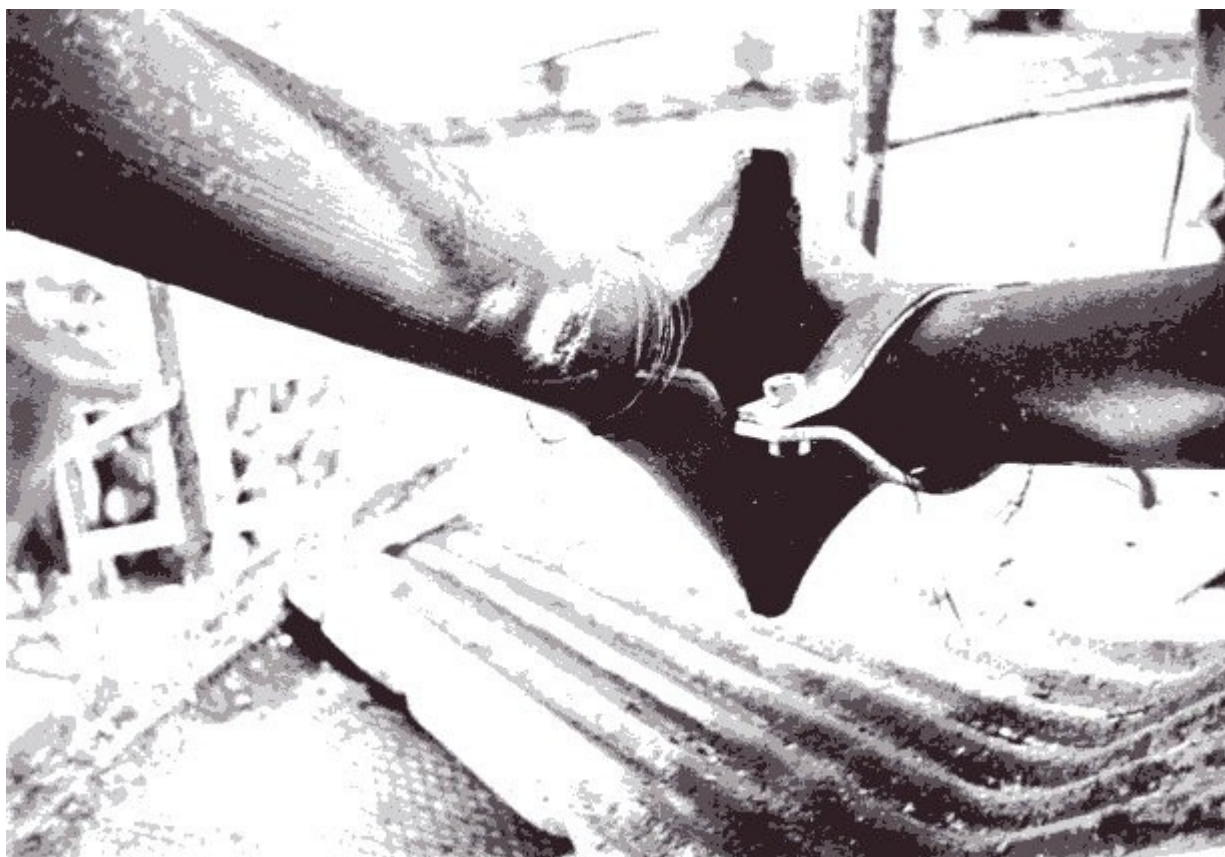
In June 1965 this 4½ inch diameter high pressure pipe burst, producing a jet of flame over 100 feet long. Fortunately the pipe was high up and no-one was injured.

The pipe was carrying a mixture of hydrogen and hydrocarbons at 250 bar and 350-400°C, conditions under which the grade of steel used should be perfectly satisfactory.

Investigation showed that the pipe had previously been used on another plant for 12 years at 500°C. At this temperature it will last for anything between 5 and 500 years before failing by creep.

Do not re-use old pipes unless their history is known in detail and tests show that they are suitable for re-use.
