No. 125

PREPARATION FOR MAINTENANCE AND ENTRY

IMPERIAL CHEMICAL INDUSTRIES LIMITED
PETROCHEMICALS DIVISION

July 1979

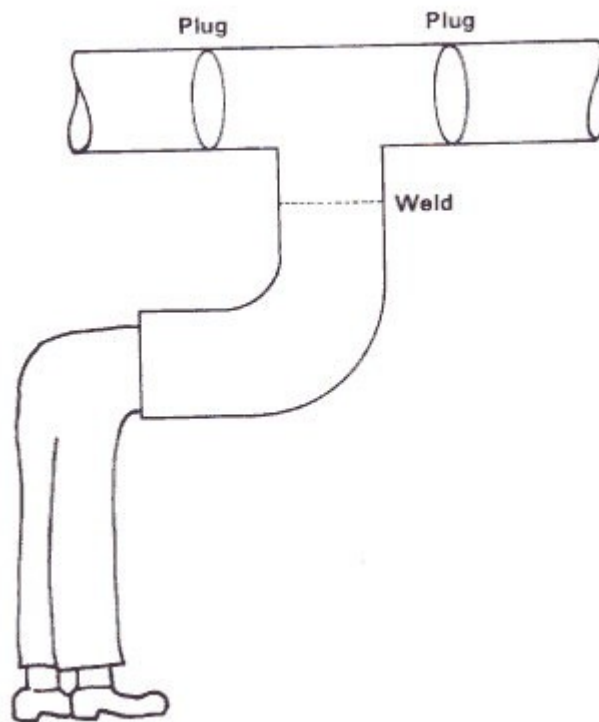
(b) A large pipe had been argon-arc welded in a workshop and two plugs had been inserted in the positions shown to save argon. There was also a plug in the open end. When welding was complete this plug was removed and a man reached into the pipe to inspect the welds and to remove the other plugs, and was asphyxiated.

Another man, passing by, gave the first man a playful pat on the behind. Later he saw the first man in the same position and realised that something was wrong.

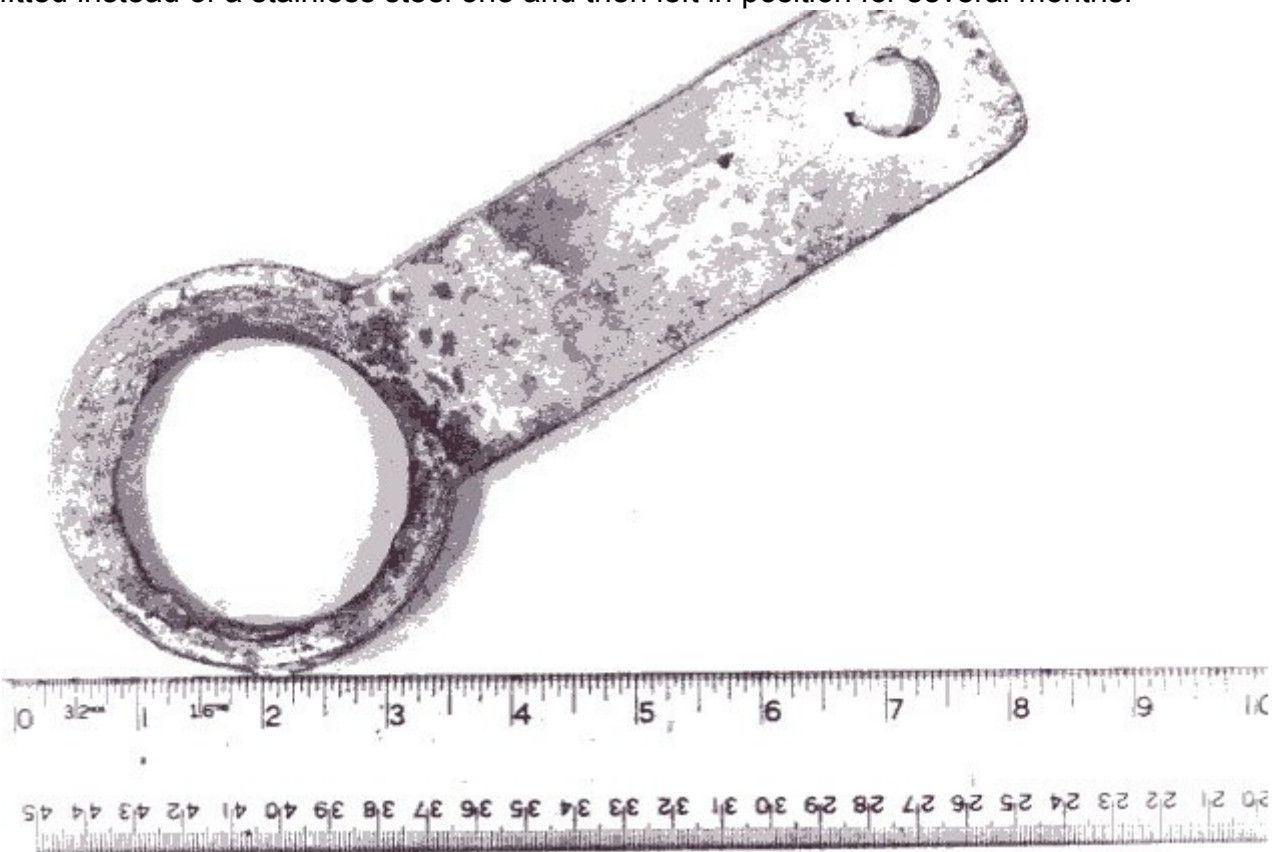
The photograph shows a slip-plate which was removed from a pipe-line. A mild steel slip-plate had been fitted instead of a stainless steel one and then left in position for several months.

If a slip-plate which has been in position for a long time is to be used to isolate equipment for maintenance or entry, then **the slip-plate must be removed and its condition checked.**

You cannot tell what a slip-plate is made from by inspecting the tag because sometimes the tag is made from a different type of steel.

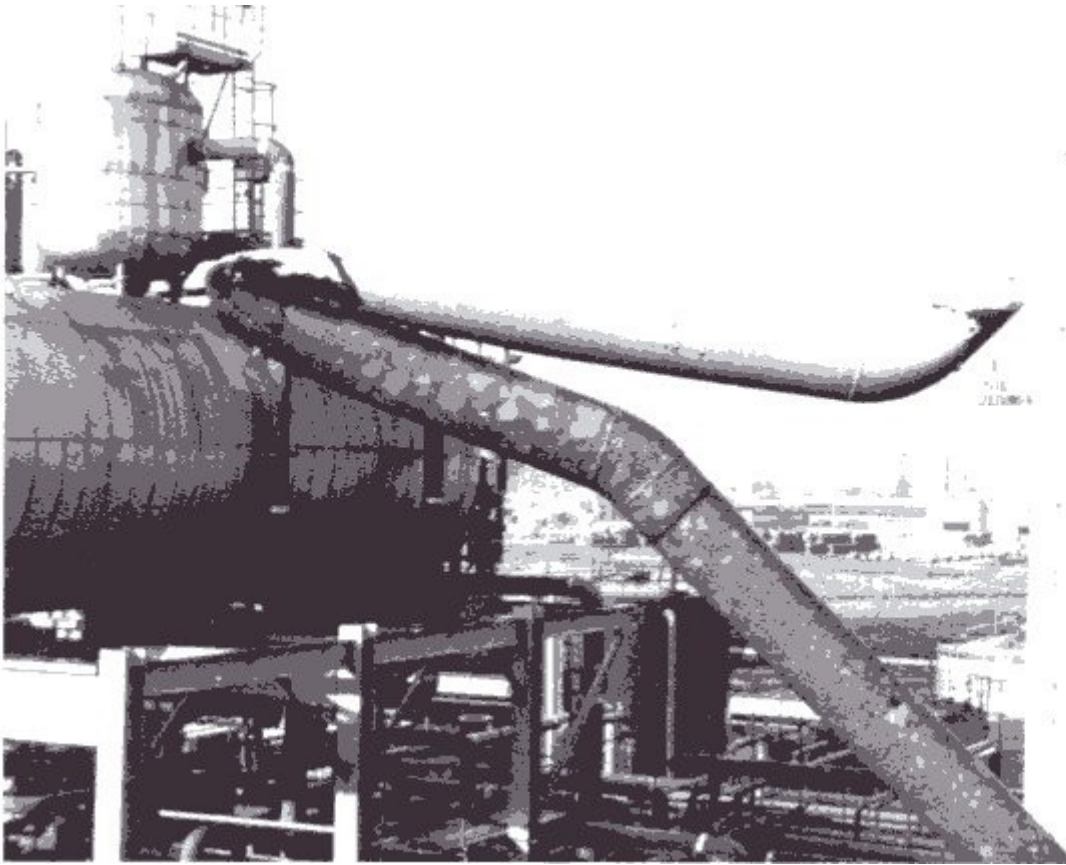
This happened in 1969 when a steam relief valve lifted and the tail pipe was not supported adequately.

If you suspect that your relief valve tail pipes are not supported adequately, Piping Design Section can advise.

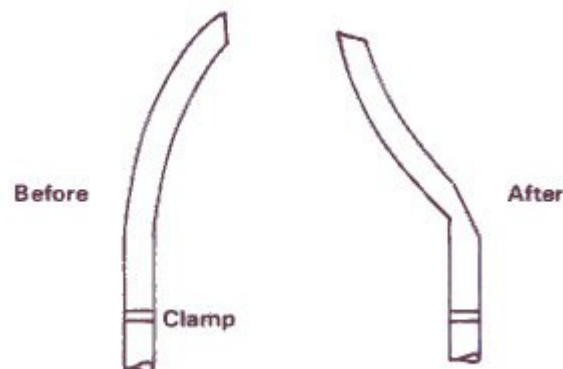
Another Company have reported a similar incident. A bursting disc in an oxygen line failed and the oxygen was discharged through a 4 inch copper pipe, which was curved to prevent rain getting in. The trust on the pipe bent it back, reducing the cross-section by 90%!
