Loss Prevention Bulletin

Process Safety Essentials

Issue 272, April 2020

The Feyzin Disaster

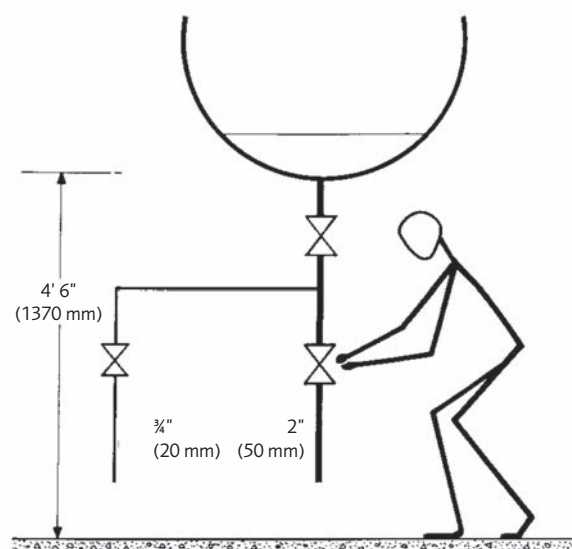
Figure 2: Sampling operation

The operator then closed the valve and opened it again. A few drops emerged, then the flow stopped. He then fully opened the upper valve. Something like a deflagration was heard, and a very powerful jet of propane gushed out, splashed up from the drain and frost burnt the operator on the face and forearm. As he fell backwards, he pulled the valve handle partly off the valve.

The primary cause of the propane leak was the operational fault of the plant operator; this fault was made easier by the difficult access to the valves and the lack of permanent valve spanners.

The discharge from the drain line was directed downwards in the immediate vicinity of and under the valves, instead of to the side. This caused the frost burns suffered by the operator and formed the cloud which made the recovery and repositioning of the valve lever impossible. Darkness and poor lighting added to the difficulties.

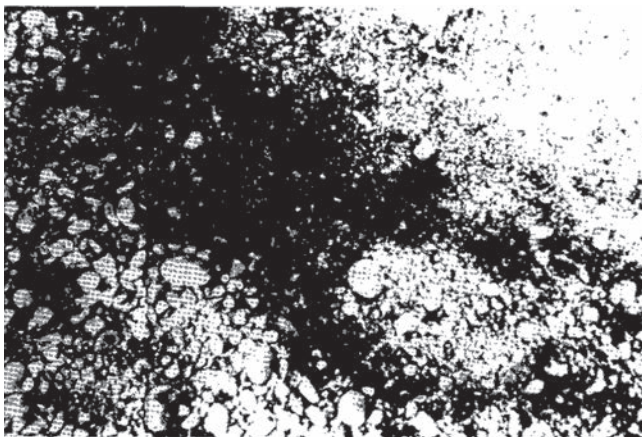
Figure 3: Carbon shadow of a man

One man who hurled himself flat onto the ground when sphere No. 443 ruptured suffered only burns to his hands. A fire department officer who remained standing beside him was fatally burned. Some of the recovered bodies were greatly reduced in size as a result of exposure to the intense thermal radiation and in some cases (Figure 3), only a carbon shadow on the ground remained of a man.

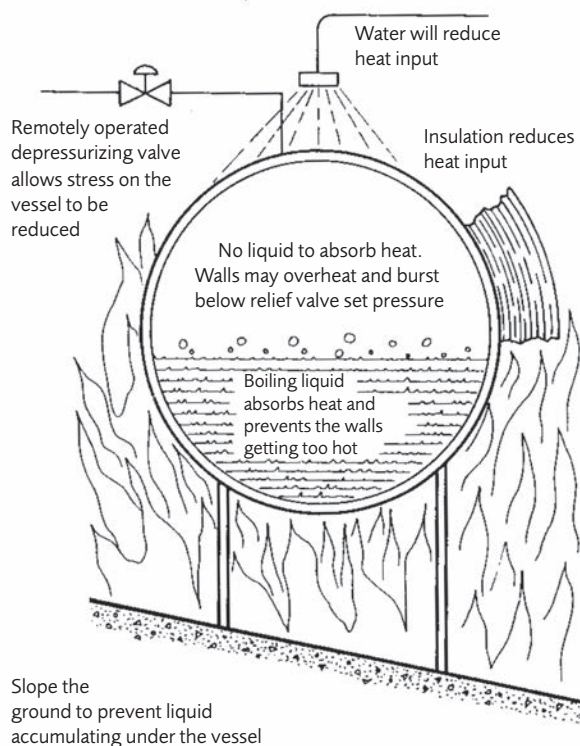
Figure 4: Preventing BLEVES in LPG vessels

It then ruptured and a BLEVE occurred. Figure 4 shows the methods that can be used to prevent BLEVEs in LPG vessels.

LPG trapped under a sphere will, if ignited, cause very high heat input to the vessel especially in the upper part of the sphere (where boiling LPG will not provide cooling). As the metal walls heat up they lose tensile strength and at some point the rupture pressure will be less than the design pressure – the pressure safety valve will not help. Modern practice is to drain any spillage into an impounding basin

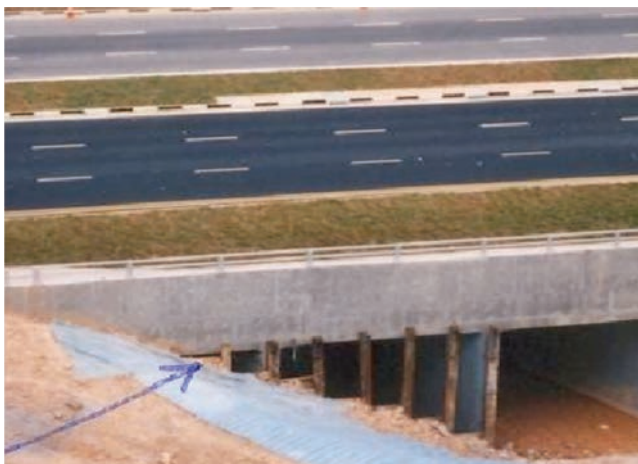
Figure 2a: Restricted access to cell 1 under carriageway

Four workers had the job of spray painting the walls and ceiling of a box culvert under a road carriageway (Fig 2a and b¹⁰). Three of them were killed as a result of acute toluene poisoning. They set up a blower at one end of cell 1, then workers 1 and 2 spray-painted for almost one hour before leaving because they could no longer stand the smell. They were replaced by workers 3 and 4. On hearing cries for help from them, workers 1 and 2 re-entered the cell but worker 1 felt nauseous, so he again left the cell but then passed out. The foreman arrived and found the three workers collapsed inside

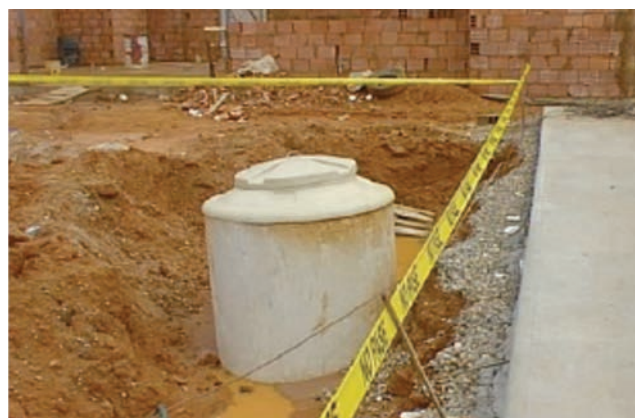
Figure 3: Underground tank with entry forbidden

A supervisor entered an underground motor fuel storage tank that was to be cleaned out. The tank had been embargoed for entry due to a change of plan and this had been made clear and the tank cordoned off (Fig 3⁸). He lowered a bucket and shovel into the tank to enable him to remove sand that had been put in as part of the previous plan to abandon the tank. He plugged his nose and ears with toilet paper and put one end of a rubber hose into his mouth to act as a snorkel. The other end was fixed near to the tank manhole. He lowered himself into the tank and was immediately affected by the fumes inside. He tried to breathe through the hose and climb up the rope to get out of the tank. The standby man tried to pull him out but he was too heavy so the fire and rescue services were called. By the time they arrived, the supervisor was dead.

This tragic accident was a result of blatant disregard of procedures and specific safety instructions possibly motivated by a misguided attempt to attempt to impress the project management. The accident is described more fully in References 8 and 11.

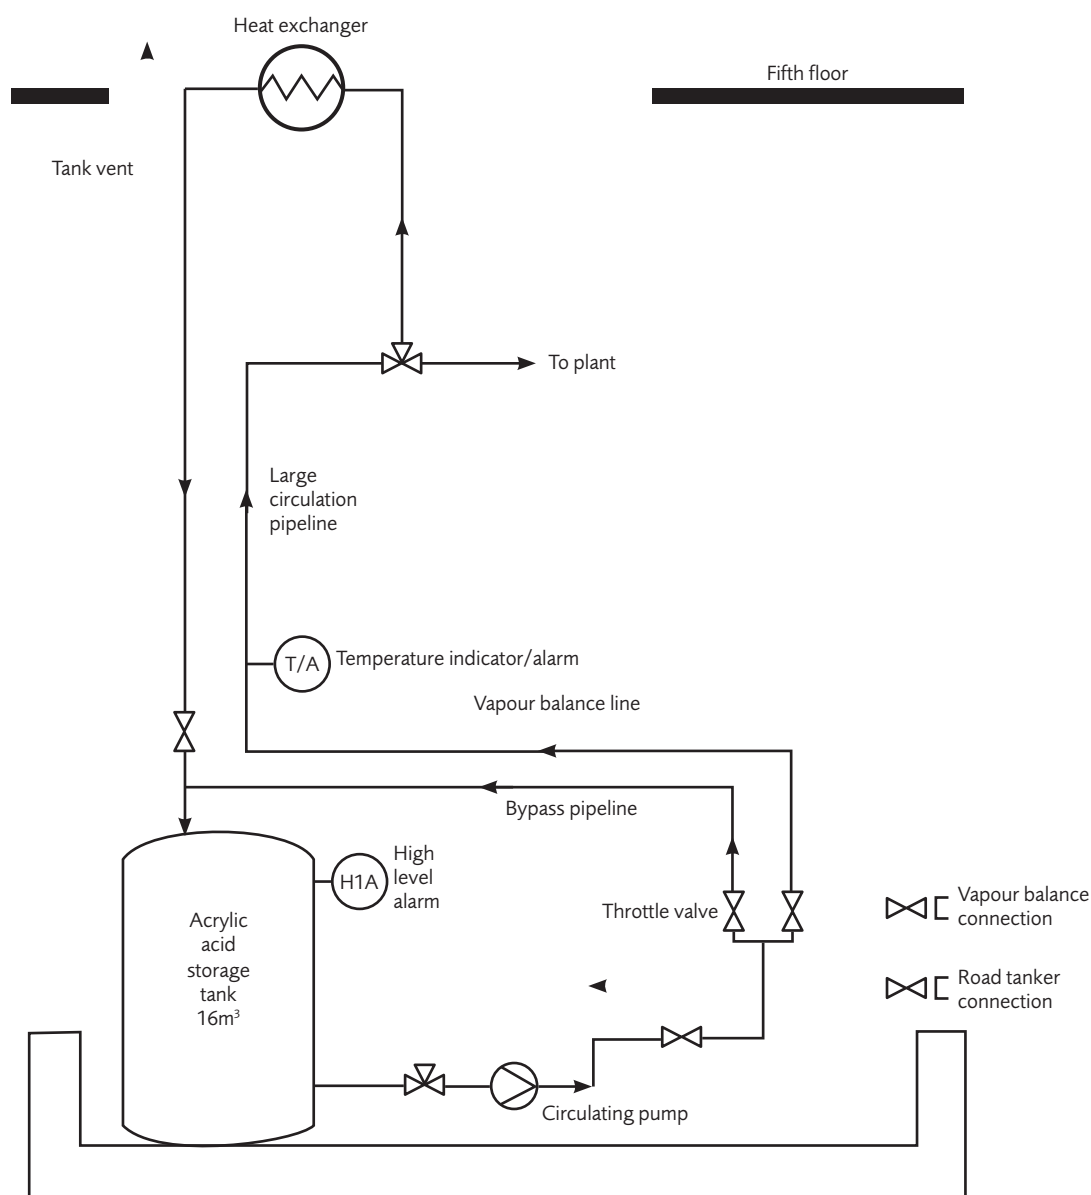
Figure 1 –Connections to the acrylic acid tank

As the bypass pipeline thawed, polymers that had formed were flushed through the throttle valve into the acrylic acid tank. This led to a very slow polymerisation to start with. Polymerisation continued slowly during the period from 23 November to 27 November 1994 but speeded up dramatically on the morning of 27 November. This was confirmed by investigators who took samples from containers of acrylic acid extracted from the tank on 24 November 1994. Small amounts of polymerised materials were found in the samples.

The large circulation pipeline, where the temperature control and cooling system was installed, failed to thaw. The temperature reading on this pipeline showed small differences during the routine checks, but values always remained within normal parameters. Deceptively, the system appeared to operate normally. As no acrylic acid was taken from the tank on Sunday, the actual state of affairs remained undiscovered. Due to the blockage of this pipeline, temperature increases in the storage tank remained unnoticed. The very slow polymerisation at the beginning of the incident, with the slow addition of energy to the system by the circulation pump running normally, gradually heated the acrylic acid in the tank. On Sunday, 27 November 1994 a high enough temperature was reached to accelerate the reaction to such an extent that it led to the bursting of the tank, and the spontaneous ignition of the escaping mixture.

The circulation pump, with a pumping throughput of 20 m³/h worked against the throttle valve—the flow rate in the bypass pipeline was around 5 m³/h. This might have caused the warm-up of the total contents of the tank by around 0.5°C/h. This probably resulted in a warm-up of the acrylic acid to above 60 °C during the period from 23 November to 27 November.

- A continuous independent temperature measurement of the tank contents will be provided.
- The circulation pump will be equipped with a temperature control safety switch.
- Safeguards put in place to ensure that temperatures in acrylic acid storage facilities and in rooms containing acrylic acid pipelines do not fall below a certain level. This will avoid crystallization of the acrylic acid in the event of a power failure.
- Analytical surveillance will ensure that the inhibitor concentration within the acrylic acid does not fall below 200 ppm.
- A measuring device will be installed to monitor the throughput of the major pipework.
- An emergency reaction inhibition system will be installed.
