# The explosion at Laporte Industries Ltd, Ilford 5 April 1975

A report by HM Factory Inspectorate

On 5 April 1975, an explosion occurred at the factory of Laporte Industries Limited which resulted in extensive damage to an electrolytor plant and the subsequent death due to injuries, of the plant operator.

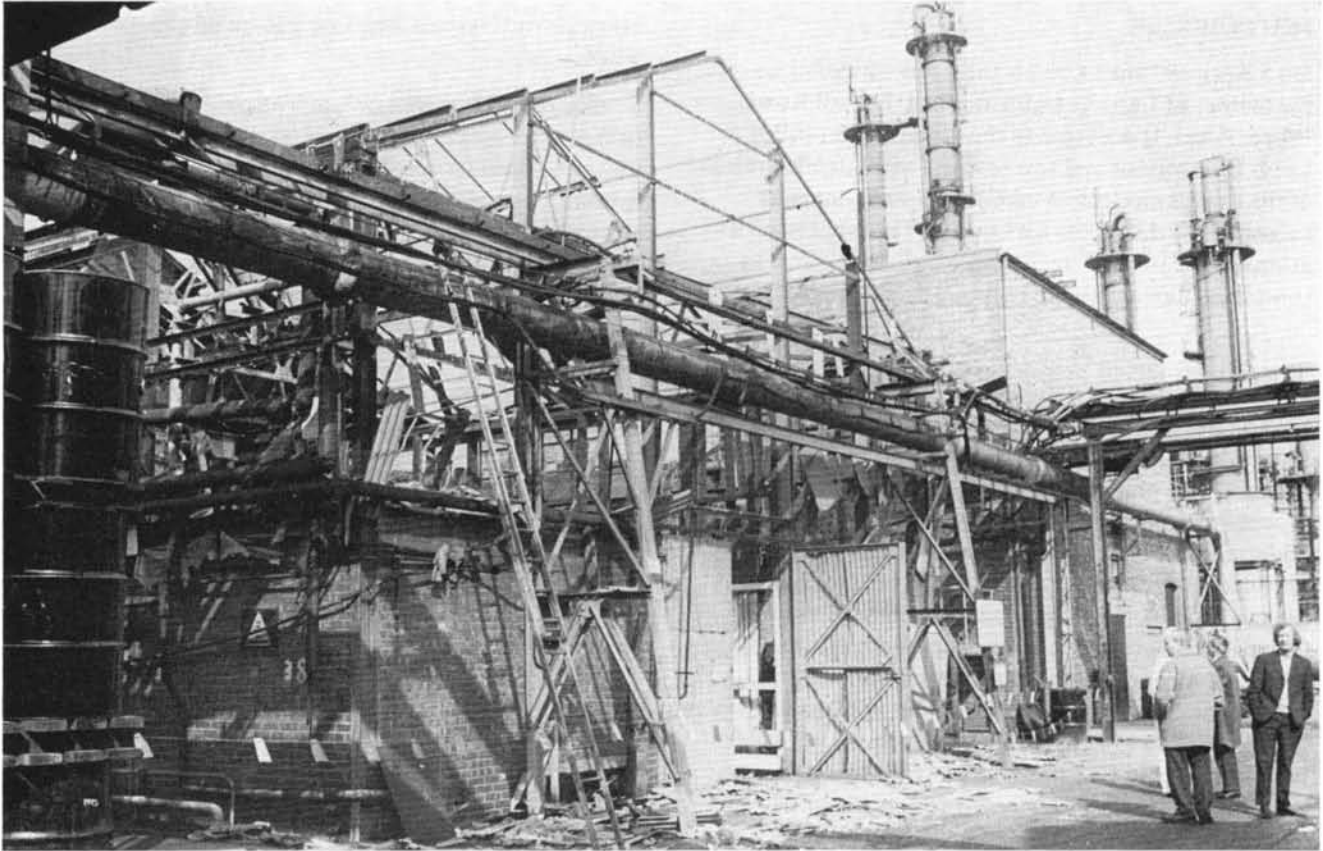
Fig 1 Exterior of plant building

20 The lightweight roof was almost completely blown off the building (fig 1) but adjacent and other buildings were hardly affected. There was no damage outside the factory, but the considerable damage to the electrolytor and its associated equipment included:

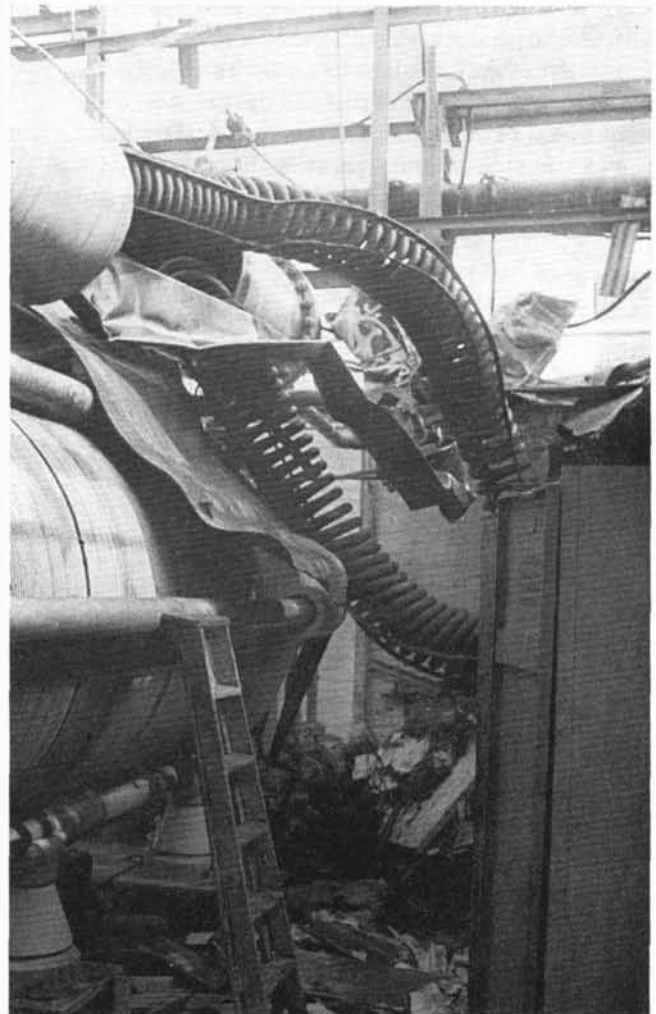
- The oxygen separator drum was ripped open and had expanded along its entire length.

Fig 2 Electrolytor showing cell block and oxygen separating drum with cooling coil

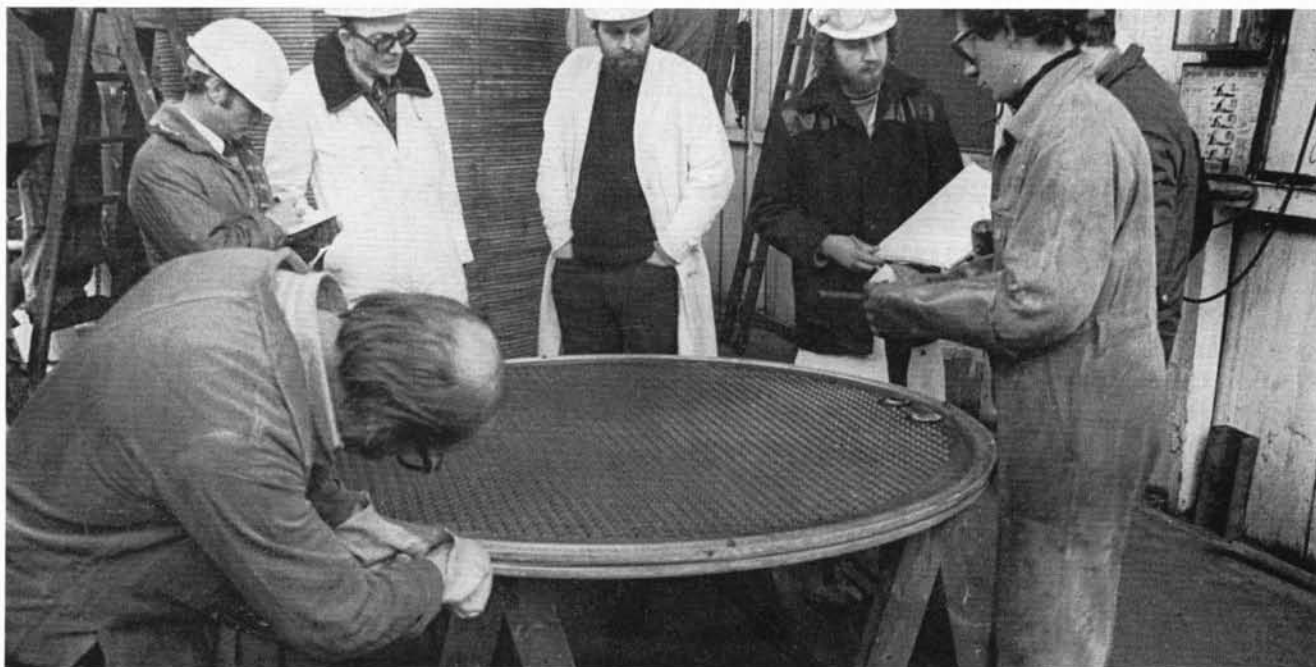
24 The cell blocks were then carefully dismantled, under the supervision of HM Factory Inspectorate. All cells were examined and any which showed any signs whatsoever of abnormality were segregated for further detailed examination. It was found that:

Fig 3 Dismantling a cell

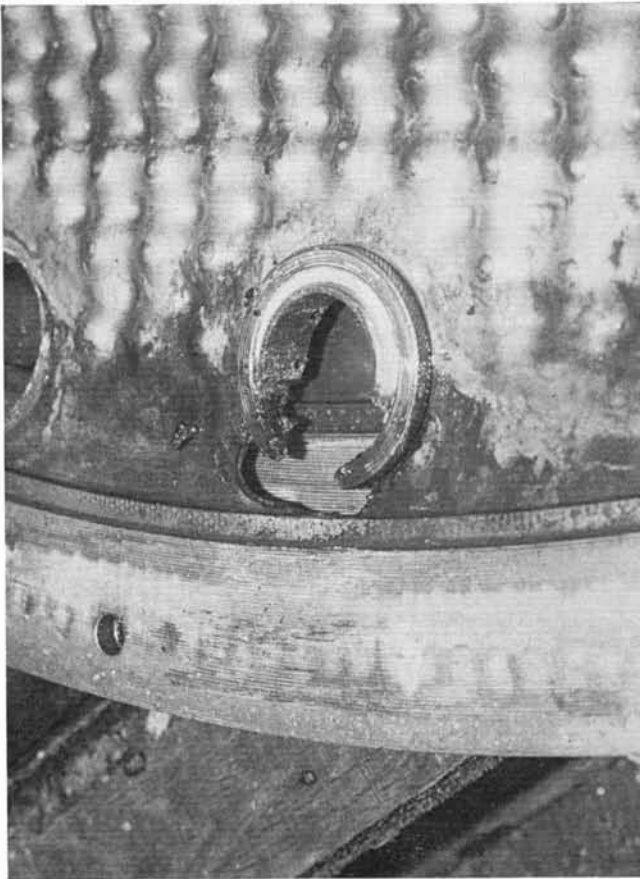
There was surface pitting of the plating on some of the goffer plates. (In some instances this had resulted in a hole right through the plate, fig 4.)

**Fig 4** Perforated goffer plate

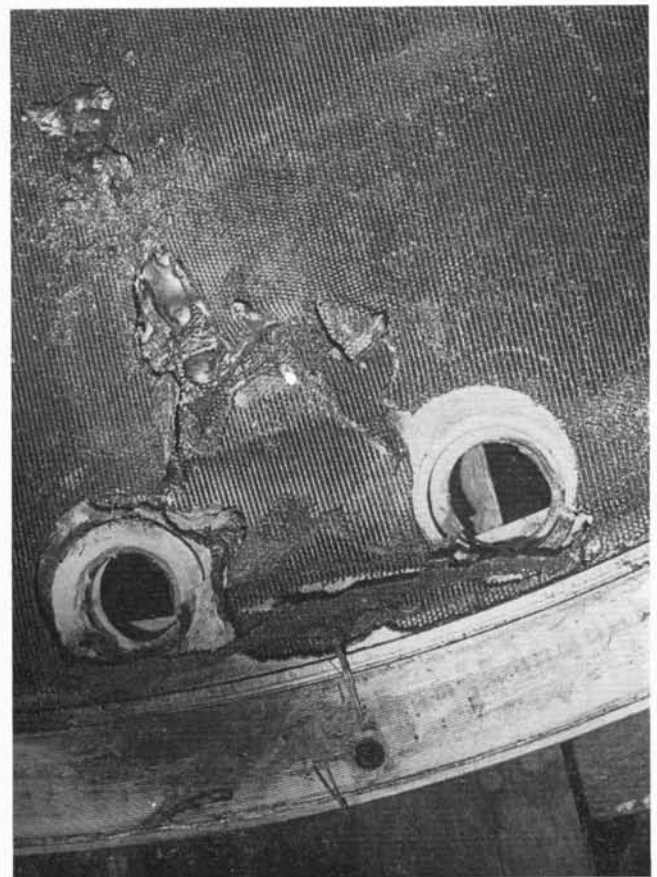
There was corrosion/erosion damage to some electrode gauzes with associated failure of the asbestos separators progressing to complete breakdown of the fabric of the cell, so that there was inter-connection between the hydrogen and oxygen ducts (fig 5).

**Fig 5** Cell 16/3 showing damage to electrodes and asbestos separator

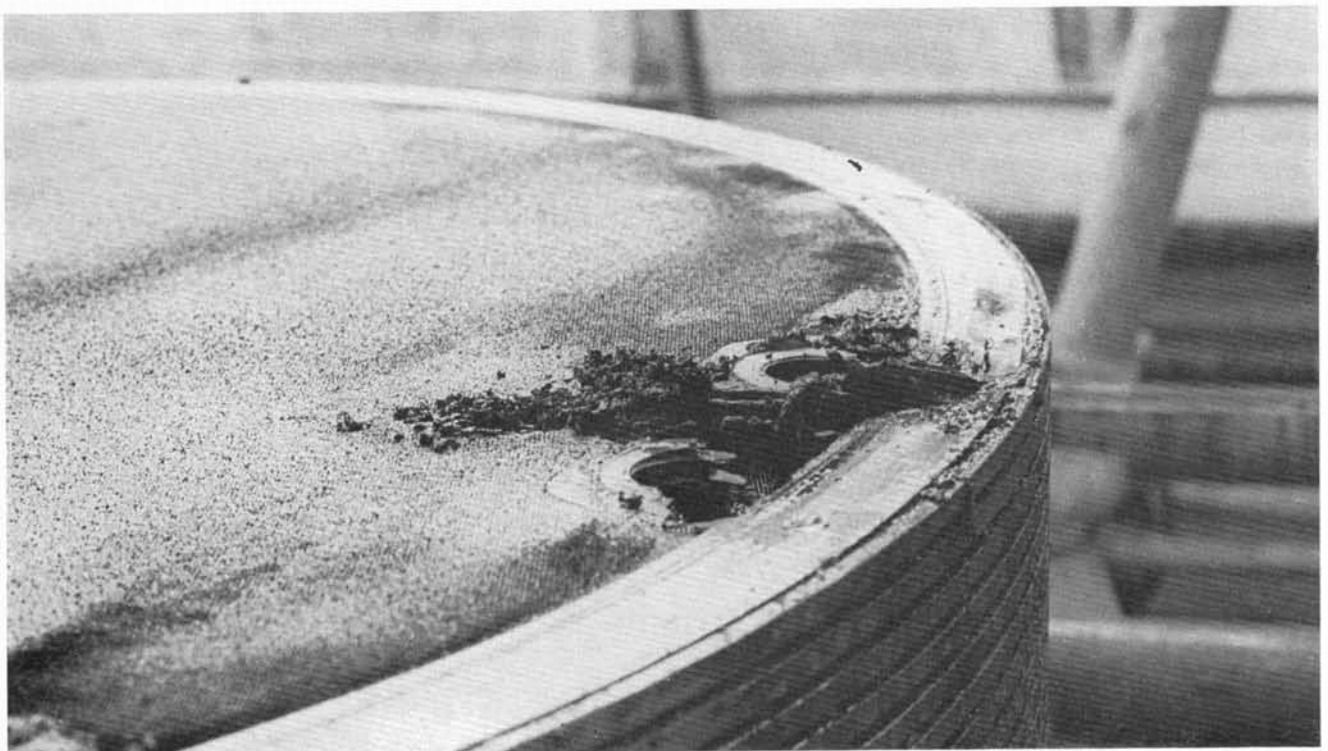
In one case (at the point where the electrolyte leak was observed on 2 April) the flange of the cell was eroded through to the outside (fig 6).

**Fig 6** Cell 79 showing damage in vicinity of gas off-takes

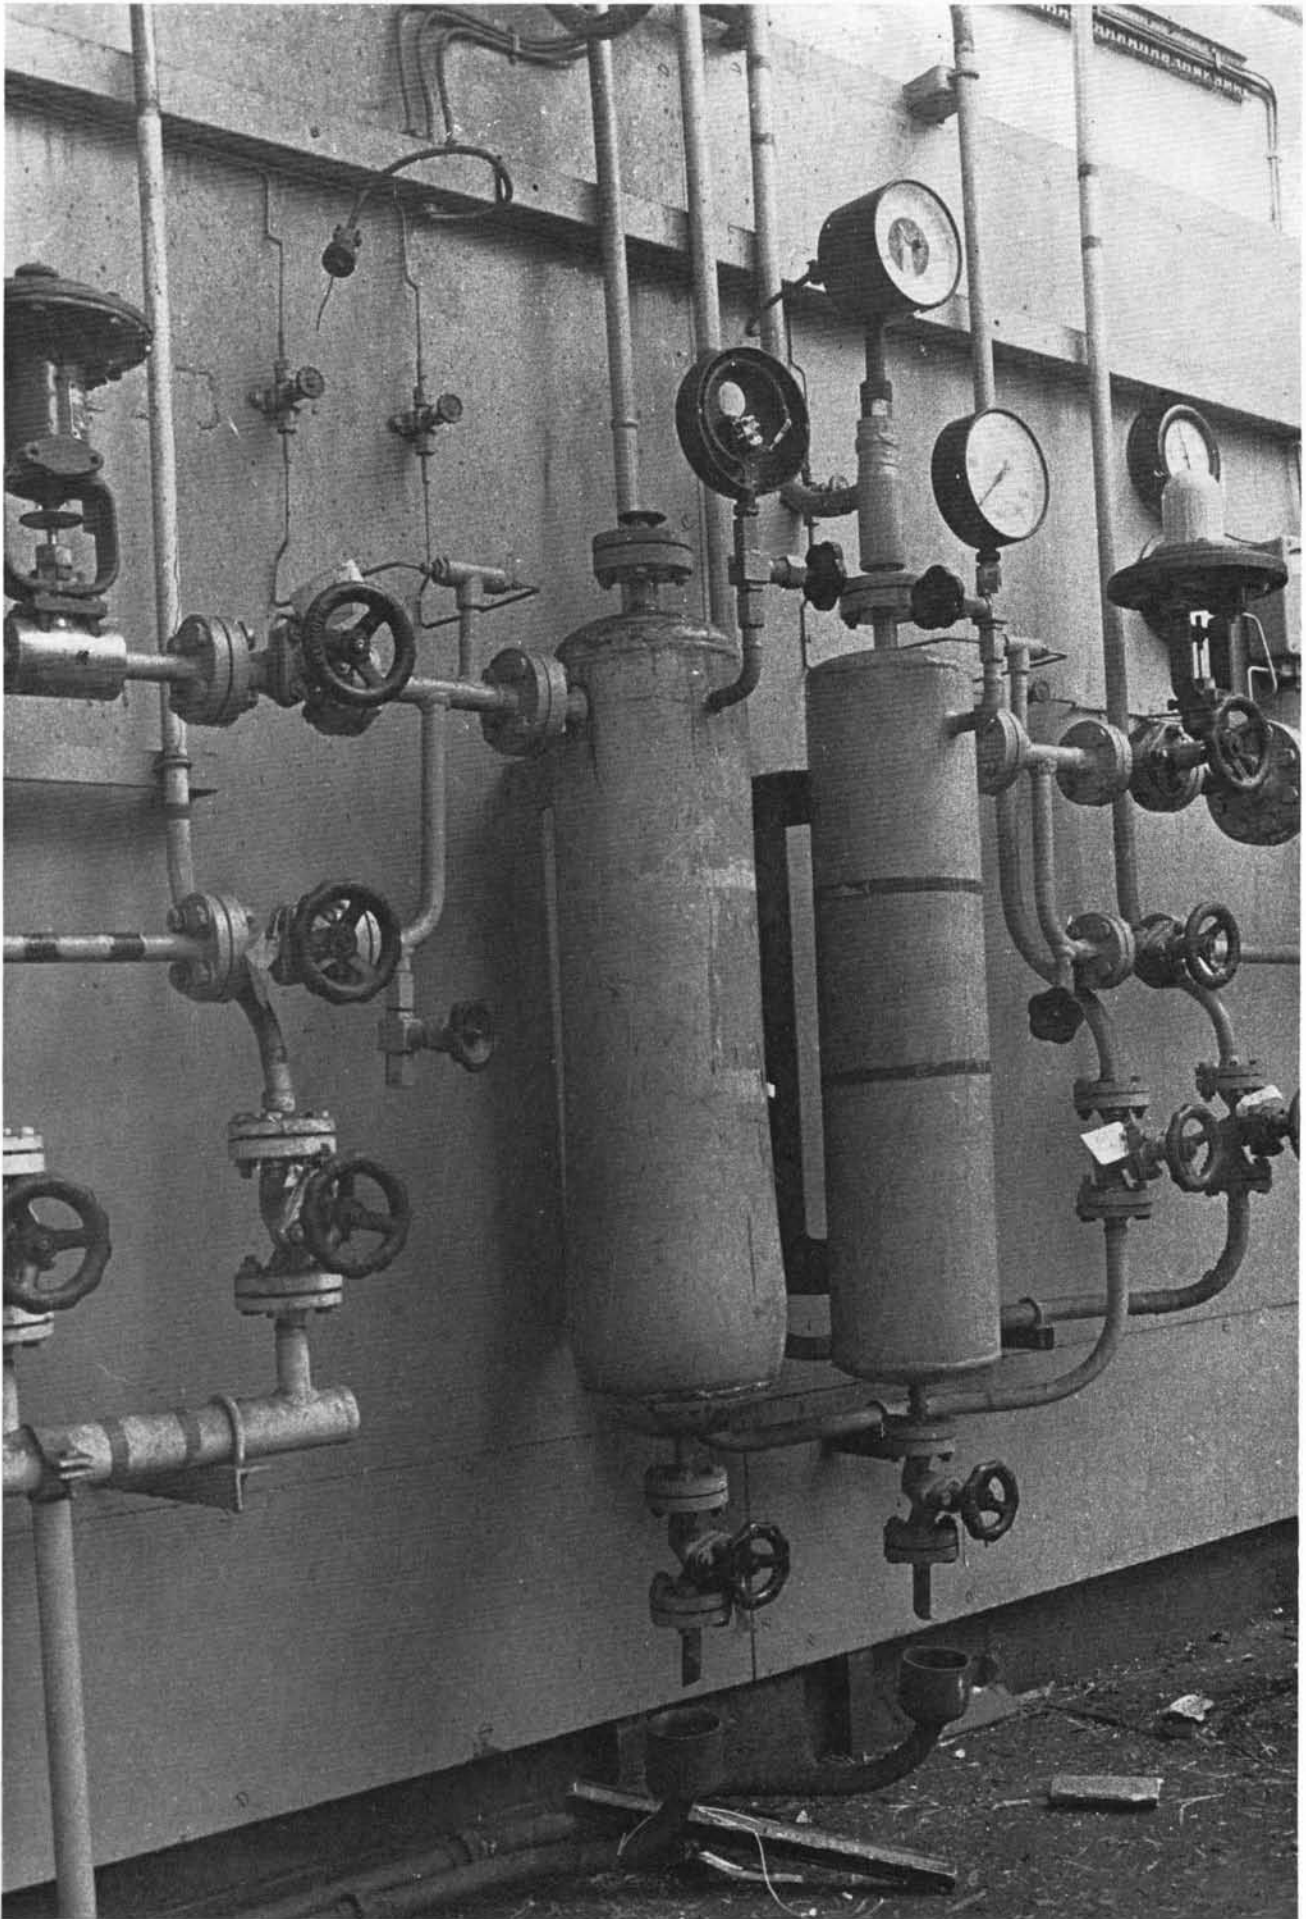
- The oxygen water separator was severely distorted by internal pressure.

Fig 7 Water separators showing distortion of oxygen separator on left

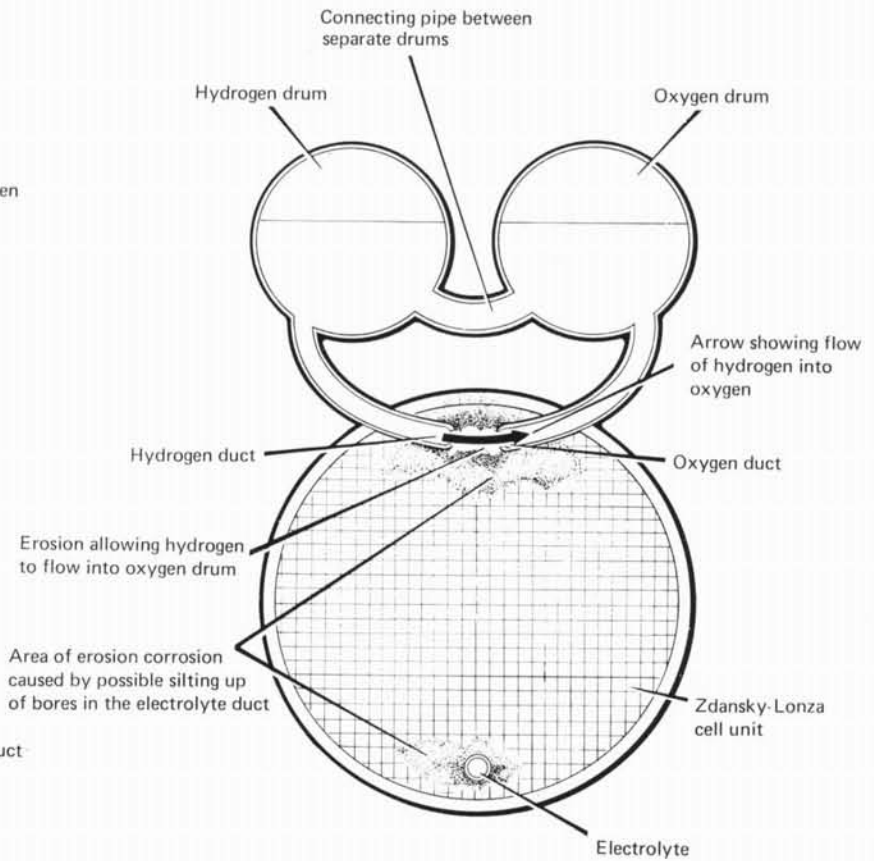
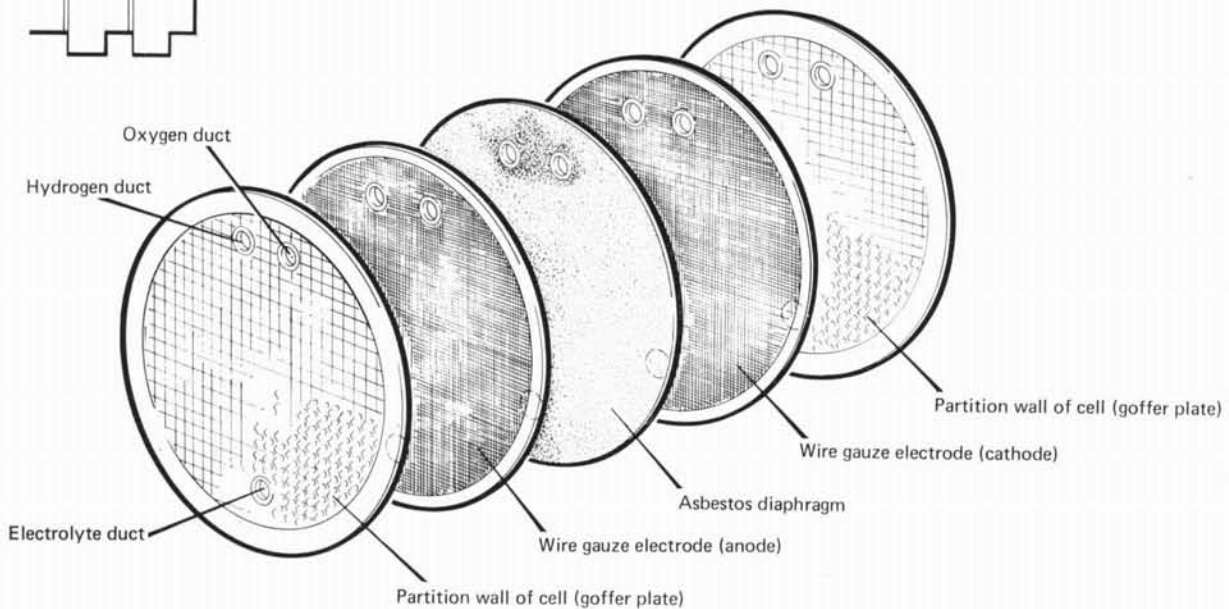
- Blockage by sludge of the narrow electrolyte passages, which admit electrolyte at the bottom of the cells.
- Reduction in electrolyte flow.
- Increase in internal or cell temperature.
- Increase in electrolyte concentration.
- Increased linear velocity of the electrolyte, where the passages are partially blocked.
- Corrosion/erosion of both the electrode gauzes possibly due to hydrogen embrittlement.
- Physical breakdown of gauzes and separators resulting in mixing of the hydrogen and oxygen.

Diagram showing possible cause of explosion
