The fire and explosions at River Road, Barking, Essex, 21 January 1980

**Health &
Safety
Executive**

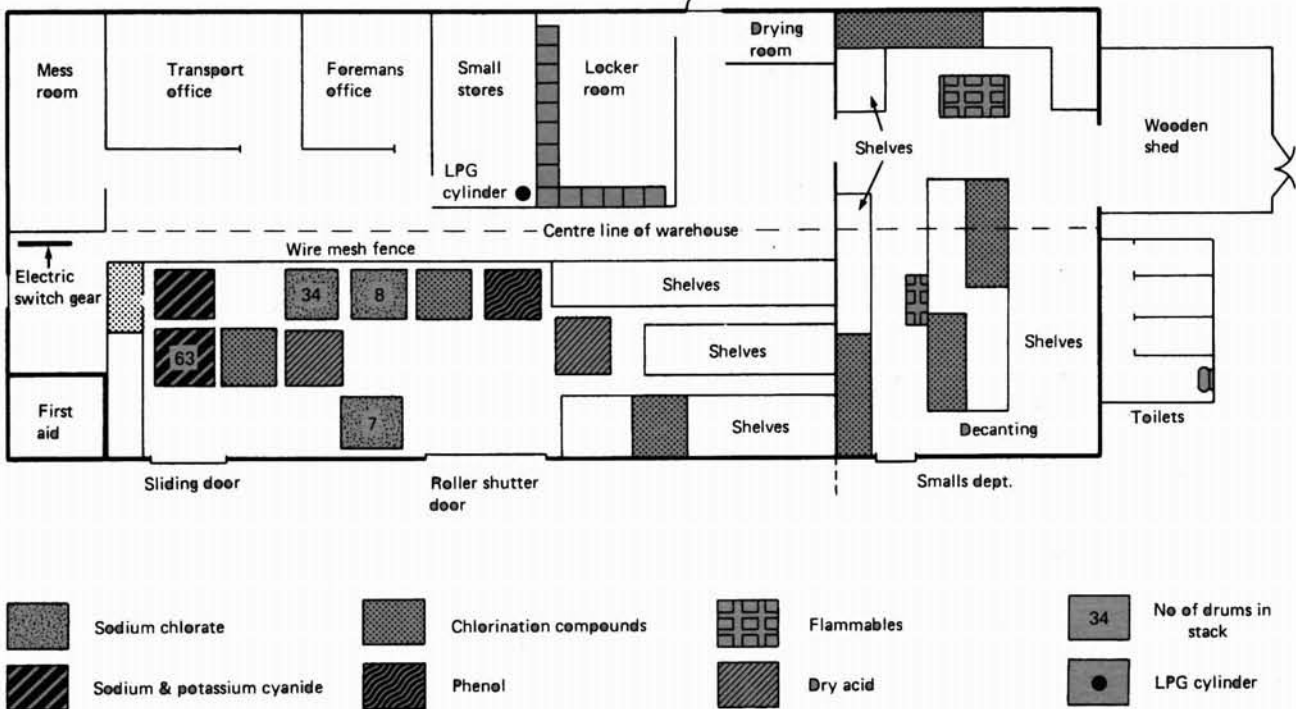
Detail of 'A'

The sodium chlorate was stored on wooden pallets in polythene lined 50kg steel drums in two main areas. The smallest pallet contained seven drums and was positioned adjacent to the small warehouse wall, between the wooden sliding door and the steel roller shutter door. The other drums were stored in the centre of the warehouse in two adjacent stacks, one stack containing a single pallet of eight drums and the other 34 drums, in a two-pallet high stack, as indicated in the plan on the inside front cover.
